Impact of Grenfell Tower fire disaster on polyisocyanurate industry^{*})

Grazyna Mitchener¹⁾

Abstract: The paper summarizes commonly available information on the fire of the Grenfell Tower, which took place in Central London on 14 June 2017. The fire was very similar in its nature to several other spectacular fires at tall buildings, which have happened around the world since 1999 but unlike the previous one, the London fire claimed an enormous number of victims – 71. The tragic outcome of the fire was blamed on a combination of several human and natural factors: faulty evacuation procedures, unsuitable fire extinguishing equipment, mistakes by the housing association managing the building, lacking fire safety provisions in the tower, weather, confusing building regulations, *etc.* However it was established that the main reason for so tragic an outcome of this fire was the speed of fire spread *via* decorative aluminum composite materials (ACM) containing polyethylene (PE), installed on the outer of a building as a part of a rain-screen cladding system. The other part of the system was polyisocyanurate (PIR) thermal insulation. The paper focuses on the role of PIR in this fire a

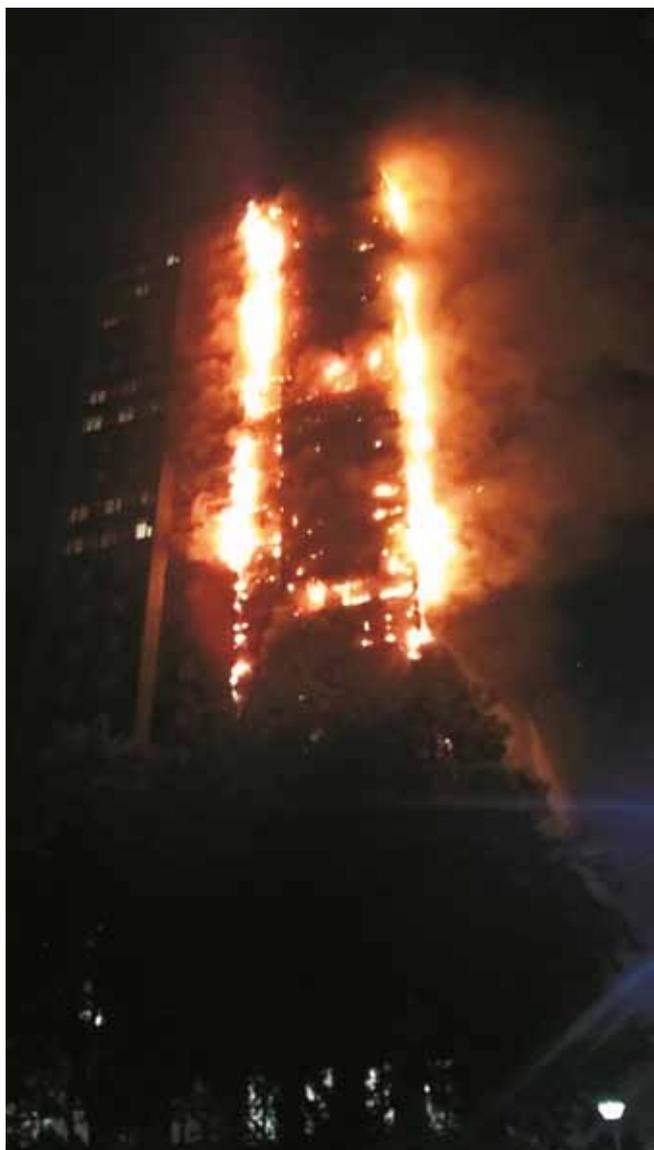
Grenfell Tower was a 23-storey residential building in Central London. In the middle of the night on 14 June 2017 a faulty fridge caught fire in a flat on the fourth floor. The fire quickly managed to get out through a window and then with unprecedented speed at first shot up to the top of the building in less than 30 minutes and then within 2 hours engulfed the whole building outside and inside (Fig. 1).

Fig. 1. Burning Grenfell Tower 14 June 2017 London (with permission of Rex Features)

24 hours later leaving behind a burnt out skeleton of the building. Seventy-one people lost their lives in the fire.

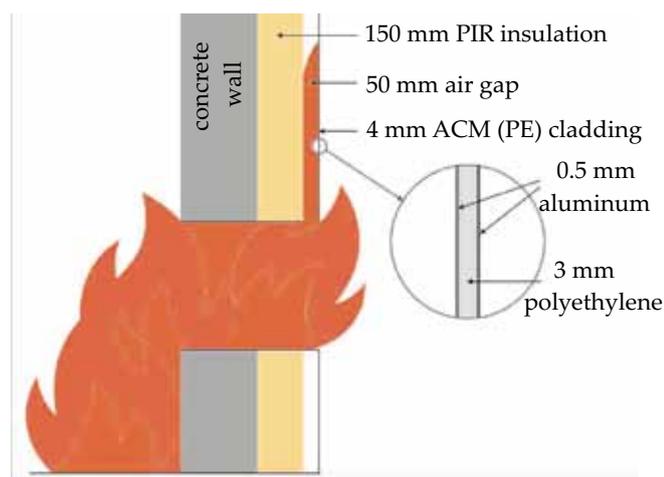
Fig. 2. The structure of the rain-screen cladding installed on the Grenfell Tower and the mode of fire spread *via* "chimney effect"

The cladding was a thermal insulation system consisting of 10–15 cm thick polyisocyanurate (PIR) boards and aluminum composite material (ACM) panels separated by a 50 mm air gap (Fig. 2).

It was believed that once the initial fire got out of the first flat, it began to be fuelled by the highly flammable polyethylene present in the ACM (PE) and then spread rapidly due to a "chimney effect" of the air gap (Fig. 2). Naturally the chimney effect propagates fire mainly

upwards, but the night of 14th of June 2017 in London was windy and warm. The wind helped the fire to spread horizontally around the whole tower. Due to the warm weather, windows in several of the flats were open and flames quickly found their way back inside the building on most of the floors.

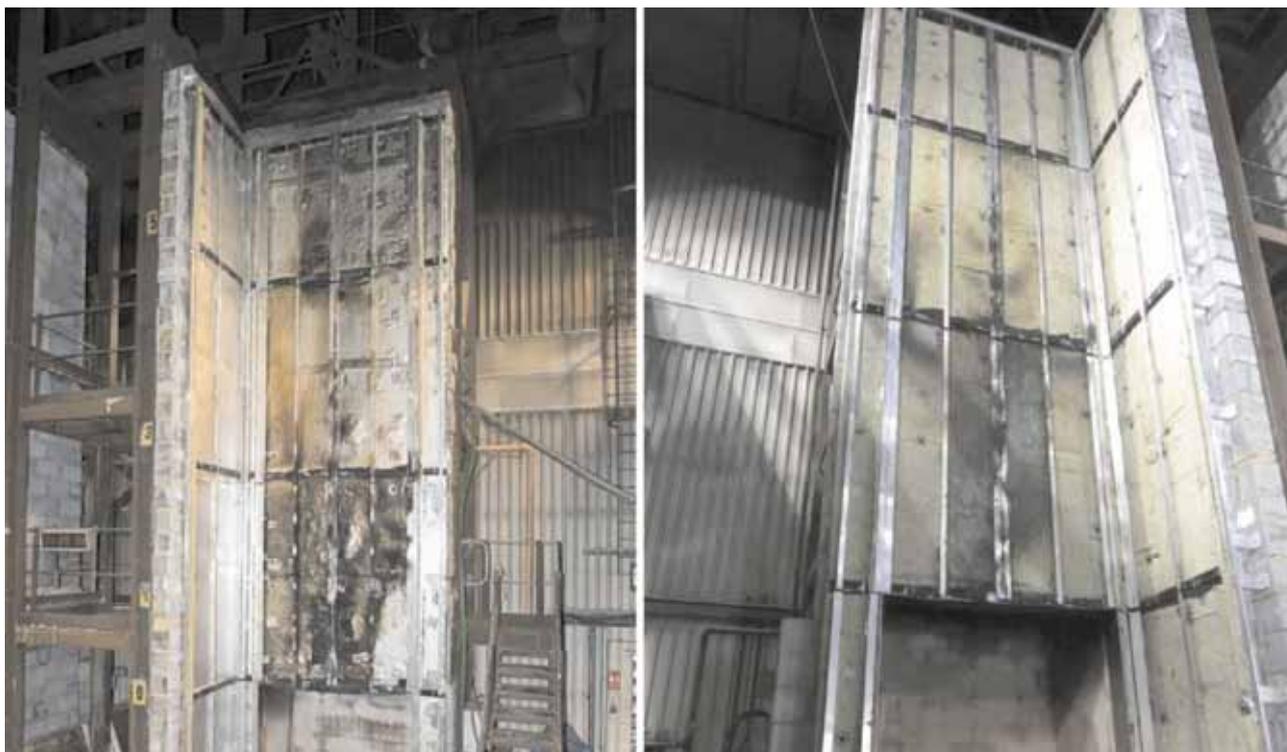
Both tests in which ACM (PE) was used over PIR insulation (test no. 1) or stone wool (test no. 2) had to be terminated after 7–8 minutes, due to the flames spreading well above the 8 m height of the rig but neither of the insulation products showed much fire damage (Fig. 4). These tests clearly replicated the speed of fire propagation observed on the Grenfell Tower.

Fig. 4. The PIR (left) and stone wool insulations (right) after BS8414 tests no. 1 and no. 2 and removing the ACM (PE) decorative cladding
