## Examples of parts regeneration used in the internal combustion engines made in LMD technology

**Abstract:** This article presents examples of regeneration of the internal combustion engines parts that have been damaged as a result of wear. Engine parts have been regenerated with the use of laser technology - Laser Metal Deposition (LMD) and selected metal alloy powder. Laser cladding have been done on the surface of the elements, in order to reproduce the shape and material loss. All elements have been presented in the used state and after the regeneration along with a discussion of specific aspects of the process.

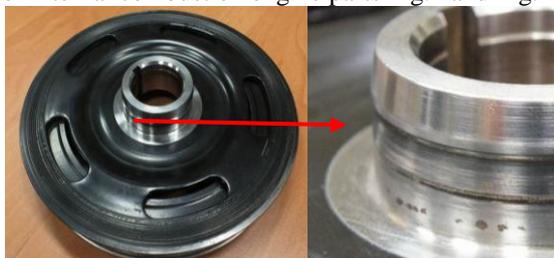
Fig. 1. Crankshaft pulley hub, damaged – used area

– For the crankshaft pulley hub: laser output power 650 W, laser beam diameter 1.642 mm, feed rate 9 mm/min, scanning speed 1580 mm/min, overlapping 30% and powder feed rate 8 g/min, angle between nozzle and pulley hub was  $38^\circ$ , Co-based alloy coating was produced in three passes.

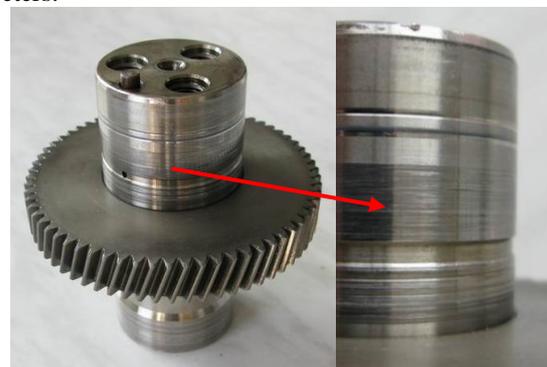
Fig. 2. Gear wheel of oil pump – used area

– For the gear wheel of oil pump: laser output power 650 W, laser beam diameter 1.426 mm, feed rate 10 mm/min, scanning speed 1570 mm/min, overlapping 25% and powder feed rate 8 g/min, angle between nozzle and pulley hub was  $28^\circ$ , Co-based alloy coating was produced in two passes.

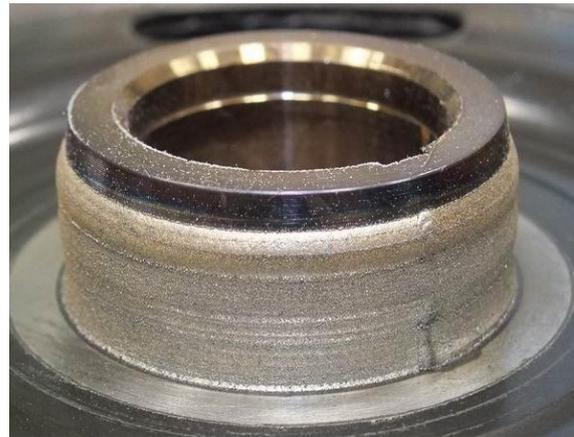
To analyze the surface condition after laser cladding process stereoscopic microscope was used. Different number of LMD passes for each element have been used, due to the different level of wear. For the crankshaft pulley hub the machining allowance after the laser cladding was ca. 0,8 mm on diameter (nominal shaft diameter was  $\phi$  40 mm (Fig.3). For the gear wheel of oil pump the machining allowance after the laser cladding was ca. 0,5 mm on diameter (nominal shaft diameter was  $\phi$  50 mm (Fig.4). Investigation of laser cladding surface proved that no surface cracks have been observed.

Fig. 3. Crankshaft pulley hub after laser cladding

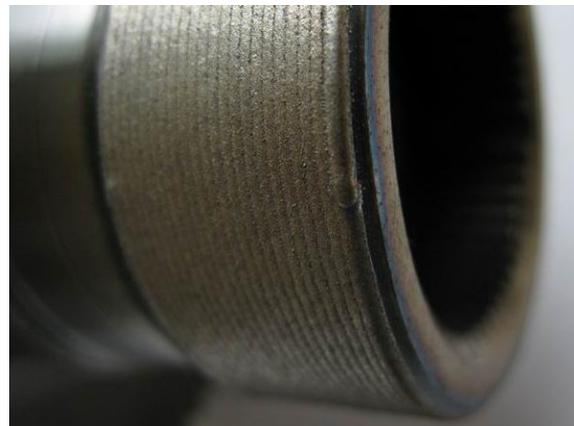
Fig. 4. Gear wheel of oil pump after laser cladding

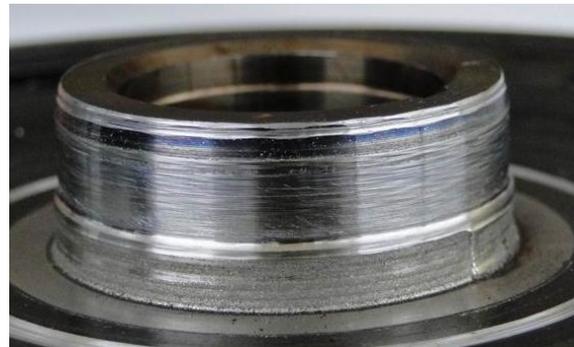
Fig. 5. Crankshaft pulley hub after machining

After laser cladding process crankshaft pulley hub and gear wheel of oil pump have been subjected to machining and grinding to nominal size (Fig.5) and (Fig.6).

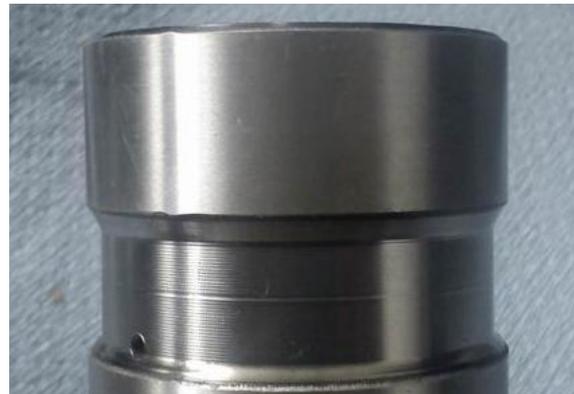
Fig. 6. Gear wheel of oil pump after grinding

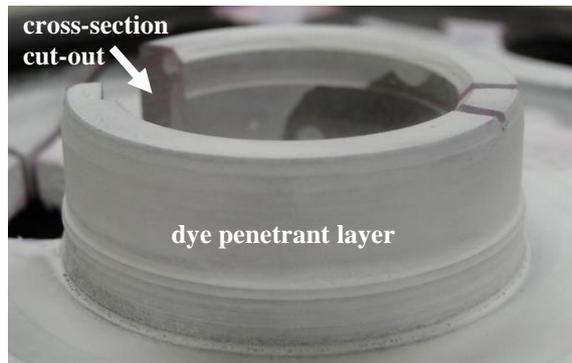
Pulley hub with the penetrant applied on repaired surface layer is shown in Fig.7. Dye penetrant inspection have confirmed high quality of produced stellite metal layer. There were no cracks, discontinuities, porosity and other surface defects ranging in size from 30 to 50 microns.

Fig.7. Crankshaft pulley hub during dye penetrant inspection

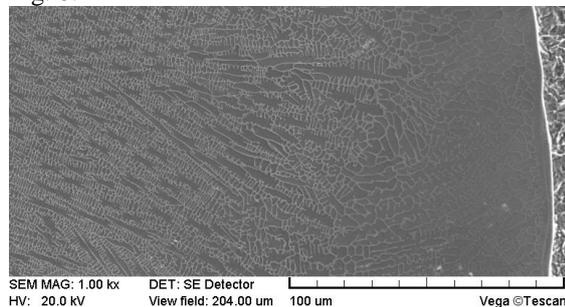
Powder metal layer consists of two zones – outer, clear and which not etching in nital and heat affected zone of fine grain bainite structure. Outer zone with a high cobalt content and other cladding powder components is characterized by a dendritic microstructure (typical for stellite) and is shown in Fig. 8.

Fig. 8. Microstructure of Stellite 6 metal layer

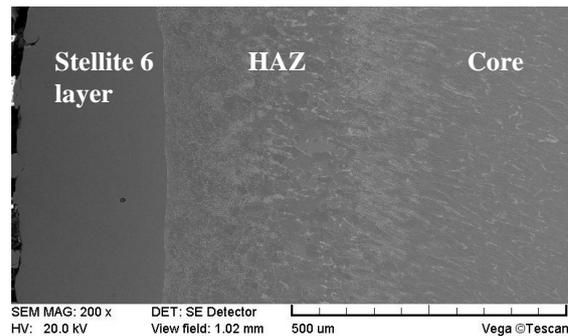
At substrate zone border the stellite layer is mixed with steel what indicates good binding with substrate. No porosity and no cracks in outer zone have been observed. Thickness of cobalt zone after machining was ca. 160 μm.

Fig. 9. Microstructure of surface layer and substrate of pulley hub after the laser cladding and machining

Under this zone was located heat affected zone (HAZ), which had 200 μm thickness and was characterized by a fine grain. Both zones (HAZ and core) had a low-carbon bainite microstructure.

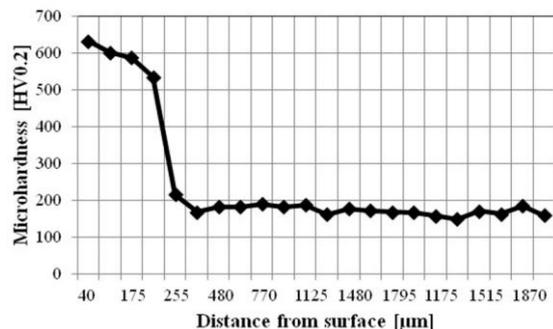
Microhardness change across cross-section profile of regenerated crankshaft pulley hub is presented in Fig.1 10. Laser clad layer have increased hardness in comparison to substrate steel. Substrate microhardness was about 160 HV0.2, while maximum value in clad layer was 633 HV0.2. It was found out that microhardness had increased also in heat affected zone.

Fig. 8. Microhardness profile on cross-section of repaired crankshaft pulley hub specimen
