Karol Firek\*, Stanisław Barycz\*, Wojciech Kocot\*, Michał Witkowski\*

## Evaluating Damage to a Typical Precast Warehouse Building\*\*

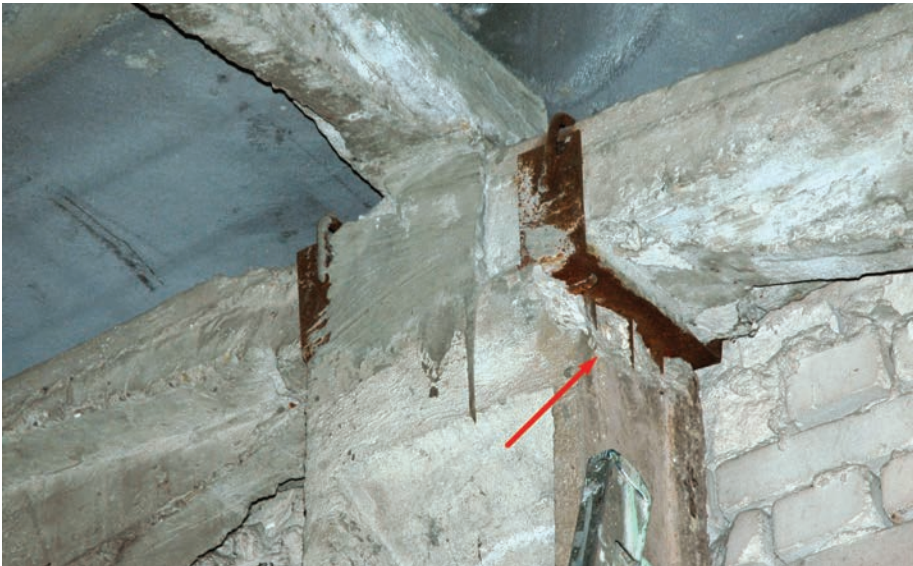
**Fig. 2.** The head of the central row column at the southern end wall. Loss of concrete of the depth up to 4 cm along the edge of the column head, at the level of the girder support

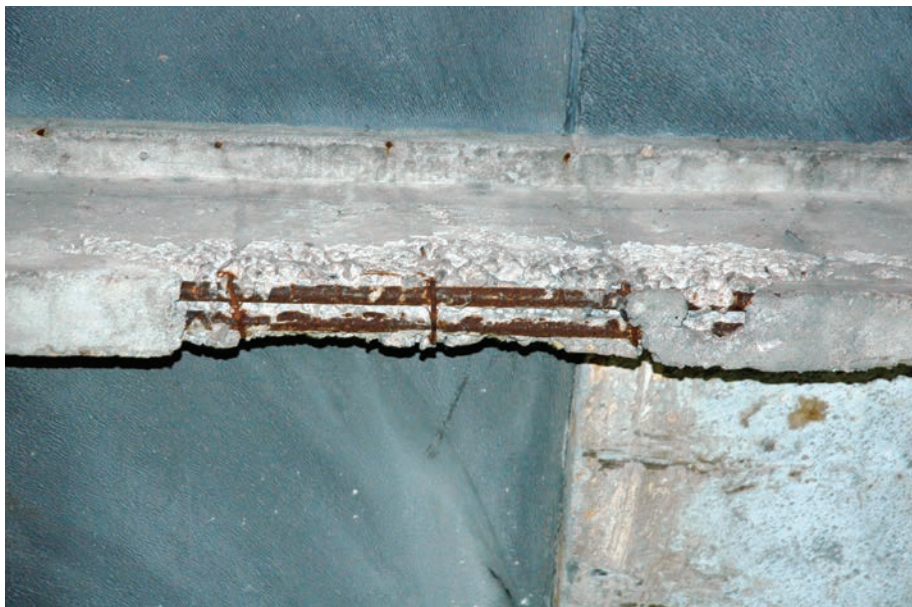
**Fig. 3.** The purlin in the middle part of the warehouse roof covering. Loss of concrete cover along the bottom edge of the beam and corrosion of the exposed rebars

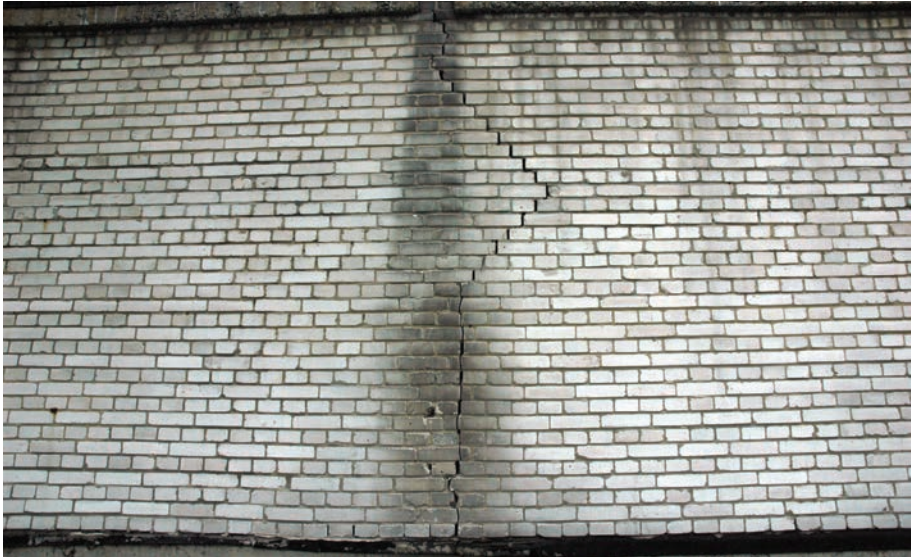
Fig. 4. Detail of the east elevation in the middle part – wall crack (up to 7 mm) in the vicinity of the load-bearing structure column

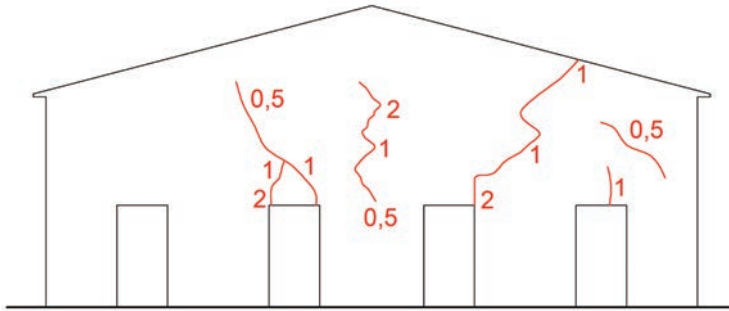
Fig. 5. Damage visible on the north elevation

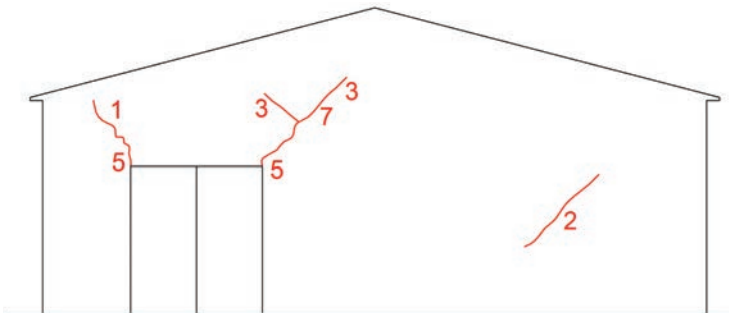
Fig. 6. Damage visible on the south elevation

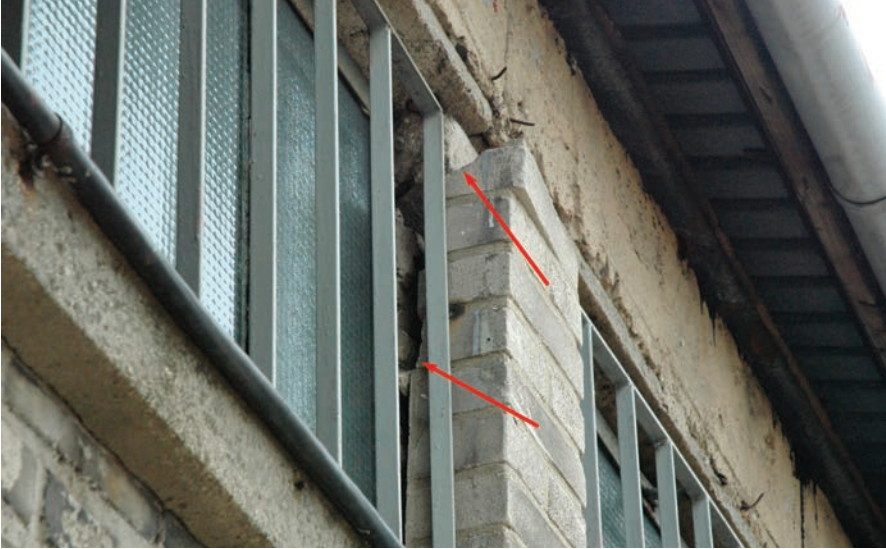
Fig. 9. Detail of the west elevation in the middle part – crack, displacement and delamination of a part of the brick pillar between the window openings

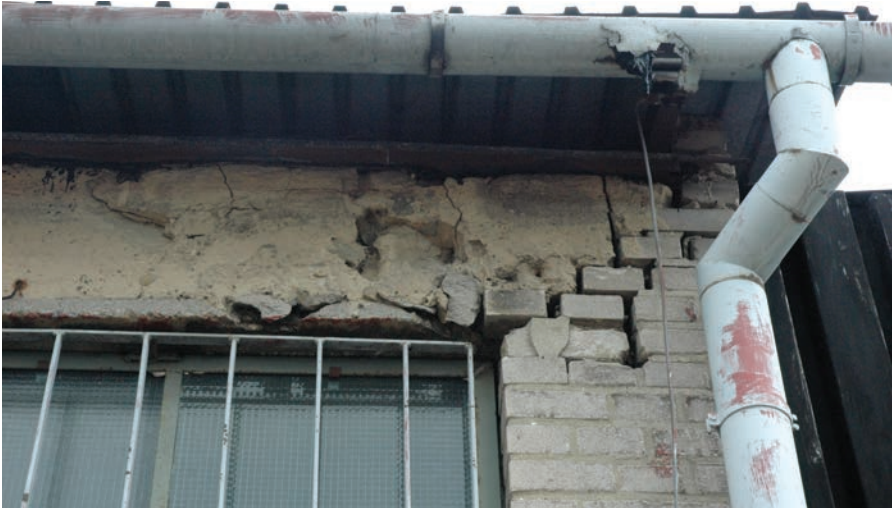
**Fig. 10.** Detail of the west elevation at the south corner – corrosion and delamination of the brick pillar as well as corrosion and cracking of the reinforced concrete lintel
