FAILURE ANALYSIS OF A FEMORAL HIP STEM MADE OF STAINLESS STEEL AFTER SHORT TIME OF EXPOSURE

Żaneta Anna MIERZEJEWSKA*, Zbigniew OKSIUTA*

*Faculty of Mechanical Engineering, Division of Materials and Biomedical Engineering, Białystok University of Technology,
ul. Wiejska 45c, 15-351 Białystok, Poland

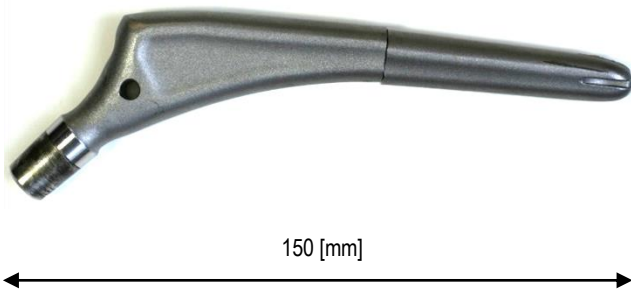
General image of the fractured stem is shown in Fig. 1. After revision, two parts of the fractured stems were prepared for further analysis. A small piece of material was cut from the stem and prepared for metallographic observations according to ASTM E1306-11 standard. The chemical composition of the stainless steel was examined by means of a spark emission spectroscopy (Thermo ARL Quantis, Switzerland). Microstructure observations after etching by means of the Vilella's echant (picric acid 1 g; HCl 5 ml; ethanol 100 ml) were carried out by an optical microscope (OM) a Nikon Eclipse LV1000. The fracture surfaces of stem were examined by means of Scanning Electron Microscopy (SEM) Hitachi S-3000N, equipped with Energy Dispersive Spectroscopy (EDS). Hardness measurements were performed using Vickers universal indenter with a load of 5 kg. Grain size and hardness measurements were performed according to ASTM standards E112 and E384, accordingly.

Fig. 1. General view of the fractured stainless steel stem

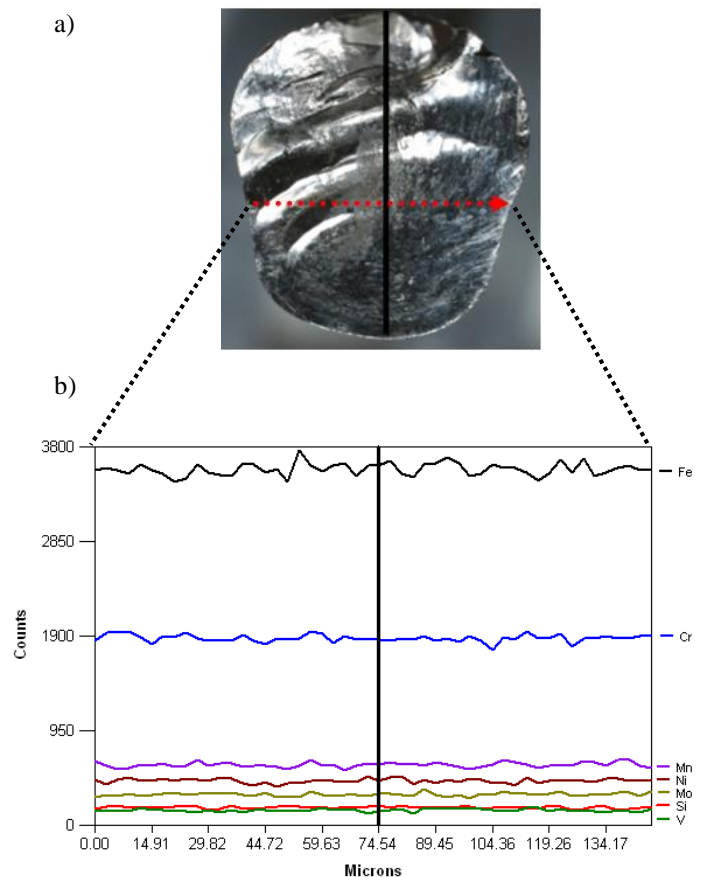
SEM-EDS linear analysis was also performed to observe changes in the concentrations of main alloying elements along a cross-section of the stem as it is presented in Fig. 2a. The results presented in Fig. 2b confirmed a homogeneous distribution of alloying elements in the steel matrix.

Fig. 2. SEM-EDS linear analysis of the elements concentration on the surface of the stem – (a) macroscopic view (b) – elements distribution

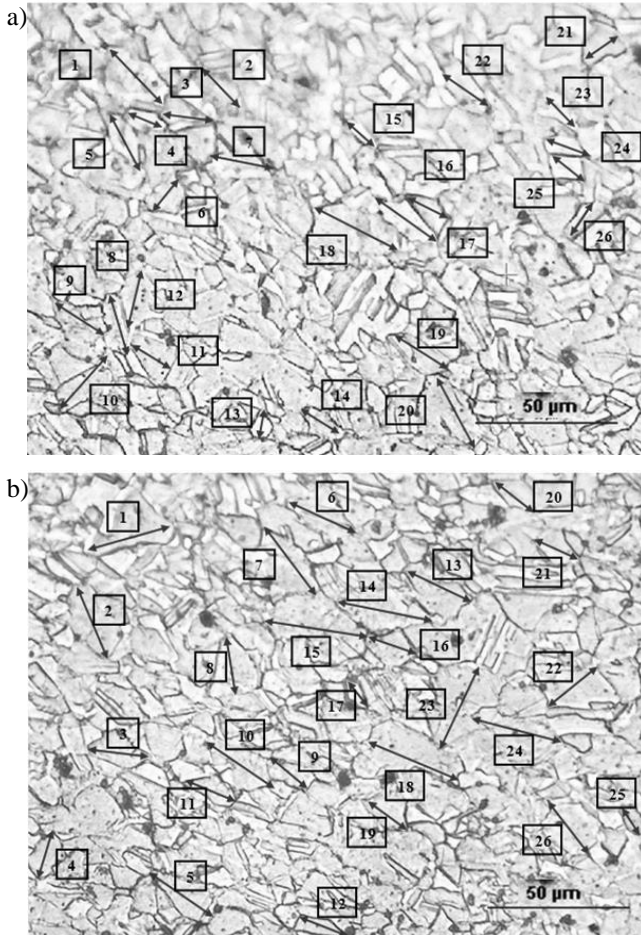
OM image of the etched microstructure of the tested sample, presented in Fig. 3 showed equiaxed austenitic grains and twins characteristic for forged and annealed austenitic stainless steels. Note, that no delta ferrite was observed.

In general, the microstructure is quite homogeneous, with an average grain size of $36 \pm 3 \mu\text{m}$ (no 7 according to ASTM). However, larger grains near the surface of the stem were also observed (which may cause an origin of a fatigue crack initiation of the steel (Fig. 3b). This inhomogeneity of the grain size is difficult to explain, however, this may be related to hardness results presented in the section 3.3 (Fig. 6).

Fig. 3. Typical OM microstructure of the femoral stem;
 (a) taken from inside of the stem
 (b) taken from an edge of the stem

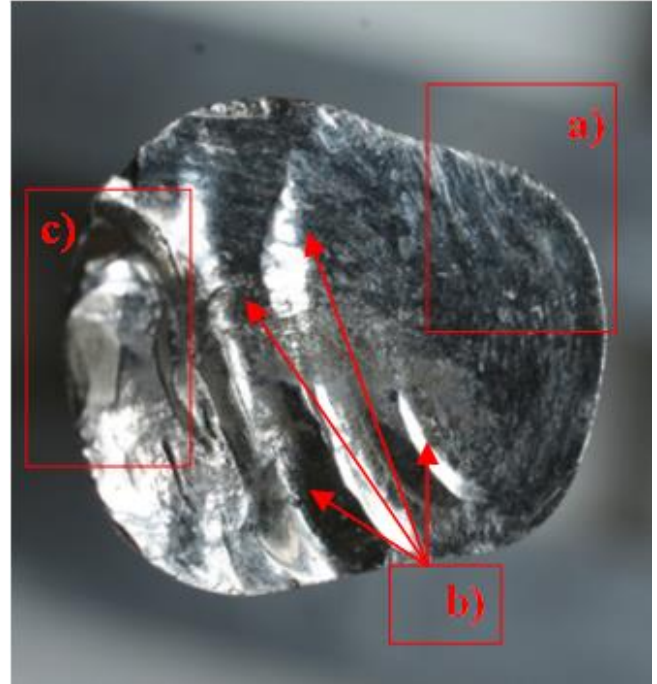
Fig. 4 shows a general view of the fractured surface of the tested material. The image shows a several distinctive features typical for fatigue fracture: an origin where a crack can be initiated (zone a), fatigue striations (zone b), and a final fracture area (zone c). The fatigue fracture probably was initiated close to the lateral edge of the material, and further propagated until a cross section of the stem was no longer strong enough to bearing the applied load and it finally broke. The fatigue zone is unique to fatigue fractures because it is the region where the crack grows from the origin to the final fracture zone. It should be pointed out that the geometry of the fractured stem did not reveal any changes. No bending of stems was observed. Also, no traces of corrosion were discovered.

Fig. 4. Fatigue surface with fracture view showing the zones:
 a) an origin, b) progression lines
 c) and a final fracture zone

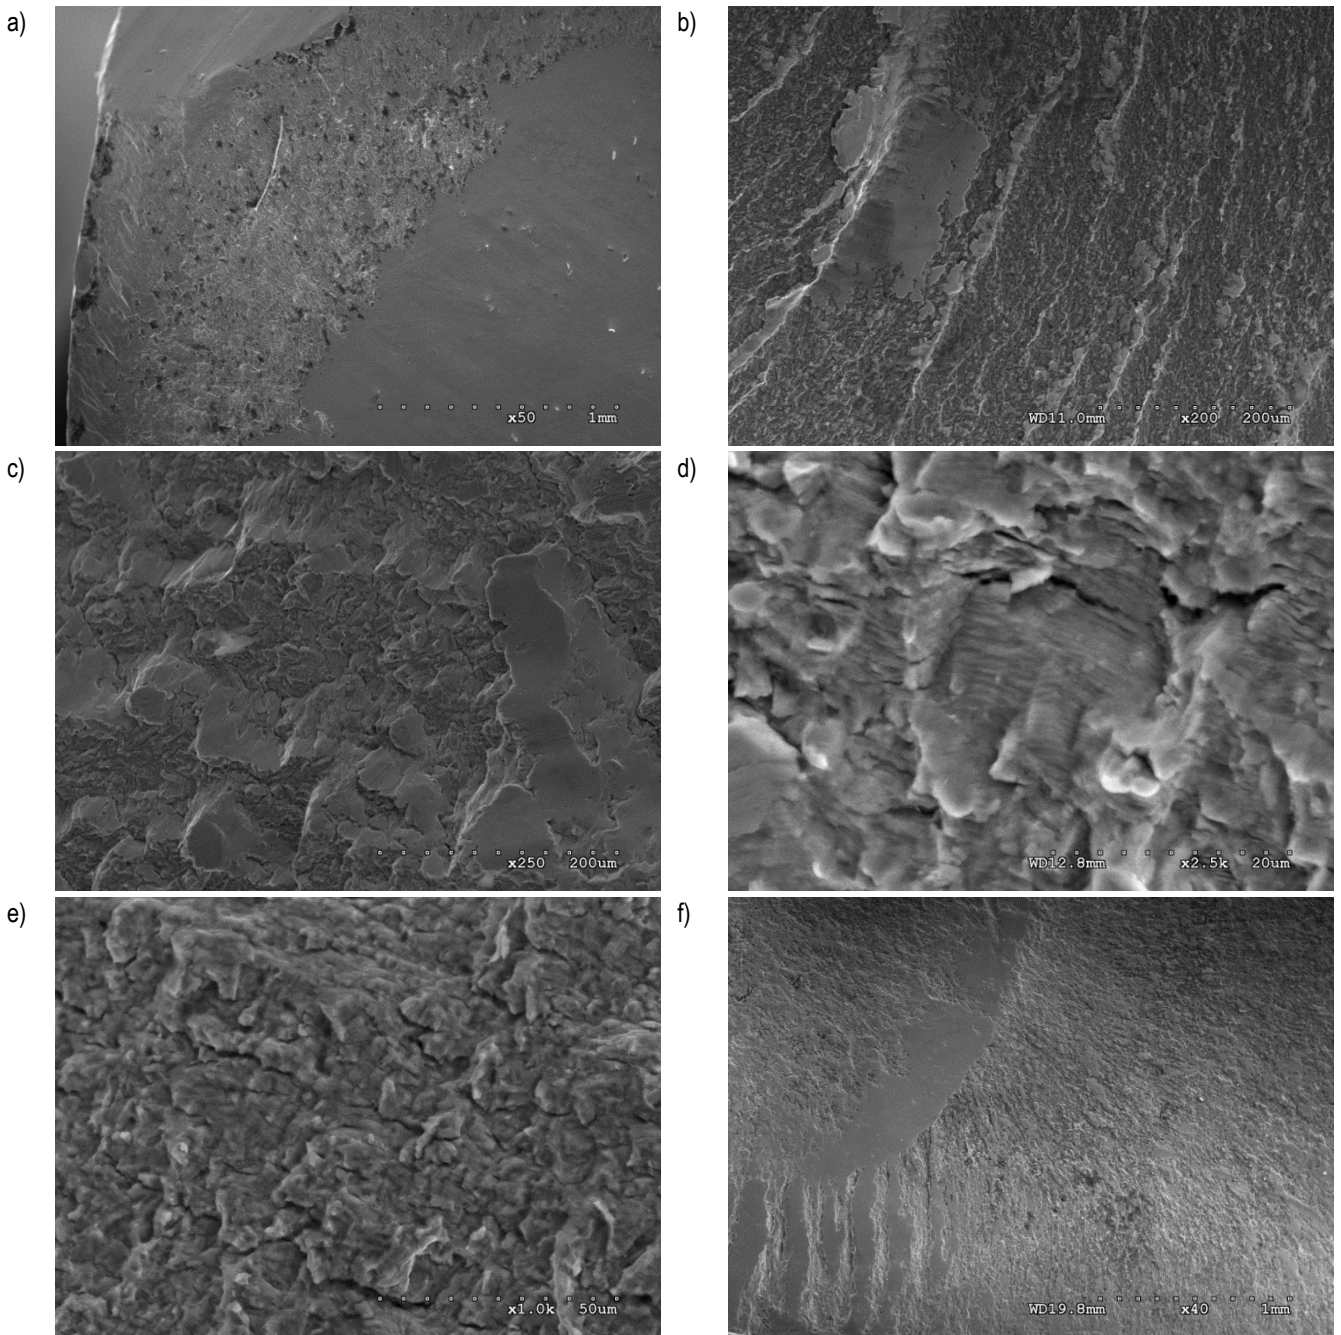
Fig. 5 shows SEM images of the fractured surface. Fig. 5a presents the magnified cracks initiation region whereas Fig. 5b shows some of the "beach marks" (progression lines) area. Each mark

or line was created when the crack stops after short distance propagation. These patterns are not clearly visible, probably because the fracture surfaces were severally smashed, as a result of friction of both broken parts during prolonged walking after fracture. There is another possible explanation reported by Brown (2014) and related to very fine microstructure of steel or unchanged load during fatigue damage.

As the cracked stem continues to be stressed, the crack progresses across the section. The amount of material carrying the load is decreasing, so the stress is obviously increasing. Fig. 5c confirms extensive friction islands at the fracture surface, however higher magnification image in Fig. 5d shows typical fatigue striations. In Fig. 5e numbers of secondary cracks were observed, propagated perpendicular to the loading direction. The length of these cracks corresponds well to the grain size of the steel. This type of fracture may be caused by the presence of non metallic inclusions. Fig. 5f shows the SEM image of the final fracture stage, where the unbroken area is reduced to the point that the applied stress exceeds the ultimate strength of the material.

Fig. 5. SEM images of the fracture surfaces of the tested steel failed by fatigue fracture demonstrating: (a) origin of the failure (b) beach marks area; (c) wear islands on the fracture surface ; (d) fatigue striation; (e) secondary cracks and fatigue tears; (f) final fracture area

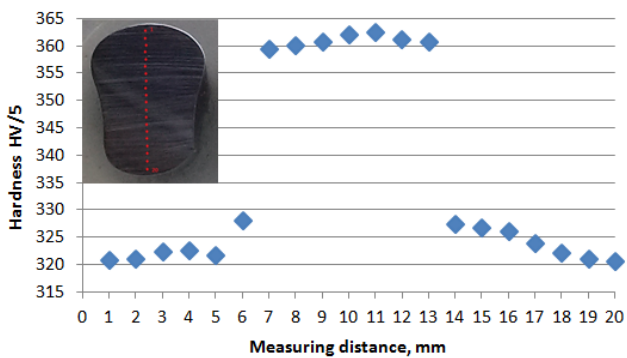
The hardness measurements of both parts of the broken stem was performed few millimeters below and above of the fracture. An average hardness of tested material is $\sim 335 \text{ HV}/5$ and fulfills ASTM requirements. However, an interesting effect was observed, not equal and strong dependence of hardness of the measurement site. In the middle of the cross section of the stem the hardness is $360 \pm 2 \text{ HV}/5$ and close to the edge of the cross section of the specimen is about 10% lower, $325 \pm 5 \text{ HV}/5$ (see Fig. 6).

Fig. 6. Hardness measurements of the tested stem as a function of the distance from the edge of the sample

It is not a significant scatter of the hardness of the tested specimen, however it is difficult to explain, because these results are not consistent with the microstructure observations presented in Fig. 3. According to the Hall-Petch equation (Petch, 1953) with decreasing the grain size the ductility and hardness of the material increase. On the other hand this statement is not valid for some groups of materials, especially with subgrain microstructure.
