ANDRZEJ GONET\*, STANISŁAW STRYCZEK\*, KRZYSZTOF BRUDNIK\*\*

**CAUSES AND CONSEQUENCES OF WATER FLUX ON THE EXAMPLE OF TRANSVERSE  
HEADING MINA IN THE SALT MINE “WIELICZKA”**

\* AGH UNIVERSITY OF SCIENCE AND TECHNOLOGY, FACULTY OF DRILLING, OIL AND GAS AL. MICKIEWICZA 30,  
30-059 KRAKÓW, POLAND

\*\* SALT MINE “WIELICZKA” UL. PARK KINGI 1, 32-020 WIELICZKA, POLAND

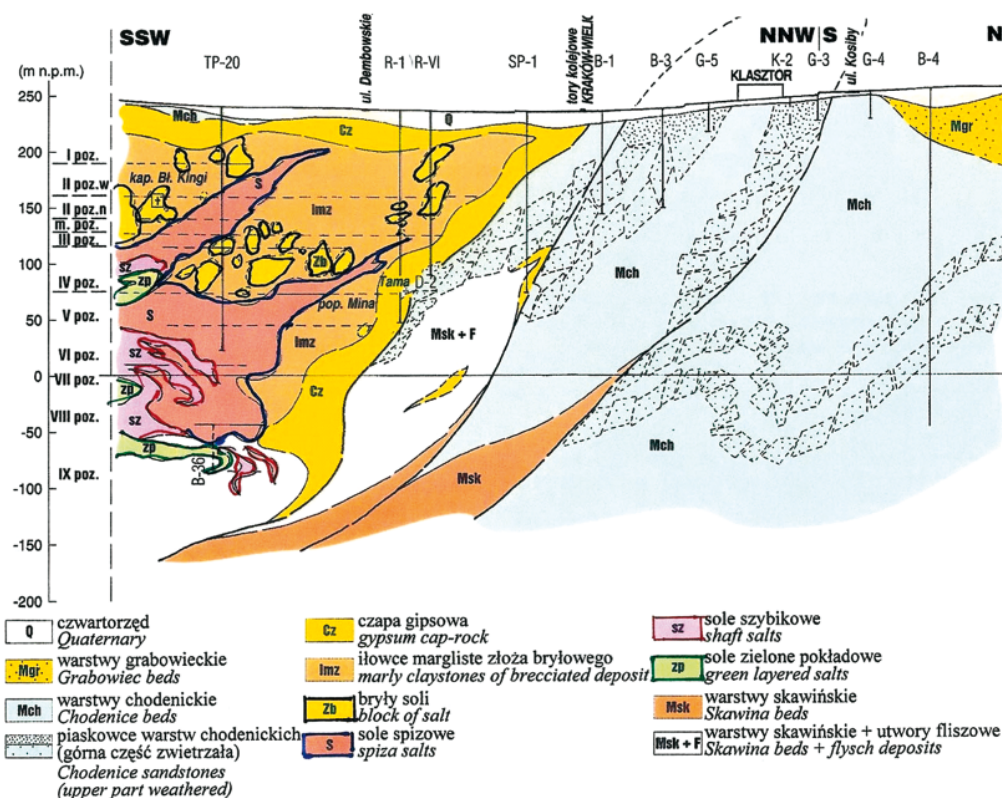
Geologically, the Wieliczka area is composed of the Jurassic, Cretaceous (Carpathian flysch), Tertiary (Miocene) and Quaternary strata. Figure 1 illustrates the complexity of geological setting of the deposit on the example of a cross section of the transverse heading Mina area, whereas cases of complex build of the deposit have been shown in photo 1.

Fig. 1. Cross-section through the northern part of the mine in the transverse heading Mina area

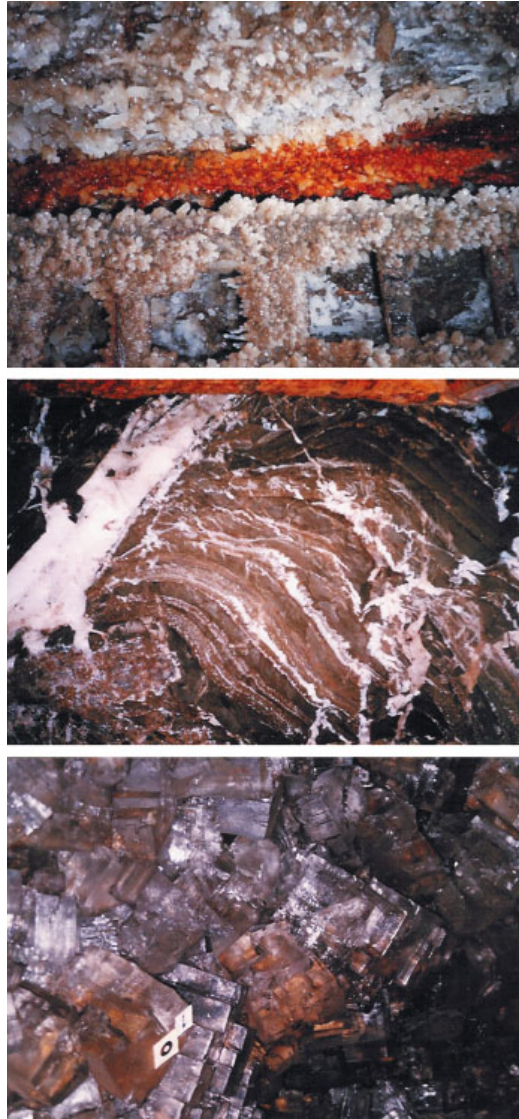
Photo 1. Examples of geological build of deposit in the Salt Mine “Wieliczka”

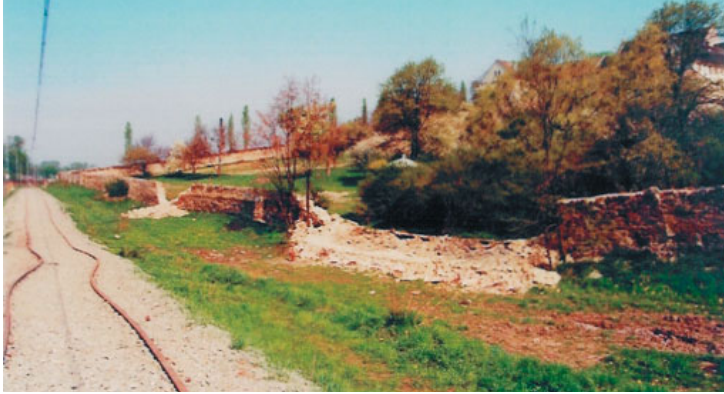
On 11 September 1992 a subsidence trough was observed on the surface. The maximum lowering of the terrain on that day was 0.3 m, to later increase to over 2 m. The railroad (Wieliczka-Wieliczka Marketplace section) became undulated and deformed (Photo 2), and part of the wall around the Reformati monastery collapsed. Dangerous cracks appeared on the walls and ceilings of the monastery (Photo 3) and the neighboring buildings, threatening their stability. Additional factor deteriorating the situation was the fractures (Photo 4) over 1 m in width and 5 m depth in the slope on which the monastery was sited, and cracking of the main collector in the area of the subsidence trough.

Photo 2. A view on the railroad and wall around the monastery

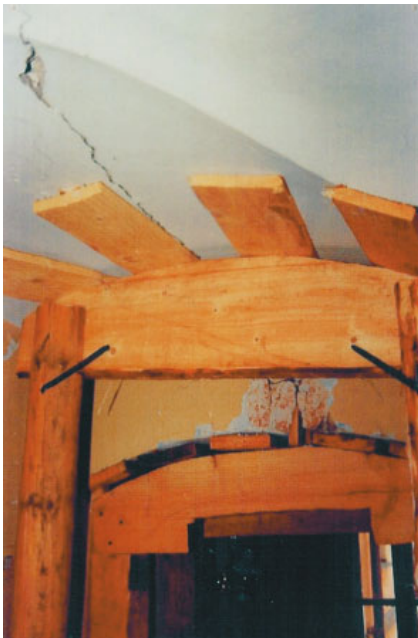
Photo 3. Fragment of supported roof of the monastery

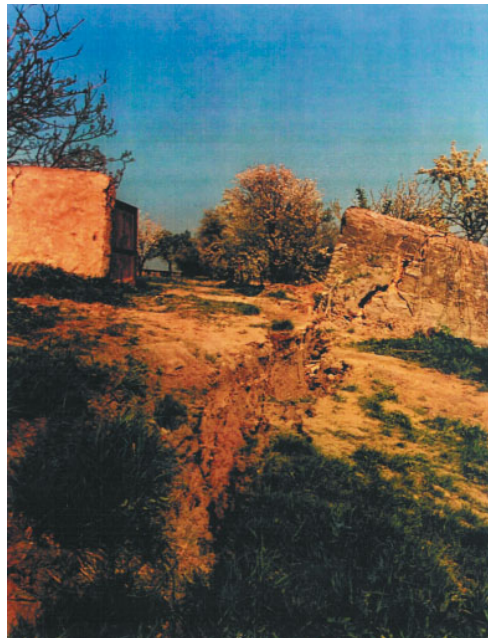
Photo 4. A view on the fractures and wall around the monastery

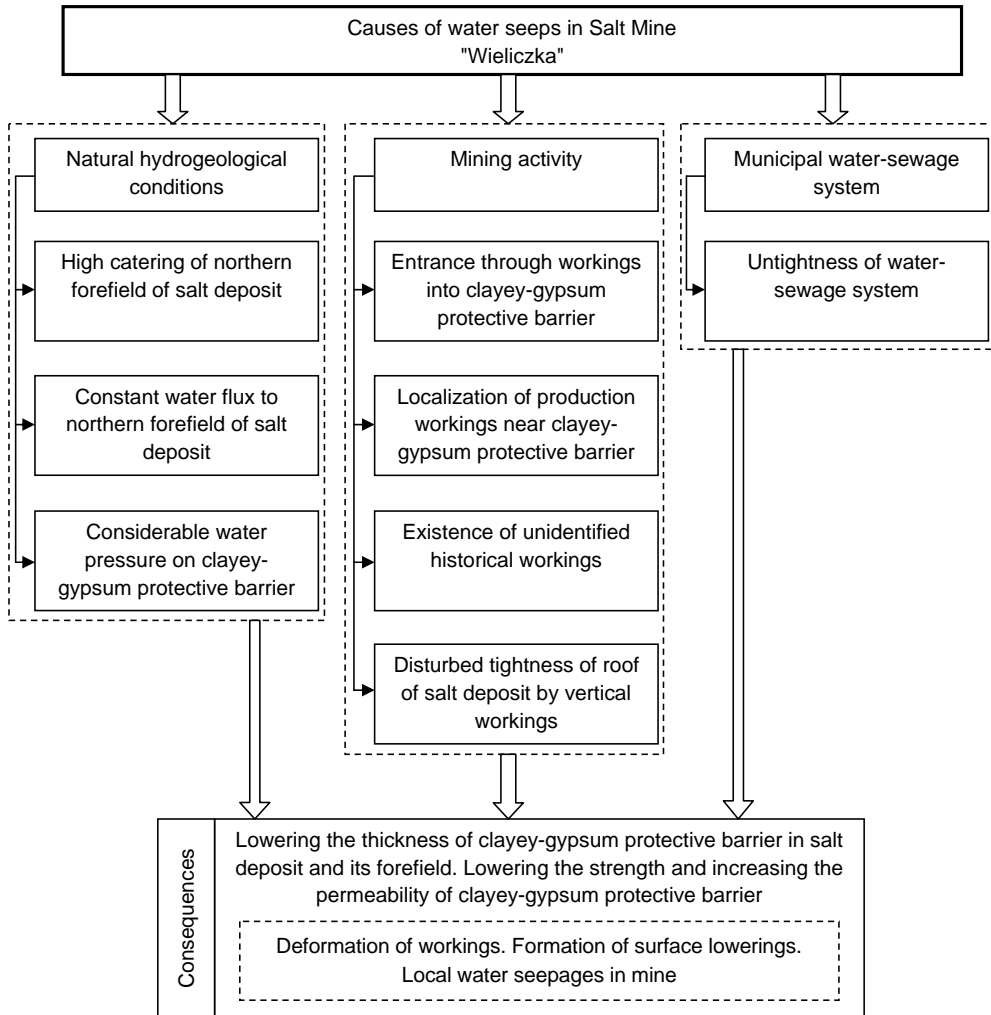
- disturbing of the northern clayey-gypsum screen around the deposit with workings,
- localization of production rooms, sited too close to the clayey-gypsum protective screen,
- existence of unidentified historical workings inside the mine and in the northern forefield of the deposit,
- disturbing the tightness of salt deposit roof with vertical workings, mainly in the form of shafts and backfilling boreholes.

All this resulted in weakening of the safety pillar (Fig. 2), which at a certain point in time could not withhold the pressure of water which rushed into the transverse heading Mina.

Fig. 2. Block diagram illustrating causes of water fluxes in the Salt Mine “Wieliczka”

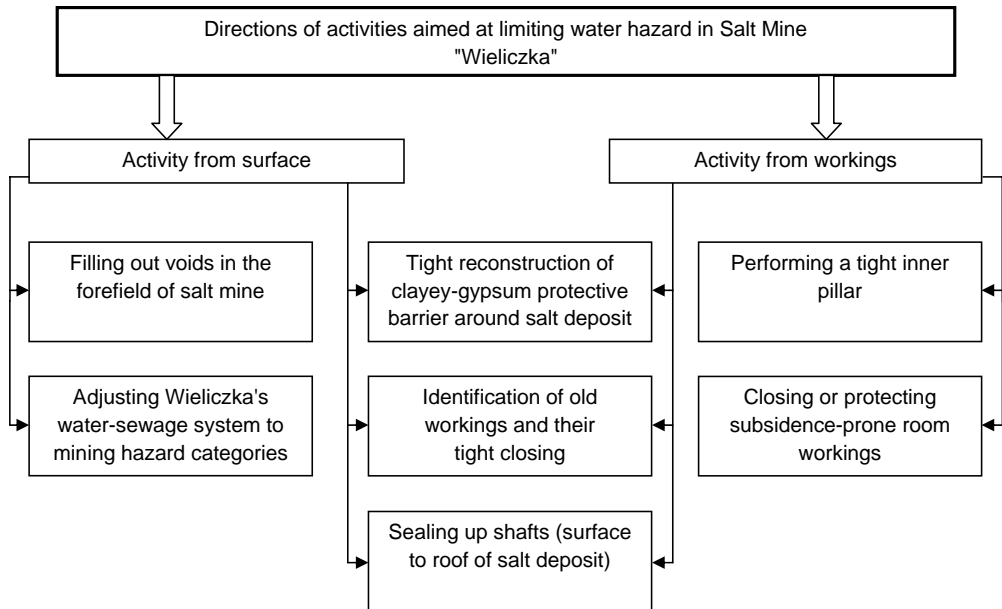
Fig. 3. Activities aimed at limiting water hazard in the Salt Mine "Wieliczka"

This however cannot be done to such outstanding historical object as the Salt Mine “Wieliczka”. There were undertaken multidirectional activities both from the surface and from accessible workings. The linking of hole injection and original pipeline injection methods turned out to be a success. Most of the operations have been presented in detail in numerous papers (Garlicki et al., 1994-95, Garlicki et al., 2004, Gonet & Stryczek, 1995, Stryczek & Gonet, 1992) therefore will not be discussed here. Figure 3 is their brief illustration.

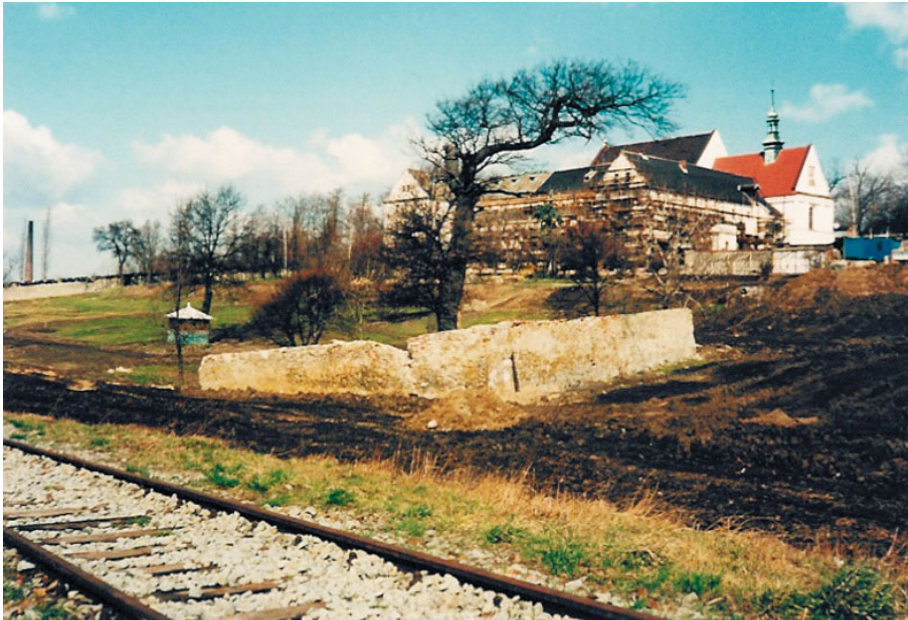
Photo 9. View on the Reformati Monastery during its renovation after a disastrous water flux in the transverse heading Mina
