## **TEST FIRE OF A PASSENGER CAR**

*The research presents results of tests of the development of passenger car fire conducted in the Main School of Fire Service. The aim of the research was to determine the mechanism of fire, threats for the driver, passengers and rescuers working at the accident place. The article depicts the full scale of a passenger car test fire. It presents the graphs of temperature taken in selected places of the inside and outside of the car. The temperature results were compared with the use of thermal image camera and thermocouples. During the test one observed on explosion and tearing of the opening mechanism of the boot cover, which was a potential danger for the rescuers. Fire development depended on the air supply, and it was very dynamic when the air supply was unlimited.*

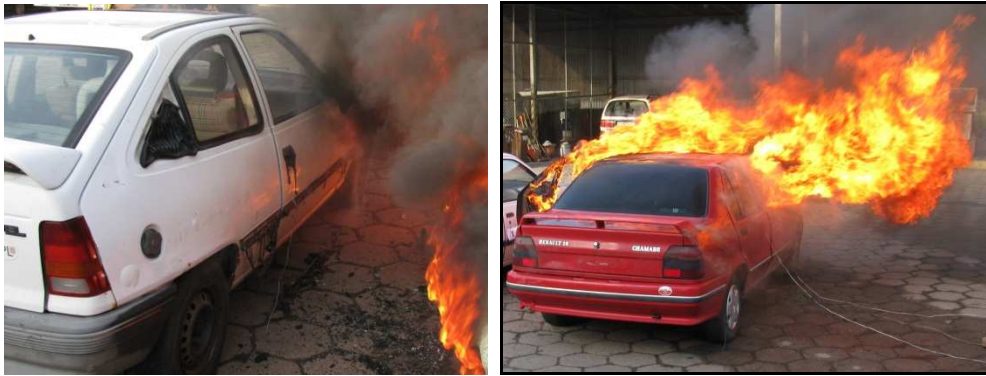
The wind direction and force made the flame bend towards the opposite side as car no. 2. This reduced the thermal impact of car no.1 on car no.2 (fig. 1.).

**Fig. 1.** Impact of the wind on the flame direction and the thermal impact of the burning car on the nearby car.

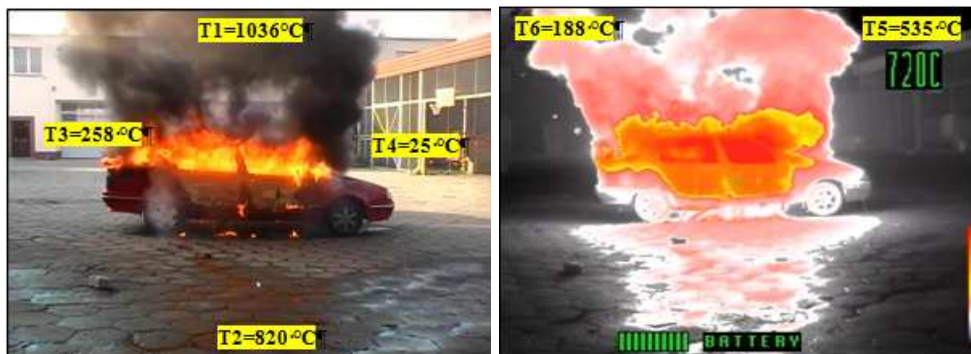
In the fifty-seventh minute on car no.2 blisters appeared on the paint coat and smoke was released from elements made of plastic (lateral strips, air intake, bumpers, door handle). Changed took place on the entire surface of the right side of car no. 2. Fig. 2. presents the view of car no.1 in the phase of full fire development in the 57<sup>th</sup> minute of the test (photograph and thermogram).

**Fig. 2.** A photograph and thermogram of car no. 1 in the phase of full fire development.

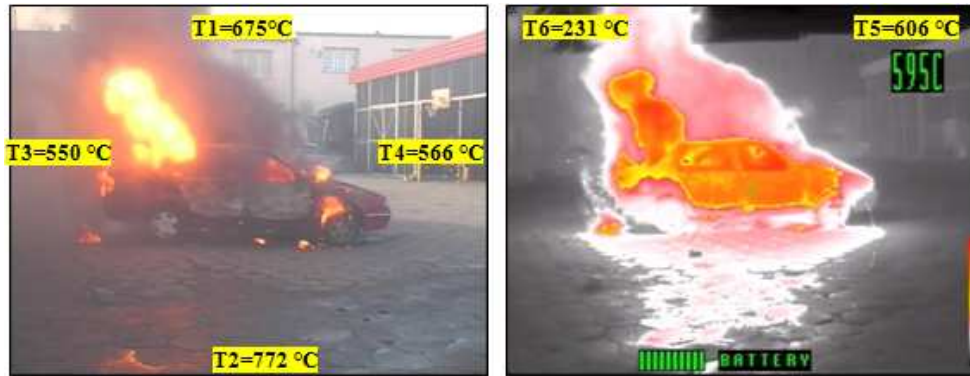
In car no. 1, after one hour from the commencement of the experiment (10 minutes after opening the door), the combustion intensity decreased mainly in the central part of the passenger area. During that time, fire spread in the engine room and the boot. Tyres and bumpers, as well as other plastic components in the area of the header panel ignited. A loud explosion could be heard in the 62<sup>nd</sup> minute. The boot lid damper broke apart. The moment of explosion is shown in Fig. 3.

**Fig. 3.**A photograph and thermogram of car no. 1 at the time of explosion of the boot lid dumper.

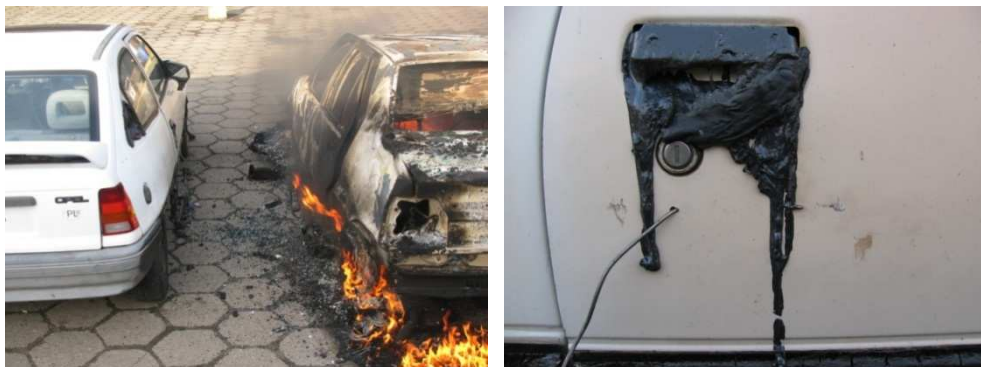
As observed, tyres started to leak from the 63<sup>rd</sup> to 71<sup>st</sup> minute. They started leaking one by one. A whiz of released air could be heard. Burning of tyres was one of the final phases of the car fire. When flames extinguished in their vicinity, the only flame combustion could be seen on the melted plastic components and in the engine room. These included melted bumpers, laying on the yard surface, and melted dashboard in the front part of the passenger area near the floor. That phase of the fire is shown in Fig. 4.

Later in the experiment it was observed that the fire was extinguishing - flames disappeared and smoke release intensity decreased. The observation and measurements were performed to the 120<sup>th</sup> minute from the commencement of the fire. Fig. 4 shows the wrecked car no. 1 after the fire stopped.

**Fig. 4.**Wrecked car no. 1, door of car no. 2 after the fire.

Having analysed the material recorded on cameras and the photographs taken during the experiment, it was found out that the reason for the sudden increase in temperature on thermal element T6 (car no. 2) was that some melted plastic dropped on the thermal element from the car handle (Fig. 4). According to the above, it seems that in the 80<sup>th</sup> minute, the thermal element T6 indicated the temperature of the melted plastic.

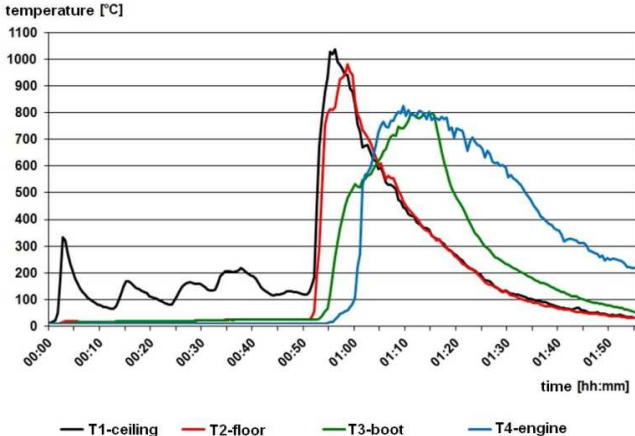
Fig. 5 shows diagrams of temperature in various spots inside car no. 1. Until opening of the door, the fire was dampened due to the fact that there was no access of air. The temperature in the upper part of the cabin initially rose to 350°C, then dropped a bit and oscillated within the range from 100°C to 200°C. Temperature near the floor as well as in the engine room and the boot hardly changed. When the door was opened, the fire developed violently and flashover occurred (Fig. 2). Maximum temperatures measured during the fire were as follows: in the cabin near the ceiling - 1036°C, near the floor - 990°C, in the boot - 820°C, near the engine, under the bonnet - 805°C.

Fig. 5. Relation between temperature and time for thermal elements placed on car no. 1.

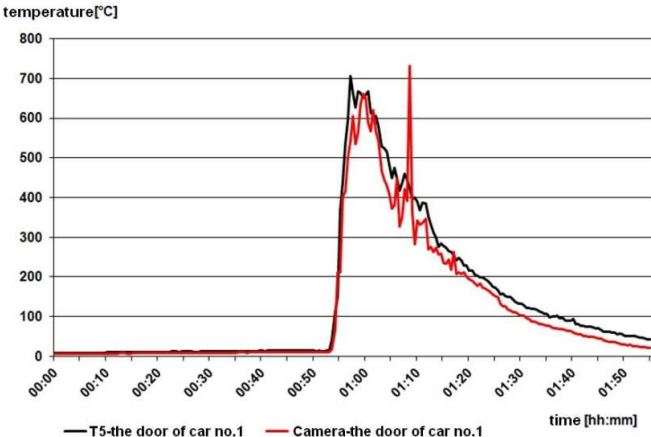
Fig. 6 shows relations between temperature and time for the thermal element T5, placed on the external door panel of car no. 1 and temperature measured with thermal camera in the same spot. A concurrence of the results of measurements with use of the thermal camera and the thermal element is visible. Sudden increase of temperature measured by the thermal camera after 1 hour 10 minutes was caused by the occurrence of flames.

Fig. 6. Relation between temperature and time for the thermal element T5 and for thermal camera on the door of car no. 1.

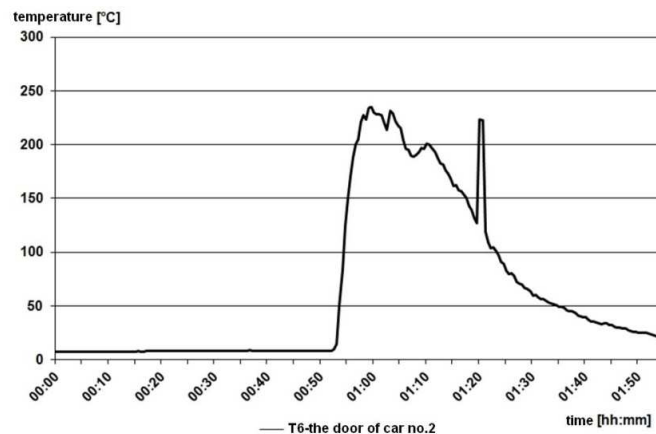
Fig. 7 shows relations of temperature and time for the thermal element T6 installed on the door of car no. 2. It shows the impact of the course of fire of car no. 1 on heating of a car parked beside.

**Fig. 7.** Relation between temperature and time for the thermal element T6 placed on the door of car no. 2.
