# The malfunction of a double-base propellant gas generator *Nieprawidłowe zadziałanie gazogeneratora z paliwa dwubazowego*

Rafał Bogusz\*, Tomasz Wolszakiewicz

Łukasiewicz Research Network – Institute of Industrial Organic Chemistry, 6 Annopol Street, 03-236 Warsaw, Poland

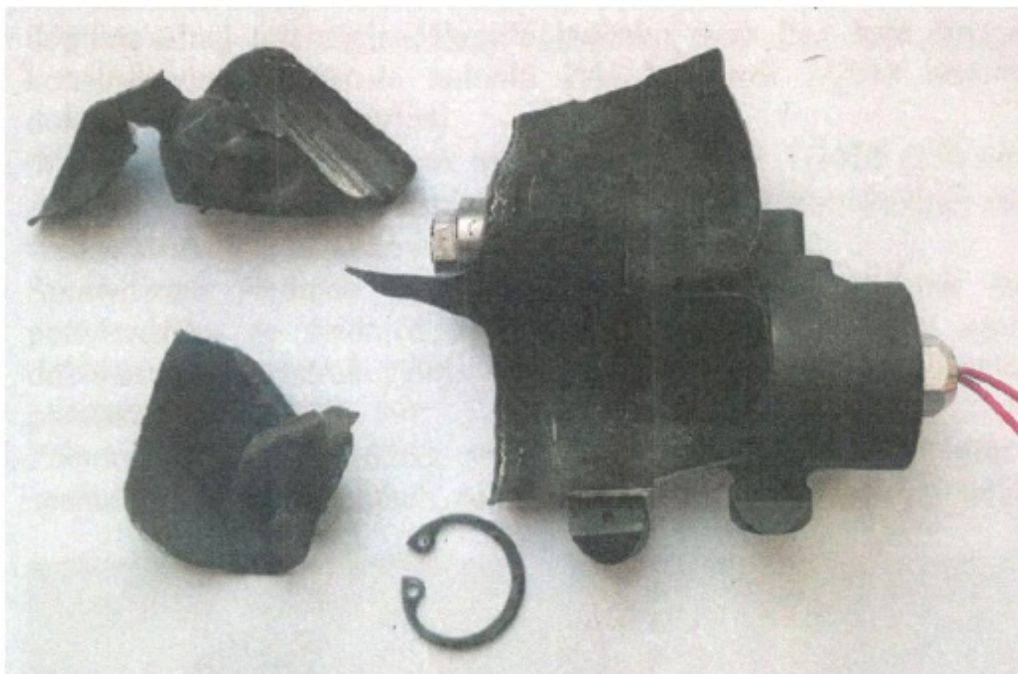
The subject of the failure was an explosion of a gas generator combustion chamber during periodic testing. During this, 14 charges of gas generator material, made of double-base propellant, were initiated. All charges had previously been subjected to accelerated aging to obtain charges aged for 12 years. 14 initiations were carried out in the following order, 7 at 55 °C and 7 at -35 °C. During the last initiation, at a temperature of -35 °C, a combustion chamber exploded. The cause of the explosion was a pressure build up which exceeded the design limit of the chamber. Figure 1 shows the combustion chamber after the incident. The relationship  $p = f(t)$ , recorded during the incident, is shown in Figure 2.

**Figure 1.** The combustion chamber after malfunction

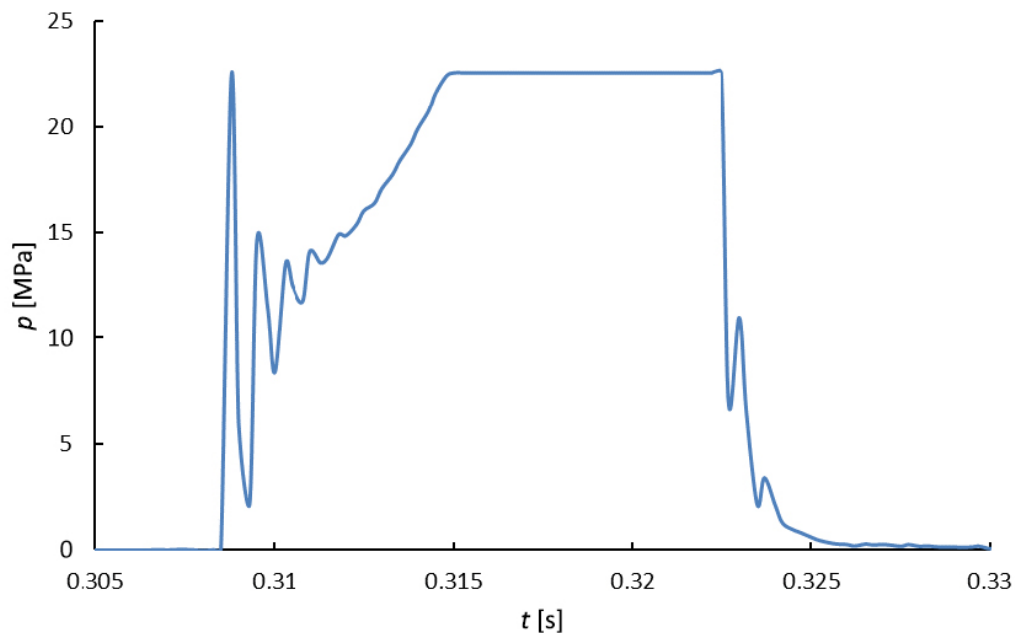
**Figure 2.**  $p = f(t)$  during the incident

The first visible peak is the effect of the igniter. Later, pressure build-up is visible, reaching 23.5 MPa. This value represents the limit of the sensor used. The sharp pressure drop after 0.3225 s shows the moment of explosion of the combustion chamber. Analyzing the above data, it was found that the explosion occurred after 0.0143 s from the moment the igniter was activated. The analysis of this failure is the subject of ongoing research.

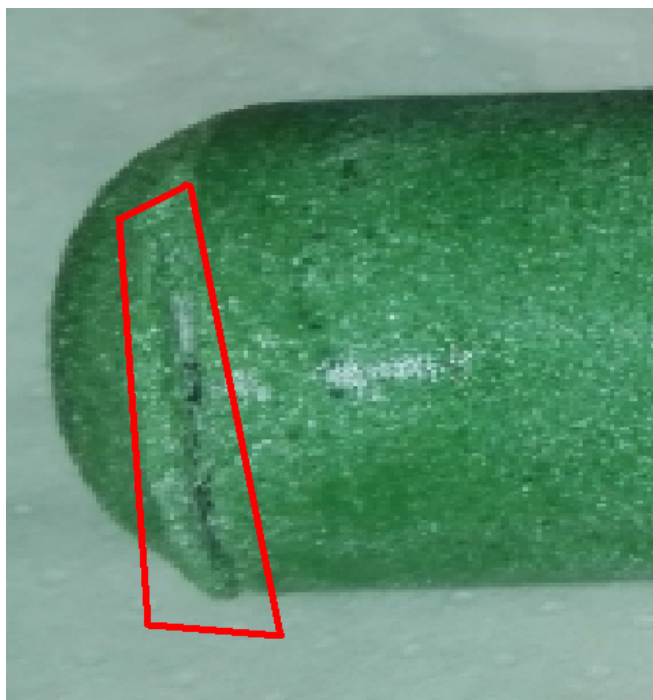
Figures 3 and 4 show the simulation of inhibitor charge damage in the upper and lower parts of the charge, respectively. Destruction of the inhibitor was marked. The inhibitor is a polymeric mass, which ensures that the propellant charge combusts with the prescribed geometry. Figures 5 and 6 present the  $p = f(t)$  plots registered during the combustion of the damaged charges.

**Figure 3.** Inhibitor damage in the upper part of the charge

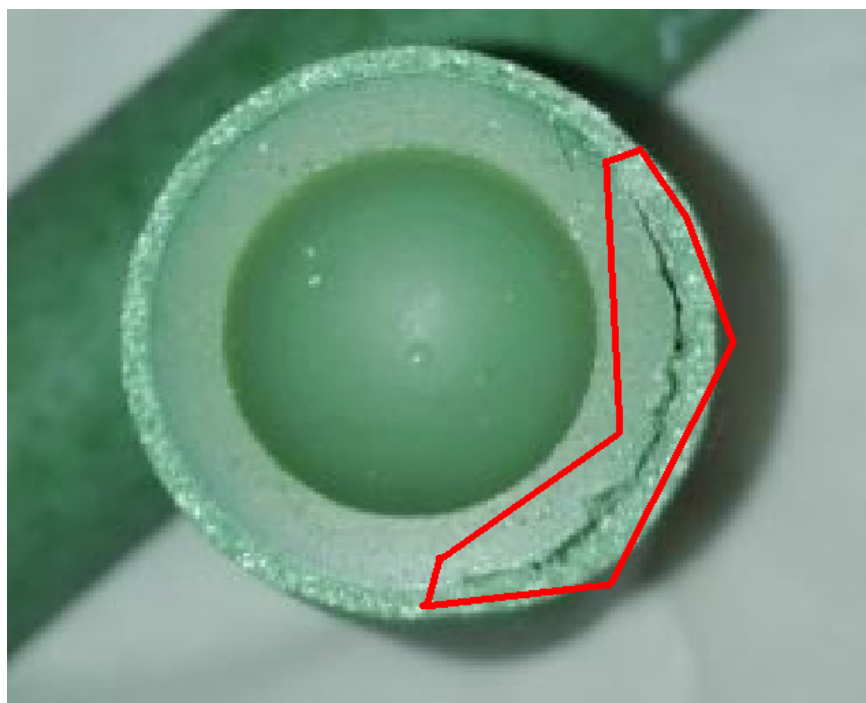
**Figure 4.** Inhibitor damage in the lower part of the charge

During combustion of the charge with the damaged inhibitor in the lower part of the charge, a stable combustion was obtained, presented in Figure 6. The expected effect of the chamber exploding, was not obtained. This phenomenon is interesting from the point of view of the scale of damage which the charge shows. The inhibitor damage depth made up 25% of the total charge length.

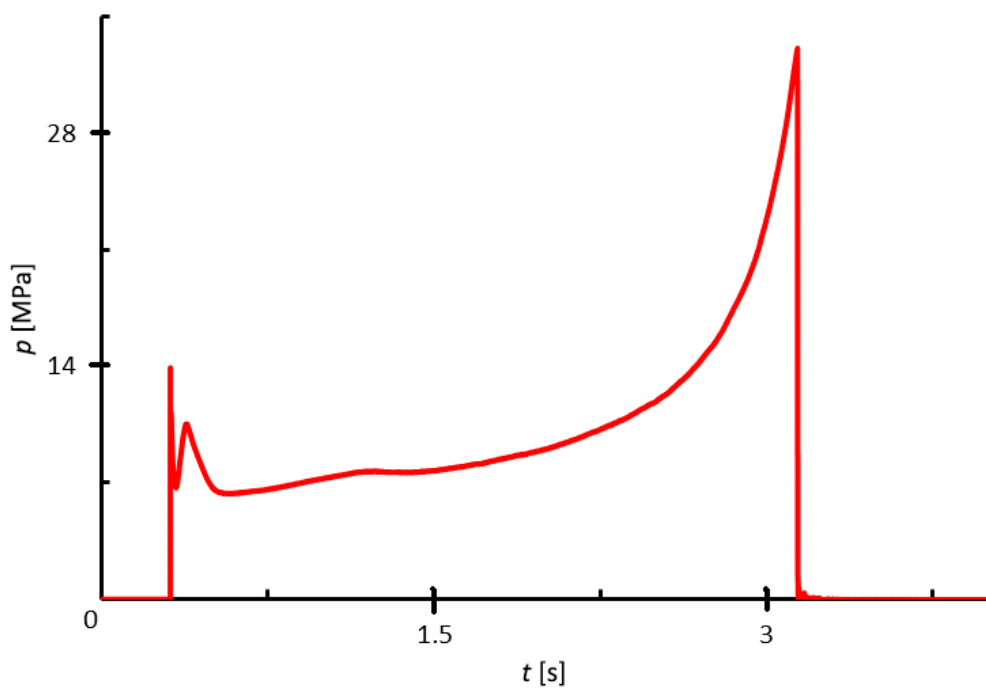
Figure 5. Plot of  $p = f(t)$  for the charge with upper part damage of the inhibitor

In the case of initiation of the charge with damage to the upper part of the inhibitor, the combustion chamber exploded. The graph of  $p = f(t)$  shows the build-up of pressure during combustion to a value of 32.9 MPa. The pressure build-up is caused by the increased surface area on the side of the damaged inhibitor. In Figure 5, the rupture of the chamber is evident in the sharp drop in pressure after approximately 3 s of charge operation.

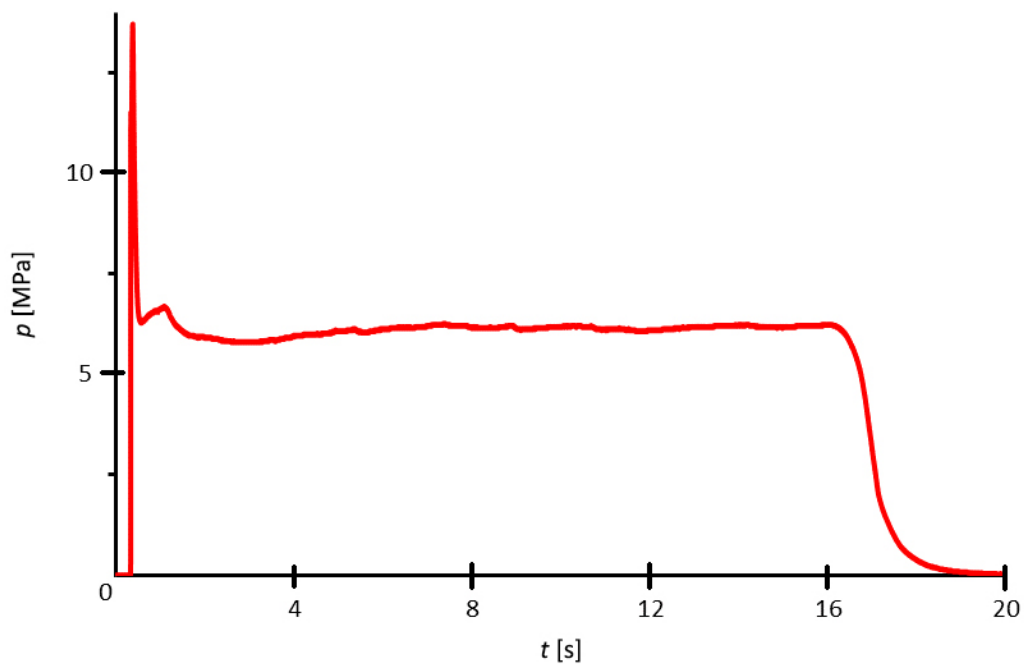
Figure 6. Plot of  $p = f(t)$  for the charge with lower part damage of the inhibitor

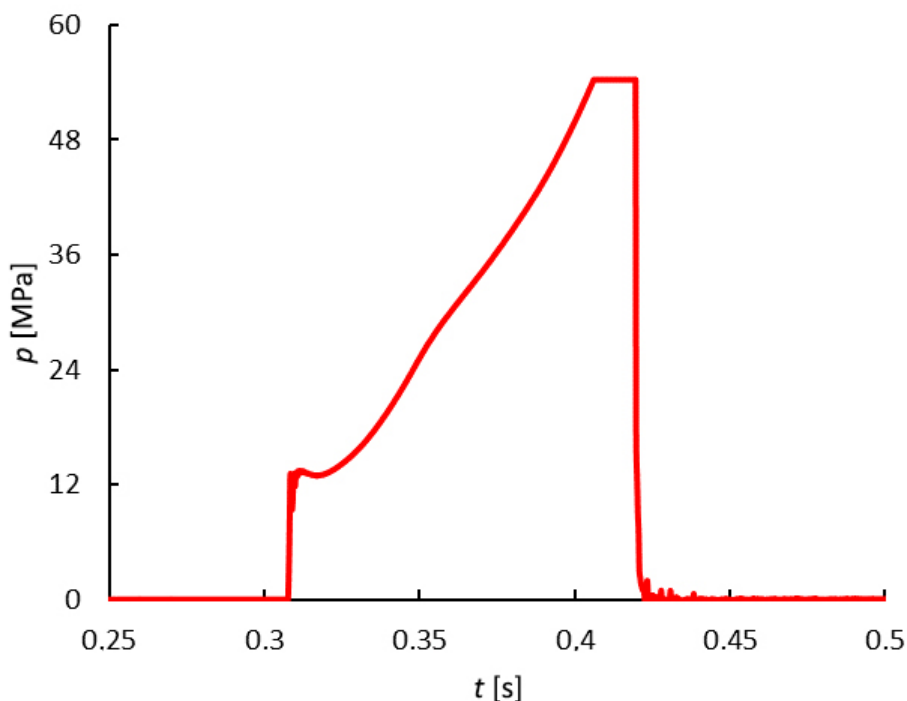
When the charge was combusted with the nozzle clogged with a steel plug, the chamber exploded. This experiment was designed to simulate clogging of the nozzle by large physical contamination. The plot of  $p = f(t)$  obtained during combustion is shown in Figure 7.

**Figure 7.** Plot of  $p = f(t)$  for the charge combustion with clogged nozzle

Comparing the above plot with that recorded during a malfunction, it can be seen that the time after which the chamber explosion occurs is definitely longer than in the case of the malfunction situation. For the plot shown in Figure 7, the chamber ruptured after 0.108 s of operation. However, during a malfunction, this occurred 0.0143 s after the igniter was initiated.
