DEGRADATION OF THE GAS TURBINE BLADE COATING AND ITS INFLUENCE ON THE MICROSTRUCTURE STATE OF THE SUPERALLOY

Józef Blachnio, Artur Kulaszka

Keywords: turbine, blade, heat-resistant coating, technical condition

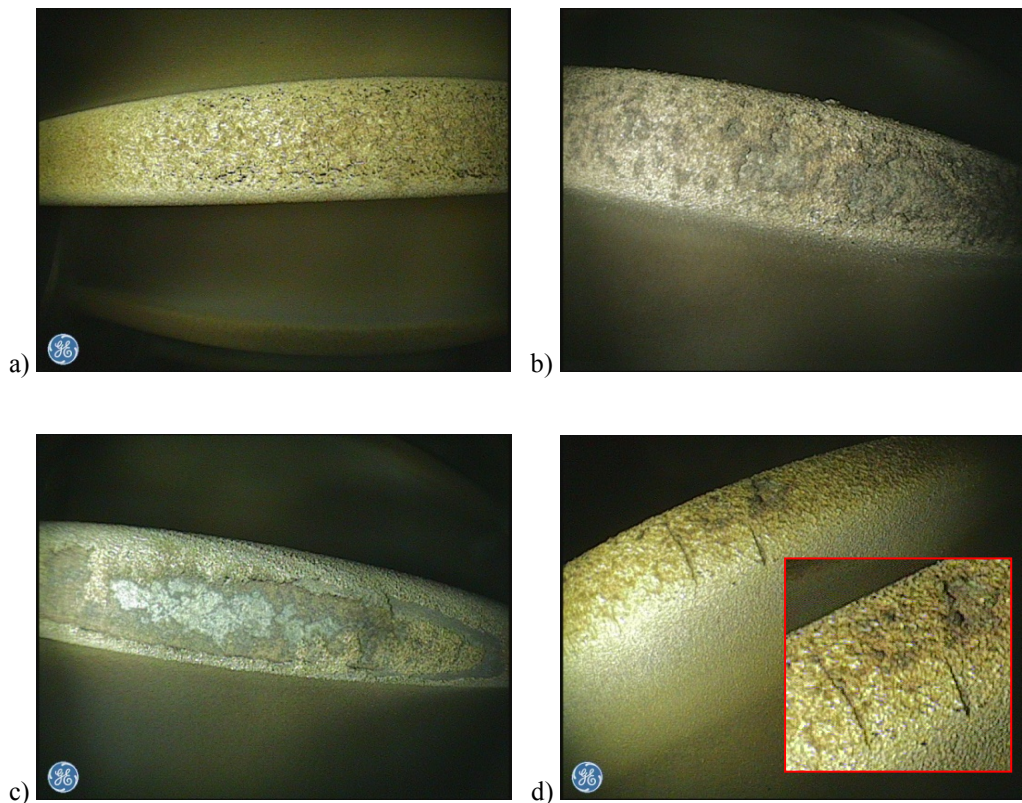
Fig. 1. Forms of damage to gas turbine blades on the leading edge: a) – coating micro-cracks, b) – partial burn out of the coating, c) – total burn out of the coating until alloy is revealed, d) – partial burn out of the coating and numerous macro-cracks [8]

As is clear from the above analysis, despite using many endeavours in order to improve the efficiency of the gas turbine, its durability and reliability, over the work process, there are still all kinds of damages to turbine elements, especially their blades (Fig. 1). The damages can be divided into few cause groups often connected with each other. We differentiate defects being results of material and technological faults, derogations from the quality of production and repairs, operational in particular. Important reasons are also improper fuel atomization in the combustion chamber, as well as its diminished physical-chemical properties [3].

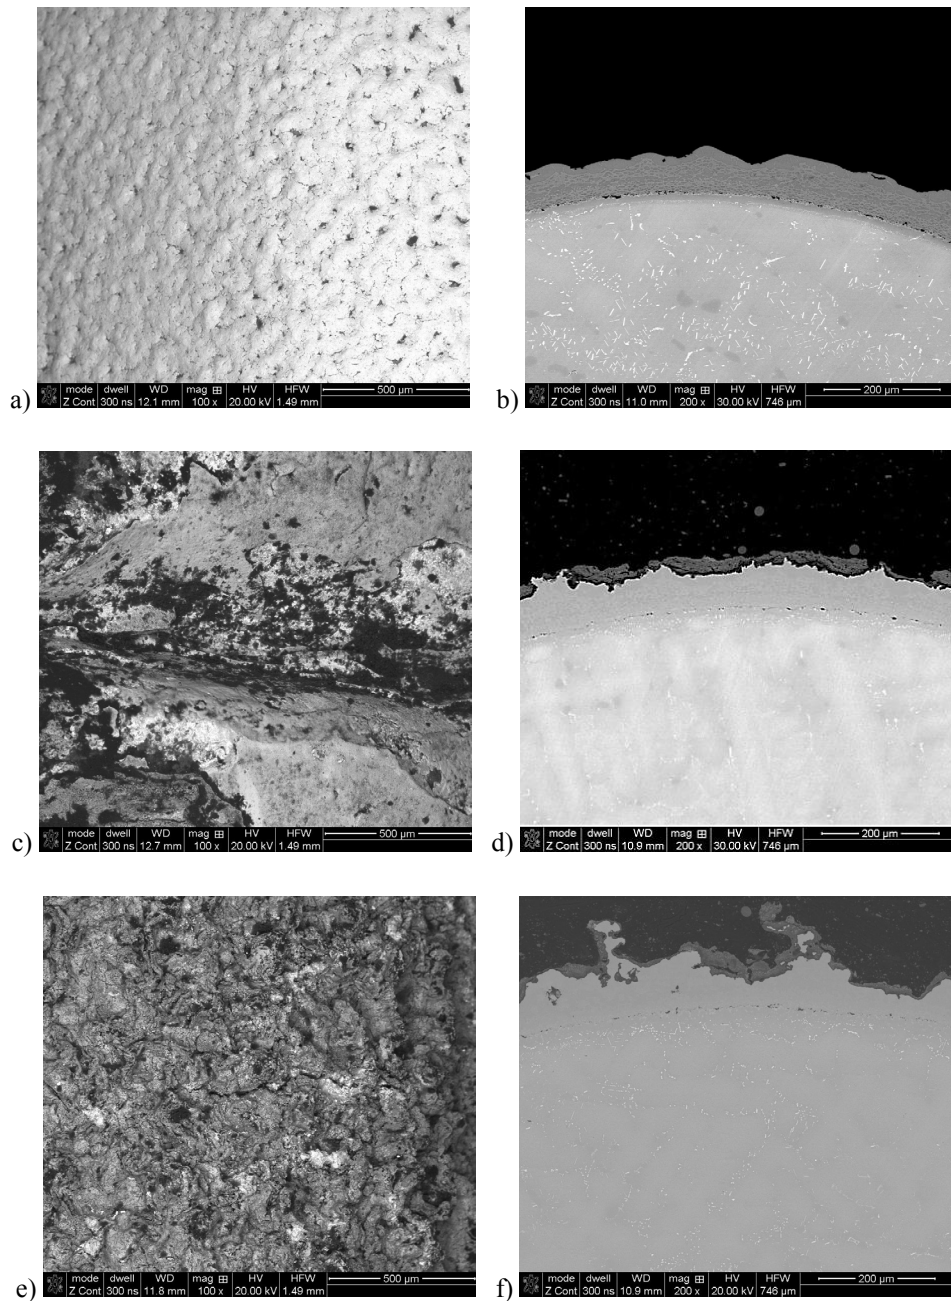
Accepted for metallographic tests were new blades and ones with different operation runtimes. The influence of degradation on micro-structural changes on the blades was tested on cut-out samples. The samples, after mechanical grinding and polishing were etched with the Kalling chemical reagent. Micro-structural tests were carried out using a scanning electron microscope Quanta 3D FEG. The observations were made on the leading edge surface and the metallographic specimens (Fig. 2). A view of the new blade surface is presented in Fig. 2a. It is characteristic for the used manufacturing process. The coating consists of the priming and insulating layers (Fig. 2b). An average coating thickness is approximately 70 μm .

As a result of carried out microscopic observations of blades in use, under the destructive influence of exhaust gases, oxide layers on their surfaces were found, with their thickness of even over 50 μm and numerous thermal, and even mechanical, damages (Fig. 2 c-f). Among others, delamination between the coating and the parent material of the blade was observed. Moreover, transverse and longitudinal cracks were noticed on the layer, as well as propagation of some cracks inside the blade material to a depth of over 500 μm (Fig. 4). It was also stated, that the oxidation process, and subsequently cracking, is preferential, on dendrites or inter-dendritic spaces.

Fig. 2. Coating morphology in the cross-section of the leading edge: a-b) new blade; c-d and e-f—blades after a respectively longer operation period

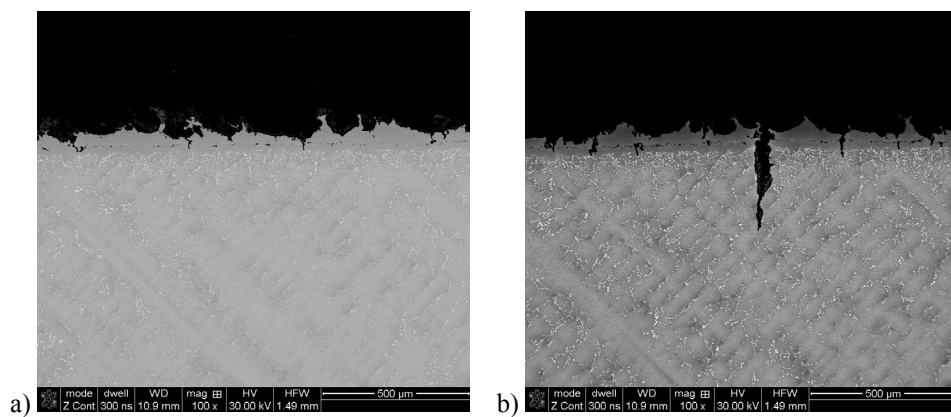
The recorded degradation of laid coatings also results in micro-structural changes that undergo within the coating itself, as well as the parent material of the blades in use (Fig. 3). An average thickness of a coating was worn down to 30 μm . On the basis of the carried out tests, it was stated that coating microstructures consist mainly of phase β , carbides and oxides (Fig. 4). A significant growth of coating structural elements was also noted. In extreme operation conditions that practically lead to a complete destruction of the microstructure and chemical composition of the coating with simultaneous intensification of the cracking and delamination processes.

Fig. 3. Morphology of a blade working with a crack on the leading edge

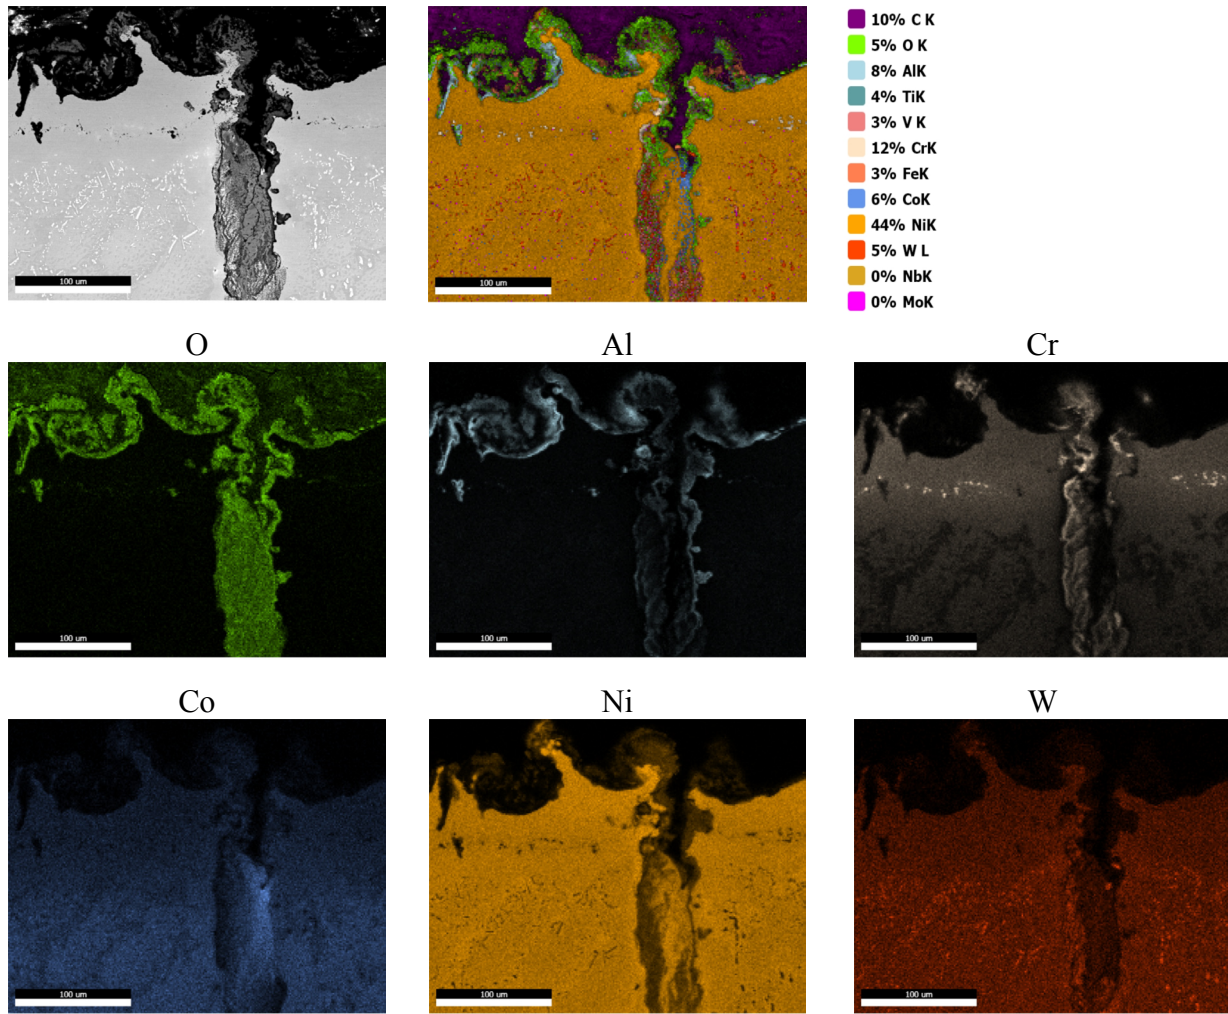
Fig. 4. Surface distribution of elements of a blade working with a crack on the leading edge

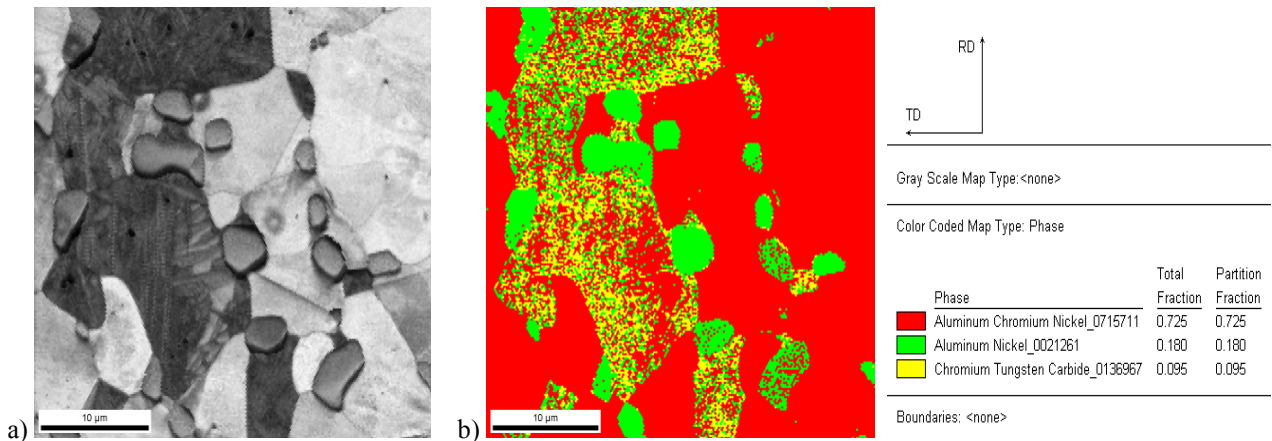
Results of metallographic tests confirmed also substantial structural changes of blades in use in comparison to new ones. Found were, inter alia, significant changes in the morphology of the particles of the hardening phase γ and its share under the coating layer (Fig. 5). Observations of structural changes were carried out on transverse (in relation to the blade axis) metallographic specimens in 5, equidistant areas. Based on these observations, it was established that micro-structural changes result from, above all, operational conditions (impact of exhaust gases with extremely high temperature) (Fig. 6). It was also found that operation conditions cause the expansion of the hardening phase γ' and a decrease of its share near the surface of the laid coating. In case of a cracked blade (Fig. 3) the surface share of phase γ' near the surface decreases from 65% for a new blade (Fig. 7a) to 30% (Fig. 7d), meanwhile causing a multiple growth near the surface.

Fig. 5. Topographic orientation results in a new blade; a) microstructure, b) surface distribution of phases occurring on a presented area of a blade in use

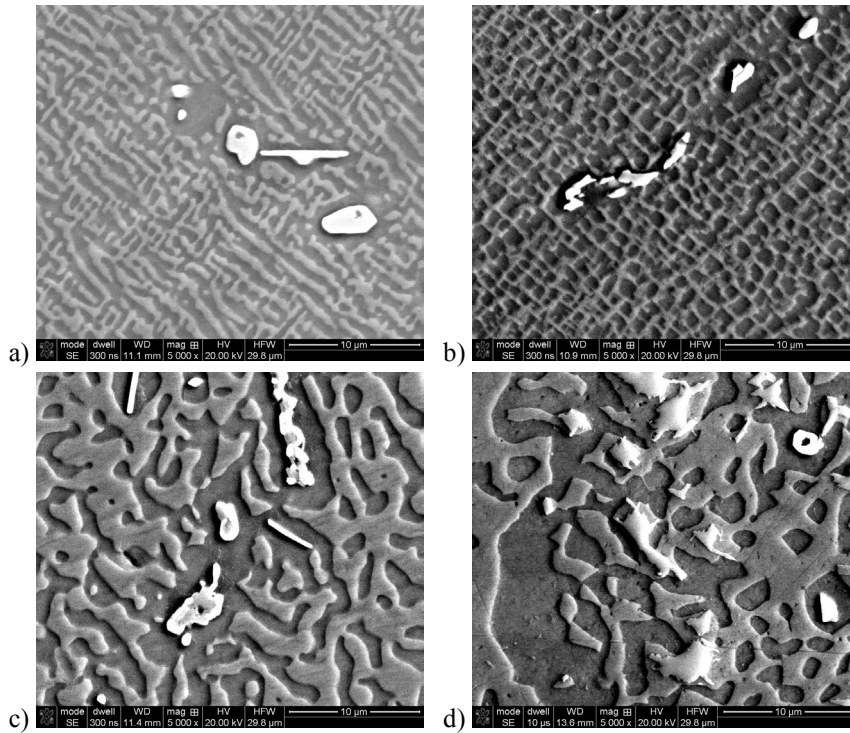
Morphology of phase γ' particles depends on the mechanical stress. Tensile stress, occurring along the blade axis during the rotation of the turbine rotor, promotes expansion of phase γ' on a plane perpendicular to the strain direction [2, 11]. As a result, the original cuboid shapes (Fig. 6a) changes into tiles (Fig. 6c, d), with wider walls, being positioned perpendicular to the strain direction and the narrow walls perpendicular to other cube directions.

Fig. 6. Blade material microstructure – leading edge: a – new blade; b, c, d – blades with a respectively longer operation runtime

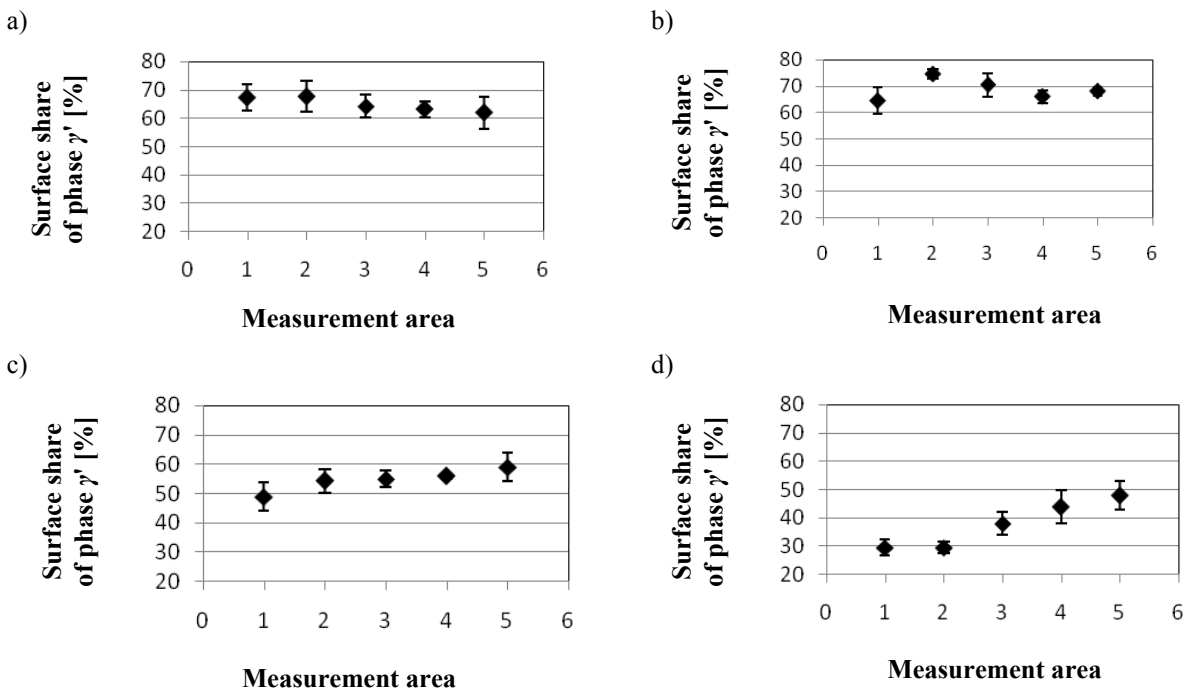
Fig. 7. Surface share of the hardening phase γ' inside the leading edge, in individual blades; a) new blade, b, c, d – blades after a respectively longer operation runtime
