RESIDUAL LIFE OF REPAIR WELDED JOINTS IN PIPELINES MADE OF 13HMF AFTER USE FOR THE DESIGN OPERATING TIME

This paper presents the results of material tests of repair welded joints carried out for samples of materials taken from high pressure steam pipelines after over 200,000 operating hours in creep conditions, made of the 13HMF steel (14MoV6-3). The aim of the study was to assess the mechanical properties and changes in the structure of repair welded joints (new material + material after use), including the original material, heat affected zone and the weld, occurring as a result of the welding process and heat treatment after welding.

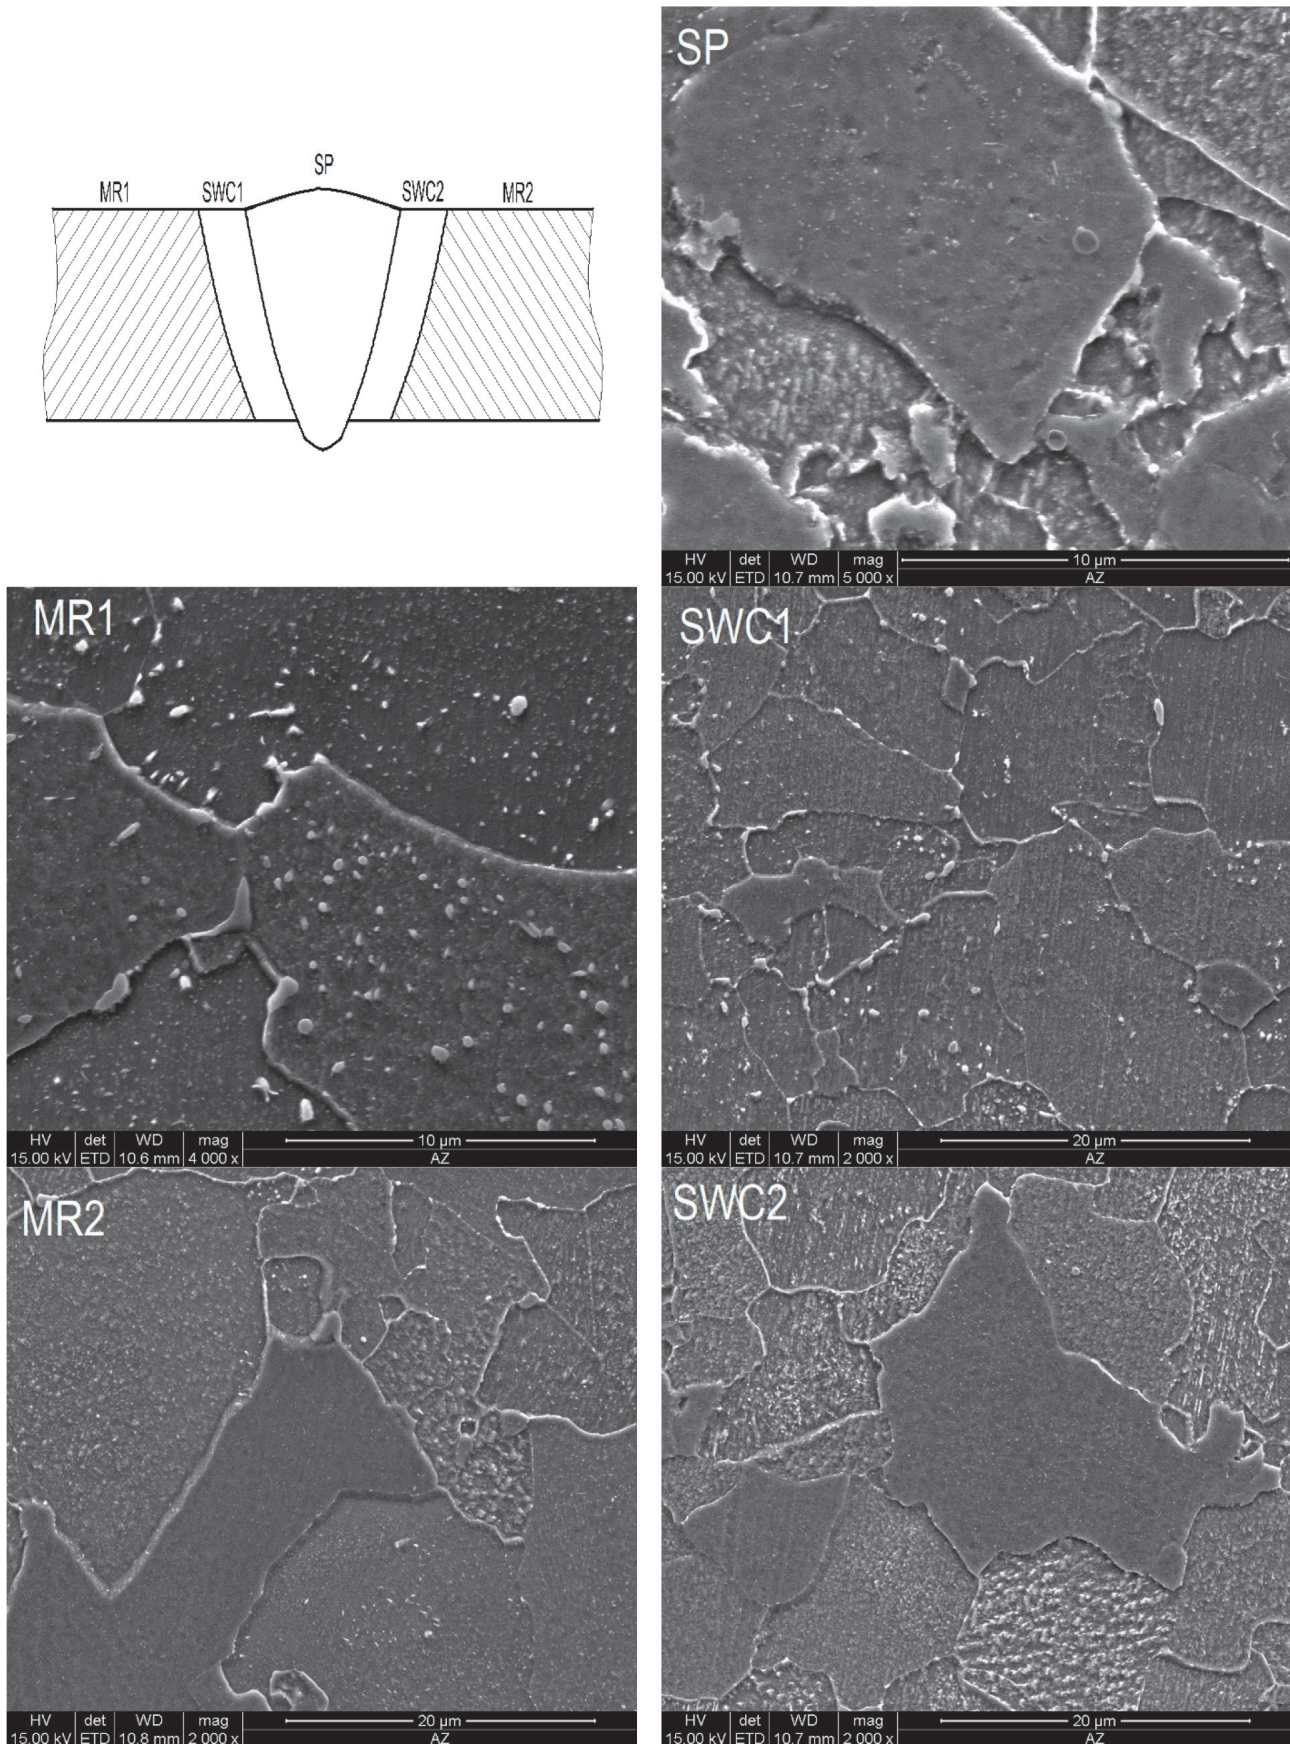
The images of microstructures along with the classification of the wear rate of bainitic areas, precipitation processes and damage processes are shown in Figure 1 for the joint made using the material designated as “1”, and Figure 2 for the joint with material “2”. The results of metallographic studies for both joints are presented in Table 3.

In general, the degree of wear of the structure of the tested materials was estimated at about 0.2–0.3 for the original material of sample number 1 and about 0.4 for the original material of sample number 2 (according to the IMŻ classification tables). For new materials in both tested samples, the structure was classified as a degree of wear equal to 0. No discontinuities and micro-cracks were found in the structure of any zone of both tested joints. No initiation of internal damage processes, which was not previously found during the research with the use of matrix replicas observed in the scanning electron microscope, was found in the tested material.

Fig. 1. Microstructure of individual zones of repair joint No. 1 – made by joining the material used for 216,000 operating hours (OM1) with the new material as delivered (MR2)

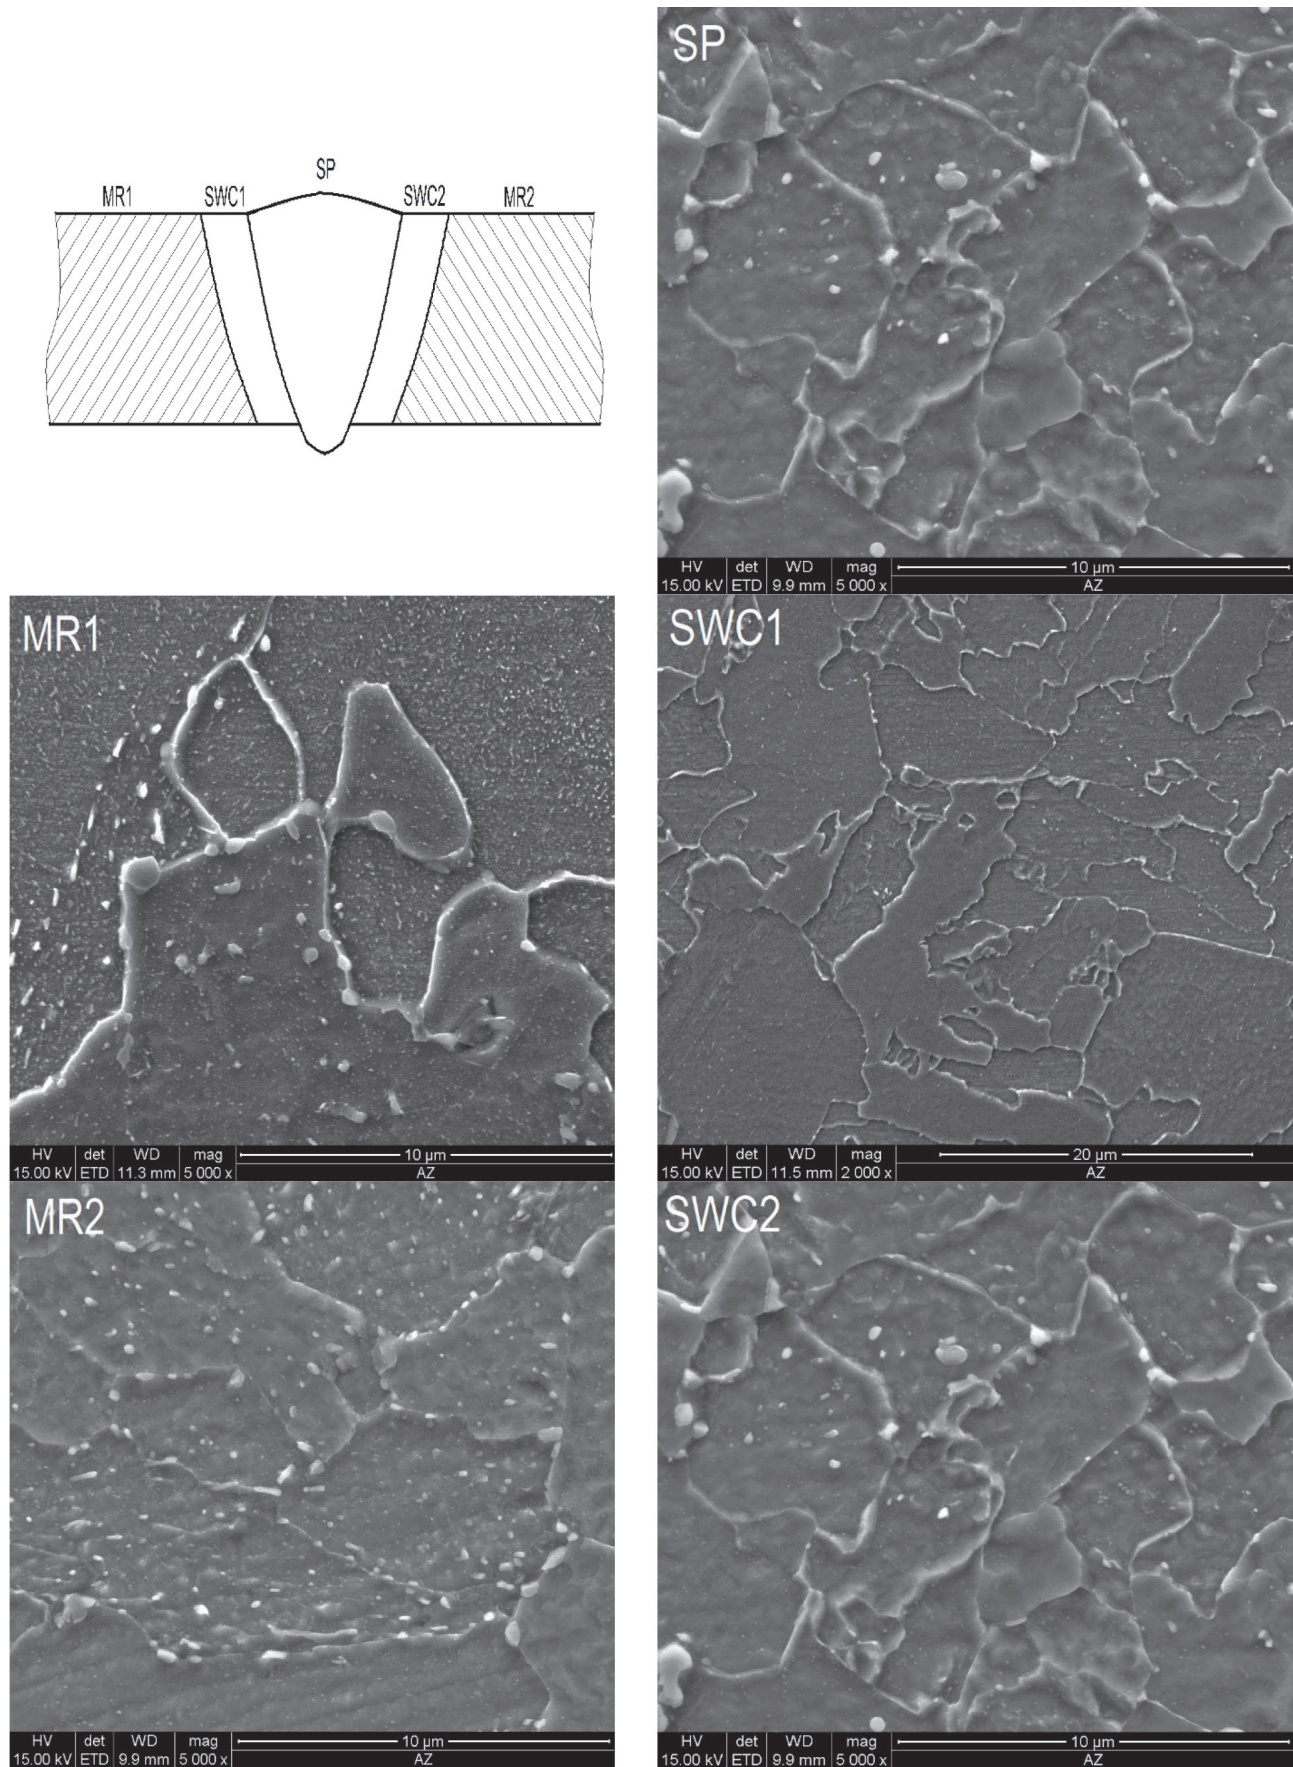
Fig. 2. Microstructure of individual zones of repair joint No. 2 – made by joining the material used for 240,000 operating hours (OM1) with the new material as delivered (MR2)

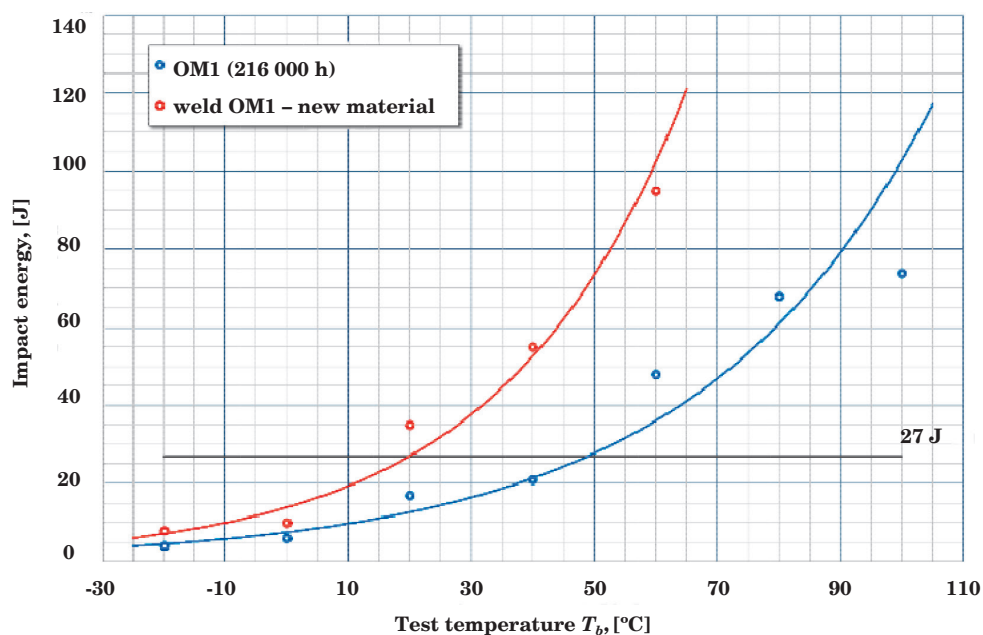
In both cases, the material’s brittle state transition temperature determined in the impact test was positive and amounted to about 50°C for the original

materials after use and about 15–20°C for the welds (Figures 3–4). With the level of tensile strength and yield strength determined for the tested samples, the possible pressure test of the pipeline may only have the character of a leak test, but it may not be a strength test of the pipeline. The positive temperature of transition into brittle state requires, however, strict adherence to the required conditions of start-ups and stops.

Fig. 3. Determination of the brittle state transition temperature for welded joint components (OM1 and W) – sample 1 after 216,000 hours of use

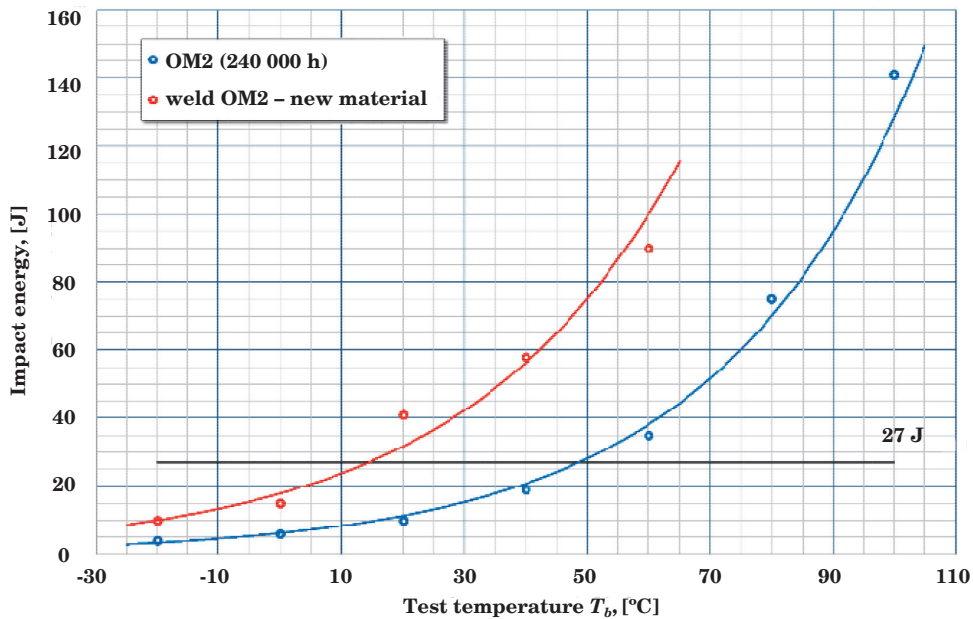
Fig. 4. Determination of the brittle state transition temperature for welded joint components (OM1 and W) – sample 2 after 240,000 hours of use

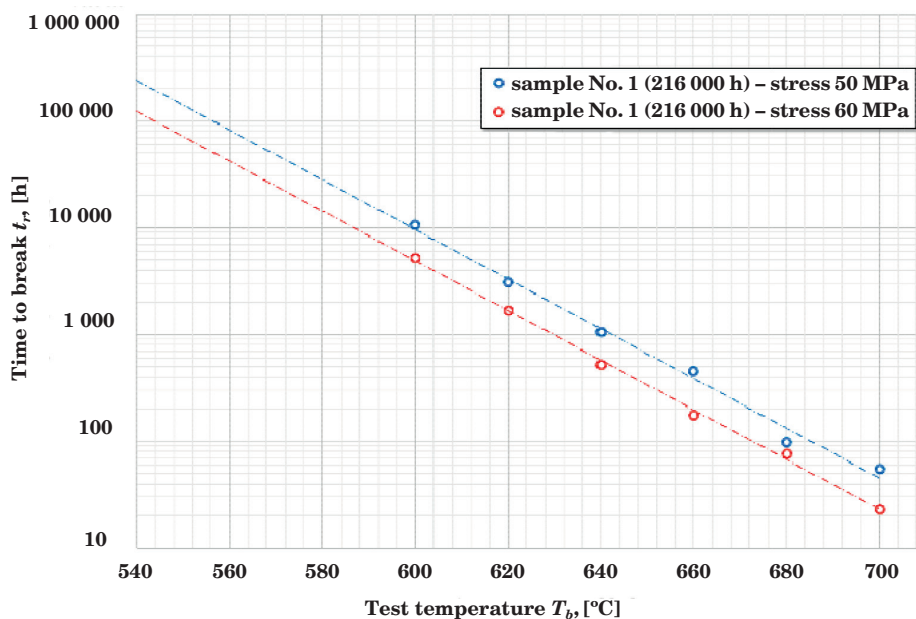
When analysing the results obtained in the shortened creep tests, it can be concluded that the welding process and heat treatment after welding caused much greater degradation in the case of the welded joint made using material 2 (after 240,000 operating hours)

than in material 1. The analysed repair joints have different durability margins – up to 116,000 hours for material 1 and only 28,000 hours for material 2. However, the determined life would be achievable under certain conditions. One of the most important of them would be to observe operating parameters, especially temperature. Its increase by 10°C may reduce the material's

Fig. 5. Dependence of time to break in shortened creep tests of the repair welded joint made of steel 13HMF (material after use + material as delivered) marked as 1 given in the form of the relation $\log t_z = f(T_b)$ at $\sigma_{b1} = 50$ MPa and $\sigma_{b2} = 60$ MPa

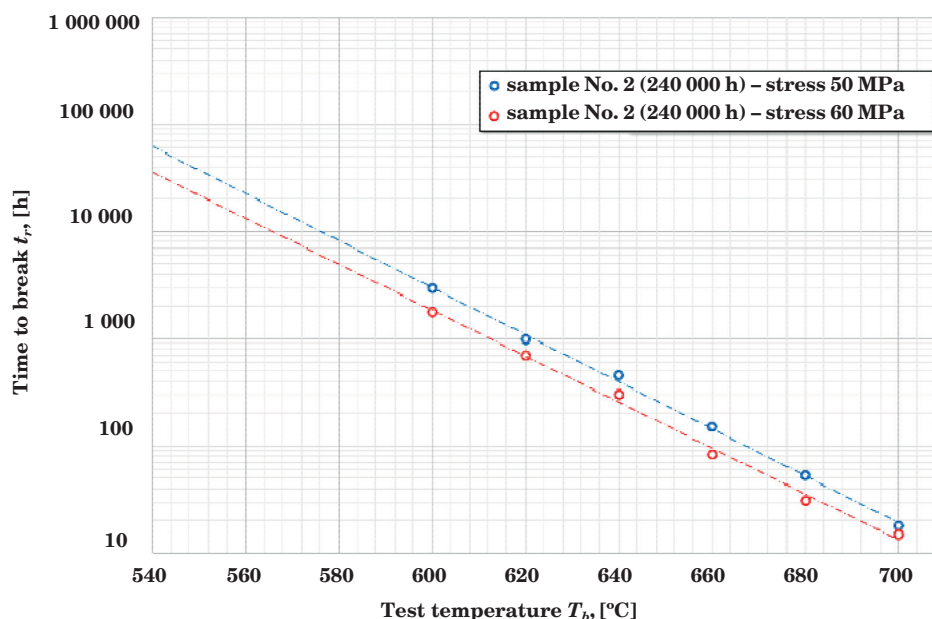
Fig. 6. Dependence of time to break in shortened creep tests of the repair welded joint made of steel 13HMF (material after use + material as delivered) marked as 2 given in the form of the relation $\log t_z = f(T_b)$ at $\sigma_{b1} = 50$ MPa and $\sigma_{b2} = 60$ MPa
