## Techniczne aspekty odbudowy i utrzymania obiektów zespołu pokamedulskiego w Wigrach

### Technical aspects of reconstruction and preservation of the former Camaldolese monastery in Wigry

**Key words:** Wigry Hill, buildings and structures of the Hill, damage and deformation, technical condition, displacement monitoring, research and protection

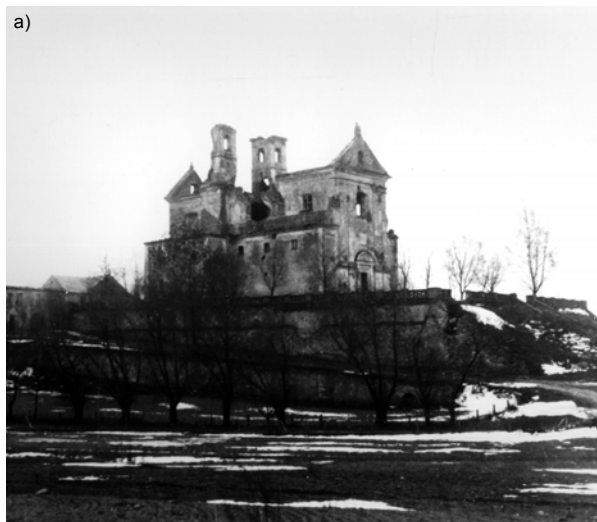
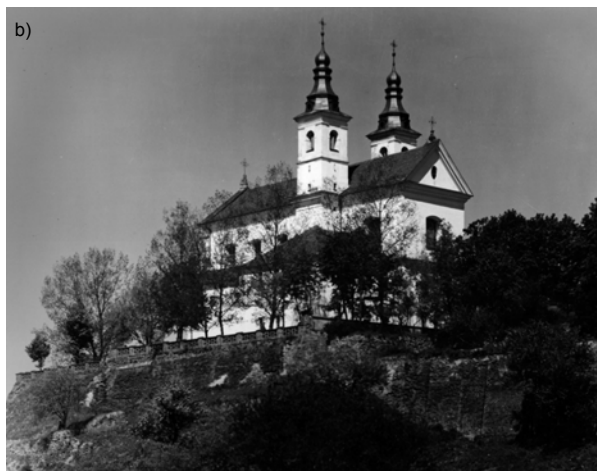
In the period between the two World Wars, the church edifice and erems were reconstructed in accordance with the designs of professor Oskar Sosnowski, as shown in fig. 3b. The Chancellor's Chapel and the Royal House are not visible from the main entrance since they were completely destroyed in military operations. During the World War Two the church edifice and erems were subjected to an artillery attack which again caused a serious damage, as shown in fig. 4.

Ryc. 3 Zniszczone wzgórze Wigierskie po pierwszej wojnie światowej i zrekonstruowany kościół w 1935 r.  
 Fig. 3 Wigry Hill damaged after the First World War and the church after reconstruction in 1935

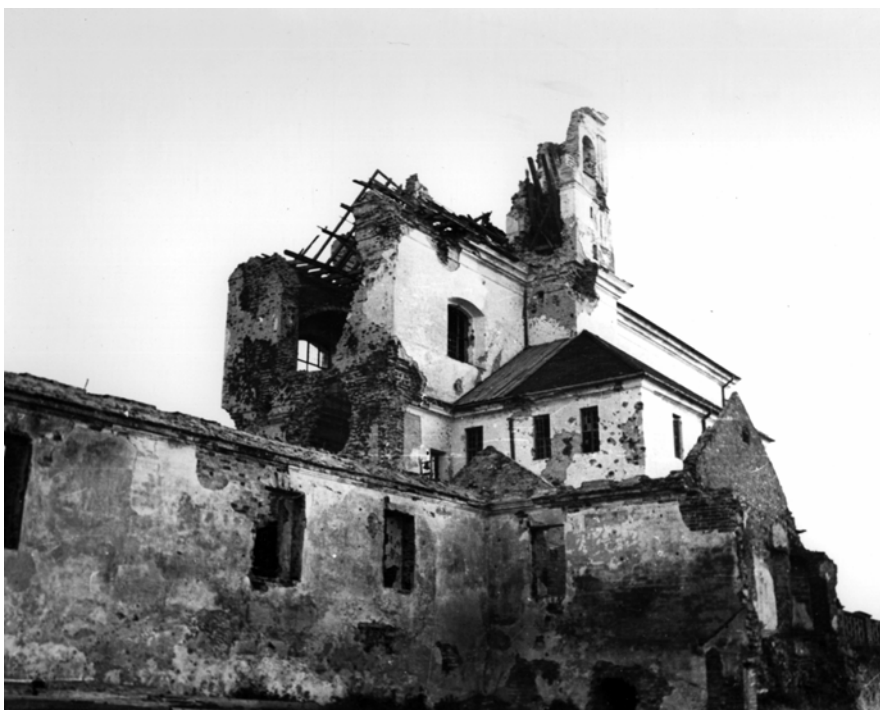
Ryc. 4. Budynek kościoła zniszczony podczas drugiej wojny światowej  
 Fig. 4. The church destroyed during the Second World War

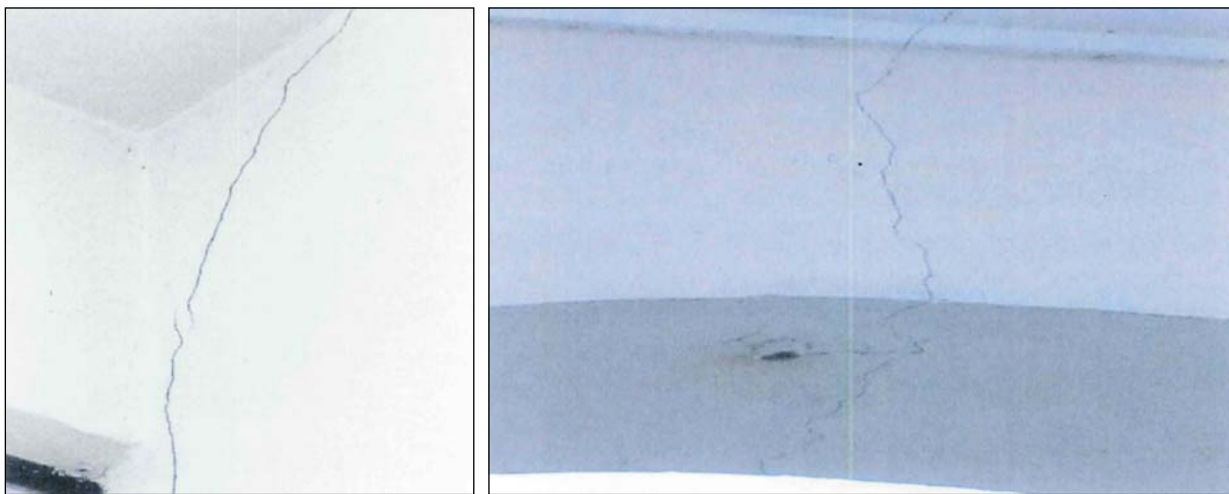
Rysy, pęknięcia i uszkodzenia szczególnie elementów nadproży, elementów stykowych i narożnych otworów widoczne są niemal we wszystkich budynkach i wielu elementach konstrukcyjnych.

Fissures, cracks and other damages, especially lintels, conjoined elements and corner openings can be found in almost all buildings and many structural elements.

Ryc. 8. Rysy i pęknięcia ścian  
Fig. 8. Wall cracks and fissures

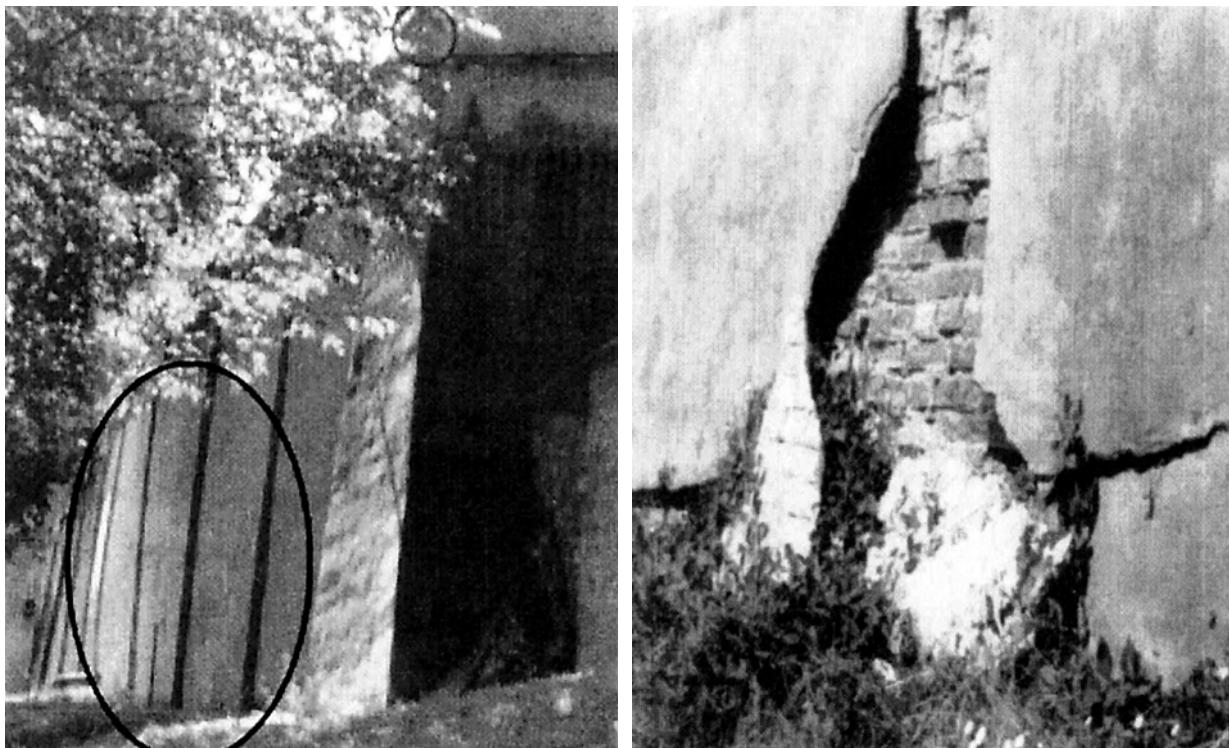
Środkowa część wschodniej ściany oporowej, jak podano wyżej, uległa uszkodzeniu w 1987 roku. Część ściany została wypchnięta, podczas gdy inna część doznała znacznych przemieszczeń w wyniku złożonego obciążenia od gruntu nasączonego wodą i ściekami z nieszczelnego i uszkodzonego systemu wodno-kanalizacyjnego. Ryc. 9 przedstawia aktualny stan i przemieszczenia wschodniej ściany oporowej.

The central part of the eastern retaining wall was seriously damaged in 1987 as discussed above. Part of the wall was pushed outwards, whereas other parts were significantly displaced as a result of compound load caused by soil infiltrated with water and sewage from the leaking water supply and sewage systems. Fig. 9 shows the current condition and displacement of the eastern retaining wall.

Ryc. 9. Wschodnia ściana oporowa i rozwarstwienie okładziny zewnętrznej – tynku  
Fig. 9. The eastern retaining wall and splitting layers of the external render

In 1999 a further part of the retaining wall suffered a considerable displacement, which forced repair of the faulty water supply and sewage systems and construction of unloading chambers. The unloading chambers were built along retaining walls, stabilising and reducing horizontal pressure from the ground, and precipitating also a return to the original concepts and modelling of static behaviour of the building structures [11].
