The Reasons of Steam Pipeline Elbow Rupture

A. Mesjasz ^{*a}, J. Piątkowski ^b

The goal of this dissertation is to determine the reasons of the damage (crack) of the steam pipeline's elbow made of alloyed steel 13CrMo4-5 after 300 000 hours.

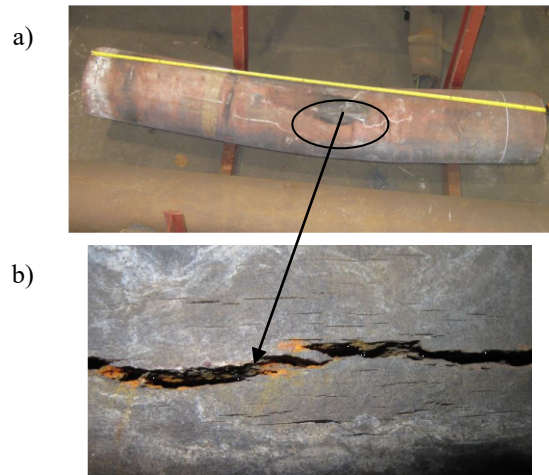
The photo of the steam pipeline elbow and the crack is being shown on the Figure 1.

Fig. 1. Pipeline elbow subjected to testing: a) overview; b) the elbow's crack area

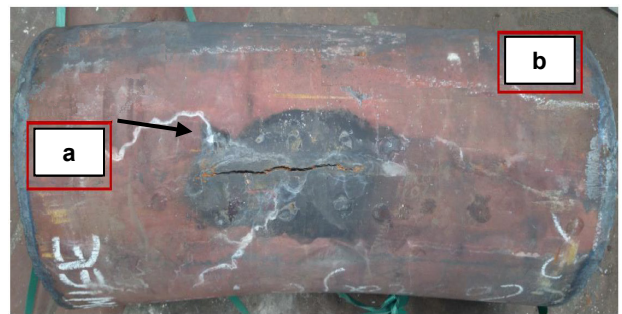
Fig. 2. (a, b) The areas from which samples were taken for mechanical properties testing: a) damaged area, b) not damaged area

Out of the data shown in the Tables 3-6 comes, that the 13CrMo4-5 steel material sampled from the place where crack occurs has lower yield strength $R_{p0.2}$ and $R_{p0.2}^{500C}$ of about 2%

from the requirement for the same steel in it's base state as per the standard PN-74/H-74252. The material sampled from the area without any internal damages complies with the requirement of mentioned above standard.

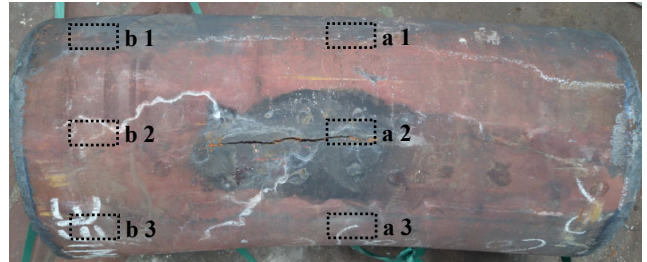
Fig. 3. The sampling places for representative samples for micro structure testing: a) damaged area, b) not damaged area

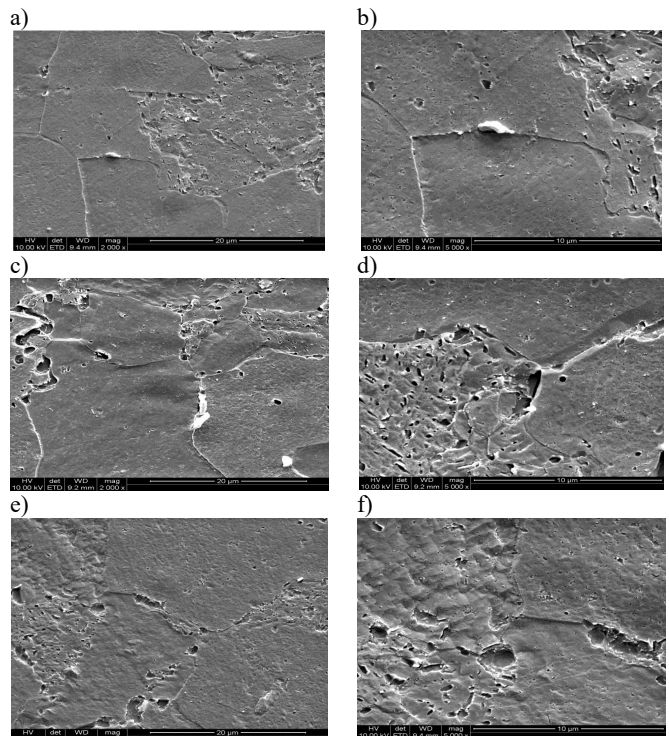
Fig. 4. The microstructure of the tested pipeline's elbow, from the area without the damage: a and b) area b1; c and d) area b2; e and f) area b3 with different magnitudes

Out of the micro structure tests it comes, that in the not damaged areas the structure depletion is the same as in the base material, and the changes are on the level I (Table 1) what equals to partial decomposition of bainite/perlite areas. In the areas where the damage was observed, the structure depletion level is B/1, and the micro structure changes are on the level I/II, what equals to decomposition of bainite/perlite secretions, and carbide balling, with distinctive micro-cracks net.

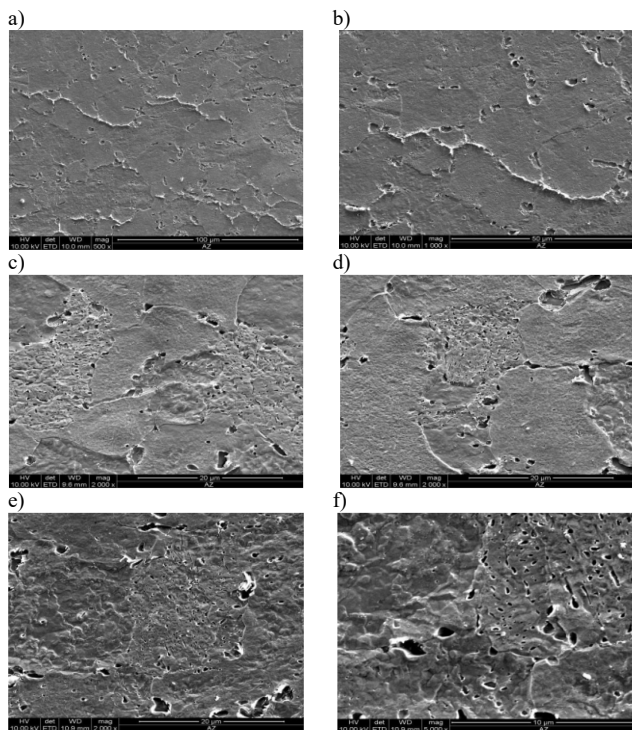
Fig. 5. The microstructure of the tested pipeline's elbow, from the area with the damage: a and b) area a1; c and d) area a2; e and f) area a3 with different magnitudes

The conducted tests proved, that the pipeline's elbow rupture happened as a result of complex tension system, which substantially exceeds the admissible tensions. One of the degradation factors was the natural and at the same time – considerable structure damage level, notes both in the damaged area (areas: a1; a2; a3) and outside the damaged area (areas b1; b2; b3).

On the basis of the conducted tests it may be stated, that the exploitation of the tested pipeline can be continued with maintaining certain exploitation regimes, with special consideration for pipeline's material temperature increase, which should not exceed 490°C. In the balance exploitation time, the use of the pipeline should be limited to minimum.

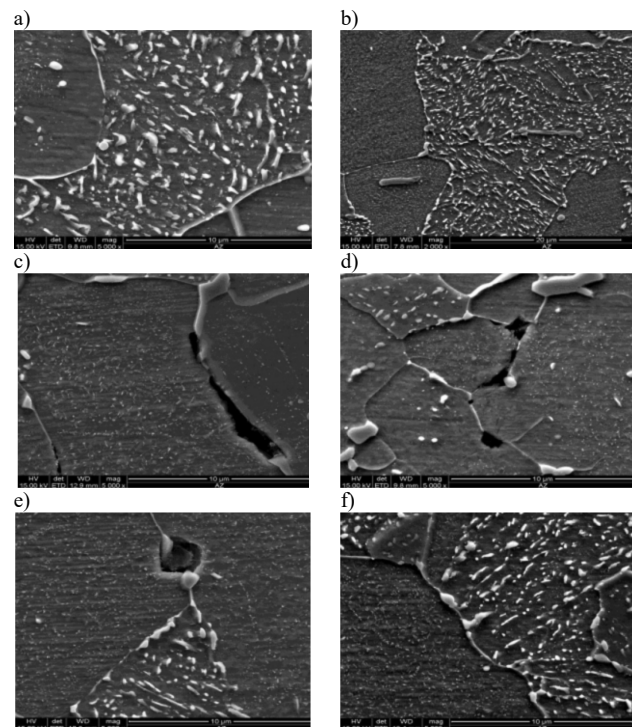
The SEM micro structures of the areas without damage and of those with damages are shown on the Figure 6.

Fig. 6. The microstructure of the tested pipeline's elbow: a, c, e) of the area without the damage, b, d, f) of the area with the damage
