# Broken engine's crankshaft misalignment inspection by using reverse engineering technique

W. Khuanlieng, S. Chuvaree, P. Janmanee \*

Department of Mechanical and Industrial Engineering, Faculty of Engineering, Rajamangala University of Technology Krungthep, Bangkok 10120, Thailand

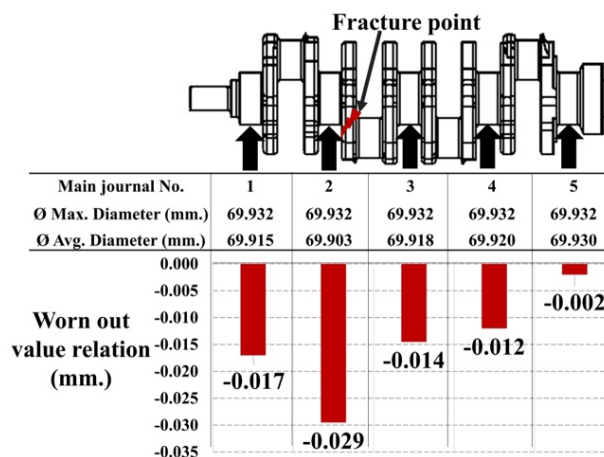
The measured value of the broken crankshaft is shown in Table 4. The worn-out value of each main crankshaft journal can be identified. Following the worn-out value of each main journal, the lowest measured value of the main journal diameter No. 2 was 69.890 mm. It was less than the limited value of 69.910 mm. Therefore, a new crankshaft was required to be replaced after inspection.

Fig. 9. Main journal diameter worn-out inspection of the broken crankshaft

Figure 9 presented the main journal diameter of the broken crankshaft. The measured value was compared with a maximum value when it was a new one. The actual worn-out value of average main journal diameter No. 5 was - 0.002 mm, which is the lowest worn-out rate. However, the actual worn-out value of average main journal diameter No. 2 was -0.029 mm, which is the highest worn-out rate. Considering the wear process, the material loss occurred due to the worn-out value relation of each main journal. The cross section area was changed by contact stress distribution while the crankshaft rotated. If the stress concentrations interfere with local concentrations of contact stresses, the surface coating may be damaged, and the wear resistance may deteriorate. Another parameter was the lubricating properties of the engine oil. If the viscosity accumulates impurities, they can act as an abrasive.[25] Generally, for the crankshaft in similar situations, all main journal diameters should be worn# closely to each other. In the case of the main journal, diameter No. 2 was immensely#worn out more than others. It was concerned with quality control on surface hardening in the heat treatment process. In addition, the worn-out value will be increased, and the clearance gap of the main journal-bearing shell will be expanded, which can lead to a misalignment of the crankshaft [26].
