## Resistograph investigation of Scots pine wood utility poles in the State Museum at Majdanek

WOJCIECH KORYCIŃSKI<sup>1</sup>, KRZYSZTOF J. KRAJEWSKI<sup>2</sup>, PAWEŁ KOZAKIEWICZ<sup>✉2</sup>

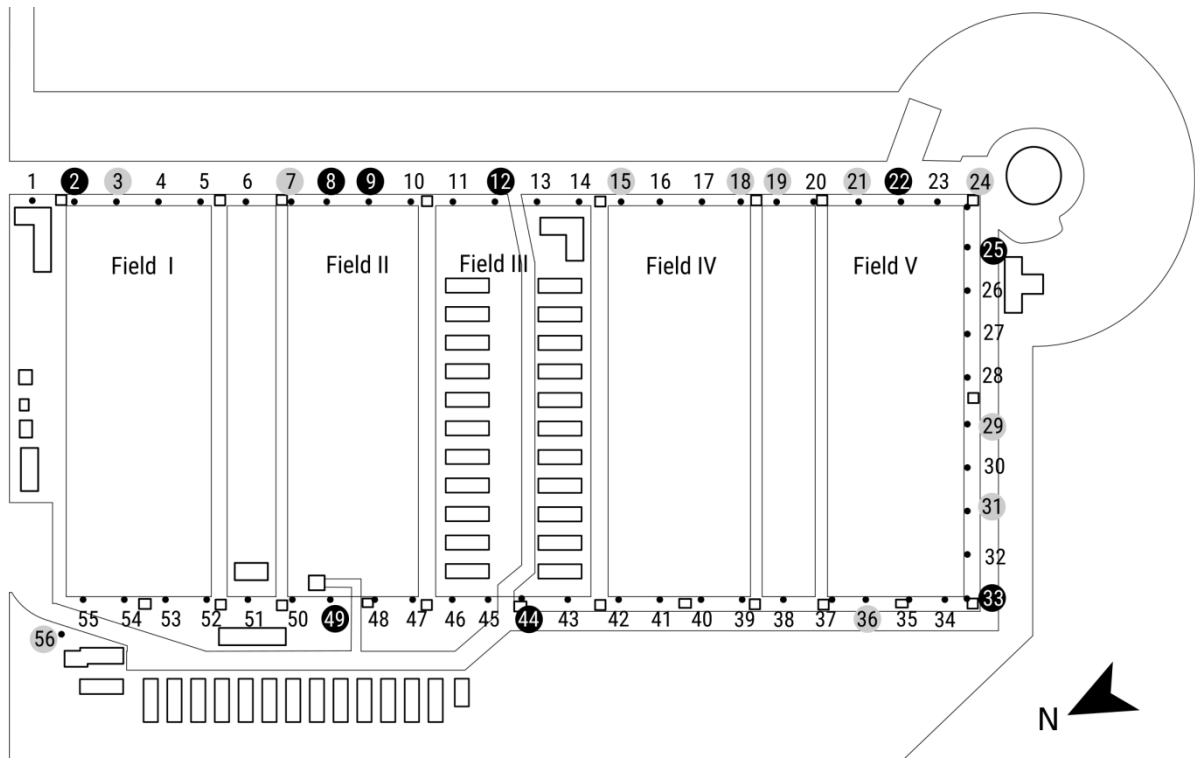
Figure 5. The current arrangement of wooden utility poles on the site of the State Museum at Majdanek - damaged poles are marked in black and the remaining poles (examined with a resistograph) are marked in gray

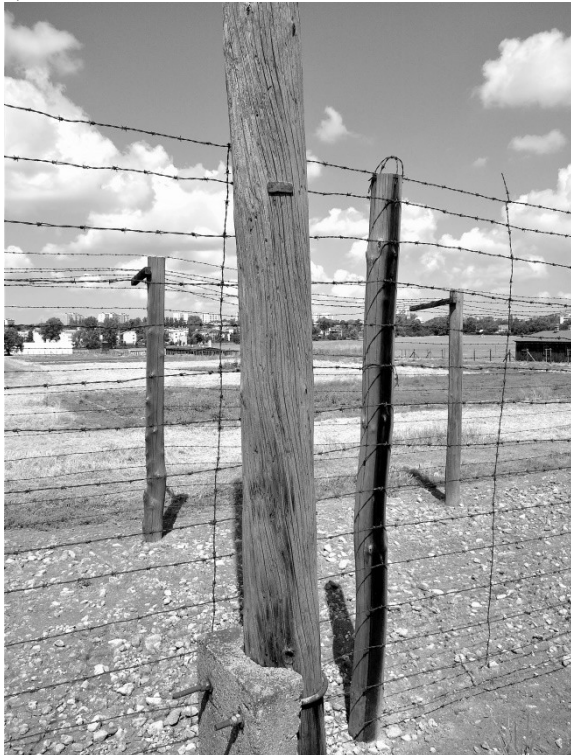
A survey of the poles with reference to the overall technical requirements for utility poles to be applied in measurement and classification of timber in PGLL Revealed quality discrepancies in three of the 56 poles examined. Two poles had irregular twisting of fibers where the deviation from straight line exceeded 90° measured in the pole's top half, one had two-sided curvature and a rotten knot whose diameter exceeded 60 mm (Fig.6). Most of the poles had marks of resin blazes, in none of them, however, excessively deep streaks were found.

Figure 6. Examples of poles with unacceptable defects: a) utility pole No. 5 with visible excessive twisting of fibers, b) utility pole No. 13 with visible curvature.

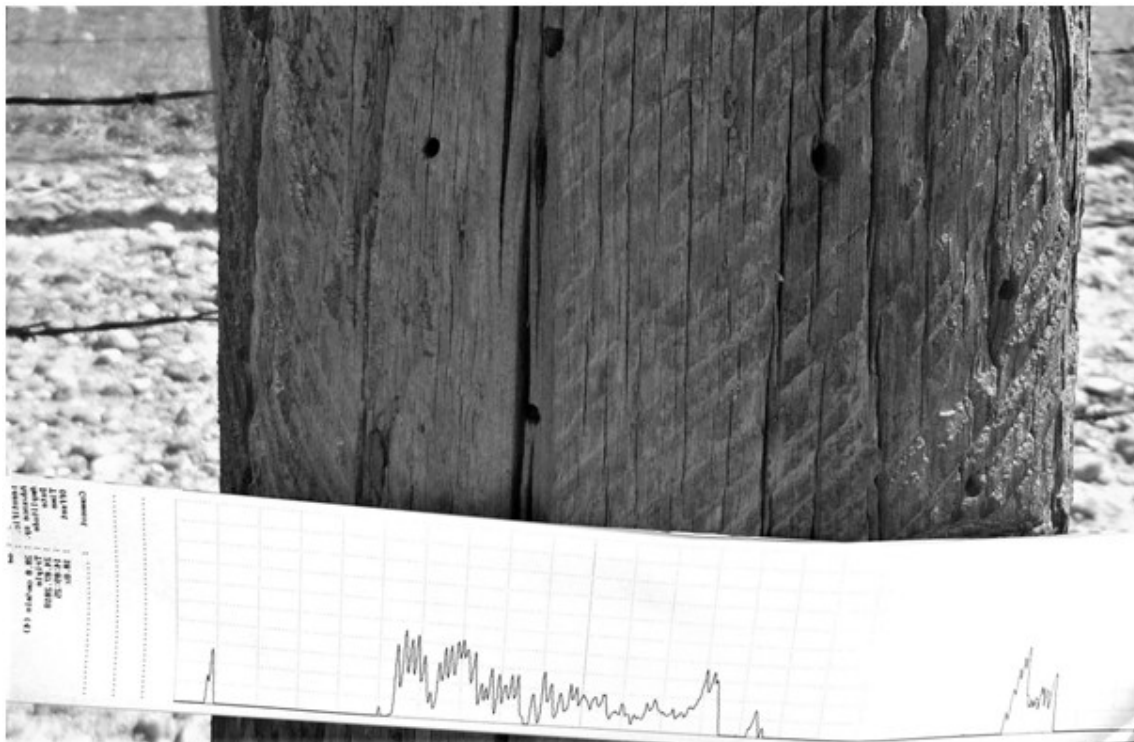
Following a preliminary acoustic assessment by means of tapping, 20 poles were singled out for resistograph testing, several of them with distinct beat effect, several others with correct sound, for reference (figure 5). Resistograph tests disclosed pole damage to occur usually at the height ca. 1 m above ground level. The damage was caused by feeding larvae of European house borer (*Hylotrupes bajulus* L.). Despite the lack of serious external damage visible to the naked eye, resistograph tests revealed reduced wood density in eleven poles; in nine of them the reduction was very considerable. In all these cases the damaged area was the sapwood. In three poles, the sapwood at the place of measurement was almost entirely destroyed (no drilling power registered). A typical result for such a case (pole No. 8) is presented in figures 7 and 8. The side surface of the pole showed marks of a resin blaze as well as distinct cracks and a few exit holes of European house borers' galleries. The total width of the damaged area was approximately 11 cm on a diameter of 22 cm. This corresponded approximately to the share of sapwood zone in the trunk of a mature pine tree (Dzbeński et. al. 2000).

Figure 7. Fragment of utility pole No. 8 with the printout of drilling power correlated with the density profile along its entire diameter at a height (photo: Rafał Krajewski, 2018).

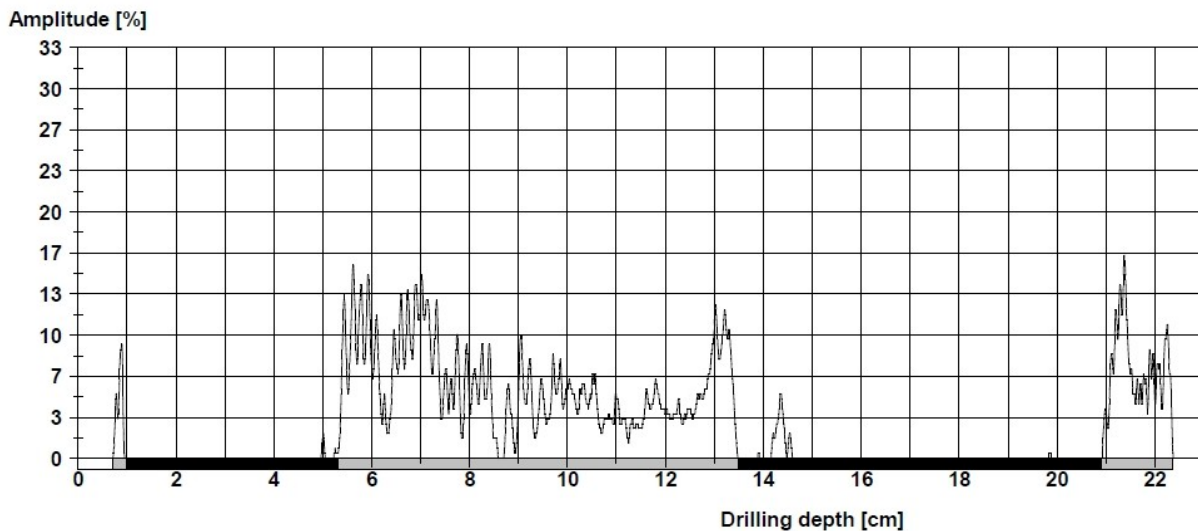
Figure 8. Analysis of the results of resistographic tests of utility pole No. 8 using the B-Tools Pro 1.6 program - the gray shade indicates fragments with typical wood density and black with reduced density

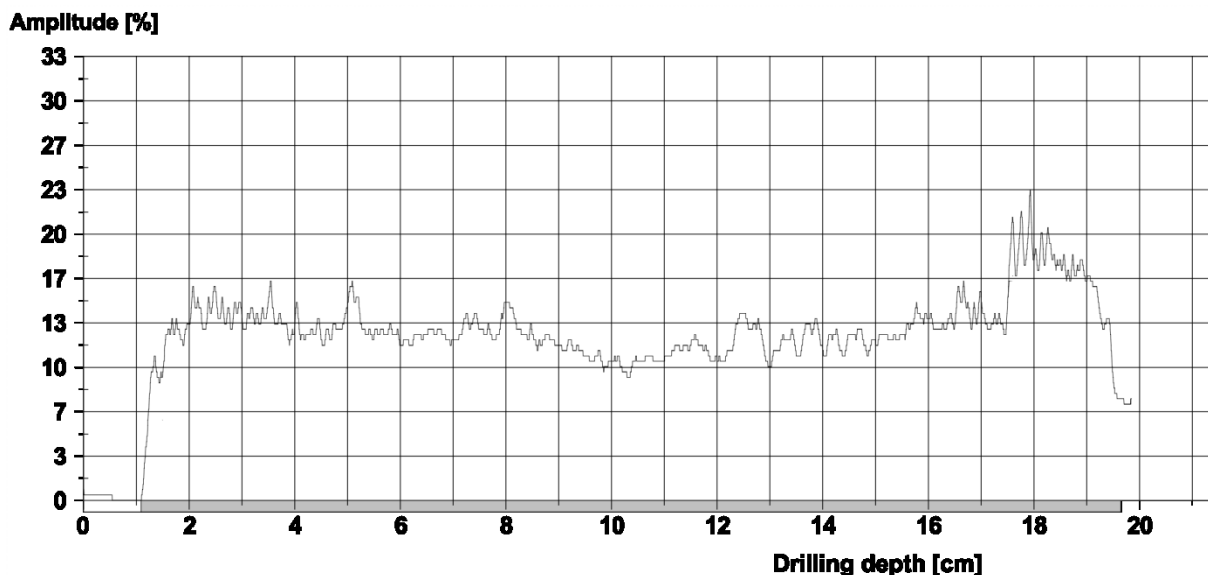
The damage to the sapwood zone varied in intensity with the height above ground level. Measurements at different heights showed diversified is tribution of density, well visible on the printouts of pole No. 33 tests (figures 9 and 10). Wood examined nearer its bottom end did not show changes in density. It was only above the concrete crutch holding the pole that reduced density in the sapwood part was clearly observable.

A lesser extent of damage, comprising only a fragment of the sapwood ring, was observed in eight poles, as exemplified in figure 10 (pole No. 33). Bores made at the same height but from different directions did not reveal losses in wood density. No changes in wood density were noted in the bottom sections of the poles (figure 9), despite the damage observed in the upperparts.

Figure 9. Changes in wood density in utility pole No. 33 - a bore at a height of 100 mm from the bottom end shows no change in density - fragments with a typical (average for pine wood) density level are marked in gray.

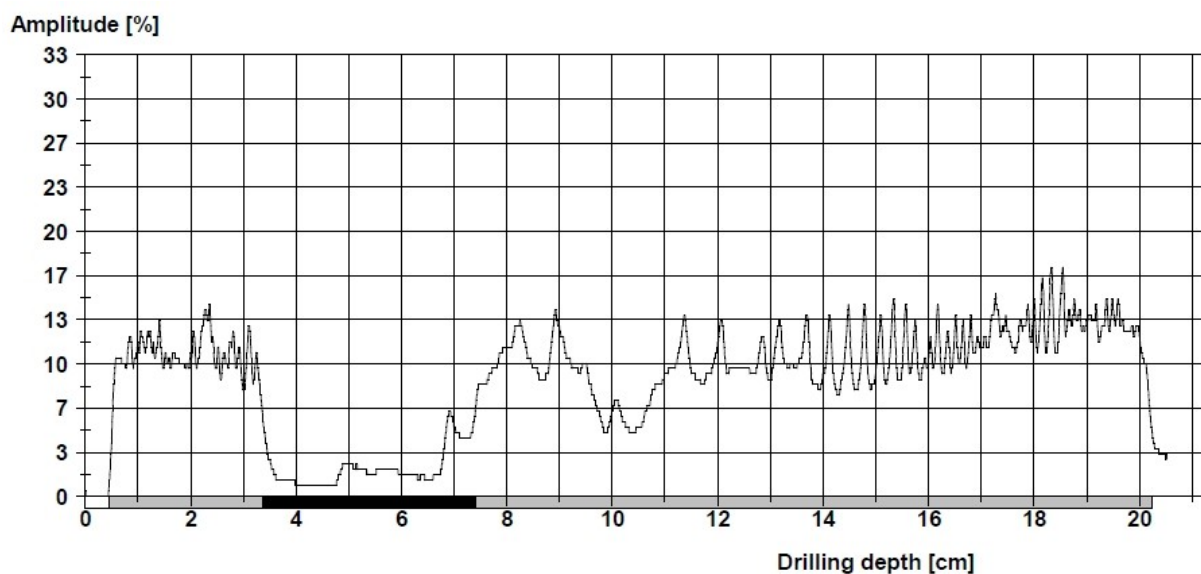
Figure 10. Changes in wood density in utility pole No. 33 - a hole at a height of 700 mm from the bottom end shows local density reduction - the gray shade indicates typical wood density and black shade reduced wood density
