## **DIAGNOSTICS AND REPAIRS OF DAMAGE OF THE LEANING TOWER IN ZABKOWICE SLASKIE**

The article concerns the diagnosis of the technical condition, as well as the possibilities of renovating, the Leaning Tower located in Zabkowice Slaskie in Lower Silesia, Poland. Damage to the structure of the facility, which occurred in 2015, constituted the basis for carrying out tests and measurements in order to enable the causes of the damage to be determined. The resulting damage is cracks in brick walls. Cracks were formed in the place where the proper structure of the Tower was connected with the staircase constituting the extension of the building. Therefore, it was necessary to carry out diagnostic work. The conducted diagnostic works resulted in the obtaining of knowledge about the technical condition of the facility, and the possibilities of the necessary repair works, which will ensure the further safe operation of the facility. It was considered necessary to stabilize the ground under the staircase by making micropiles. Cracks in the walls were stabilized by making steel ties, rebuilt and reinforced with steel bars. The Leaning Tower, as a historic and unique building in Europe, requi

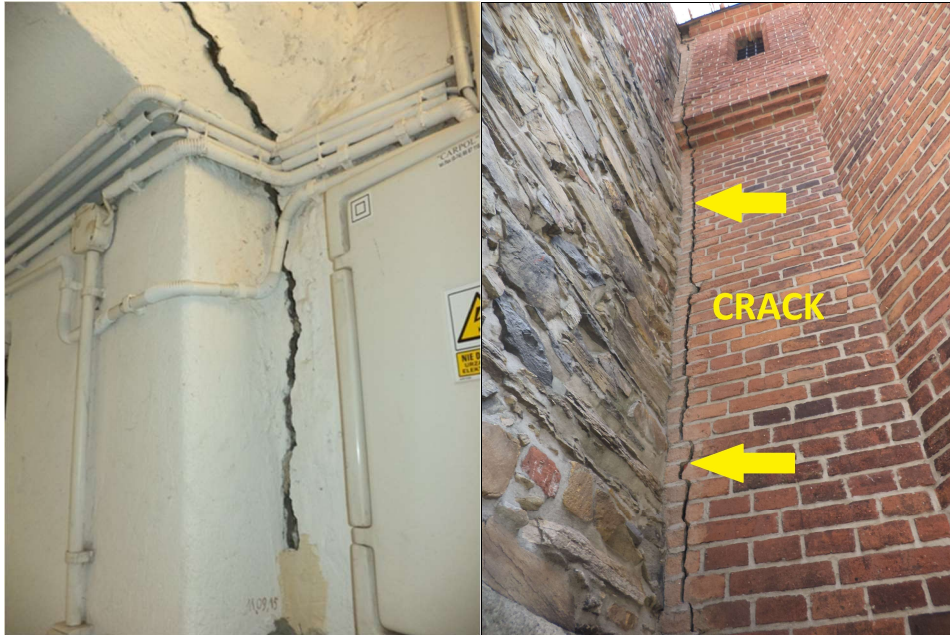
The cracks and scratches of the structural elements – at the connections of the walls of the outbuilding with the south-west wall of the tower - are continuous cracks that occur along the entire length of the elements and which propagate through the elements into their interior, as shown in the photo documentation below (Fig. 3).

Fig. 3. Crack at the connection of the tower and the outbuilding – the view from inside and outside

Strongly cracked wall fragments above the windows (fragments of lintels) in the passage between the staircase and the tower (see Fig. 3), which had cracks with a large width (over 10 mm), were rebricked. The purpose of the rebricking was to recreate the original connection between the bricks, while at the same time to ensure the joining of the parts of the wall separated by the cracks.

Bricks taken from demolitions, or bricks with similar properties to the original ones, as well as mortar similar to the original one in the wall (renovation mortar systems), were used. The brickwork was performed partially - first one brick deep from the inside, then one brick deep from the outside. In order to avoid the formation of shrinkage scratches at the connections between the old and new walls, anchoring reinforcement and renovation non-shrink mortars were used [10, 11].

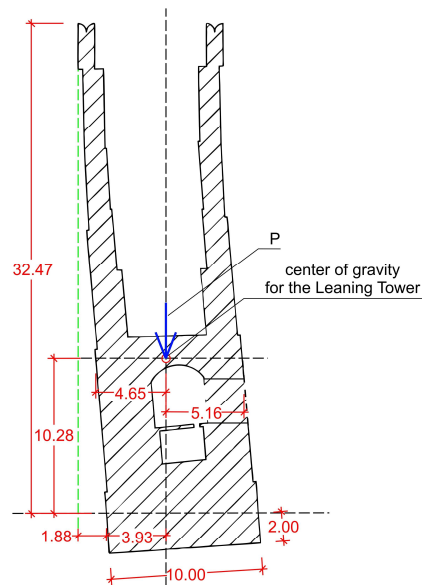
By projecting force  $P$  onto the foundation's base, it is possible to determine the arm of its action, which in this case is equal to approximately 1.30 m. The core of the tower's foundation -  $B = (10,0\text{m})^6$  - is equal to 1.66 m. Therefore, the force remains inside the core, which is shown in Figure 6.

Fig. 6. Location of the centre of gravity and the stabilizing force (P)

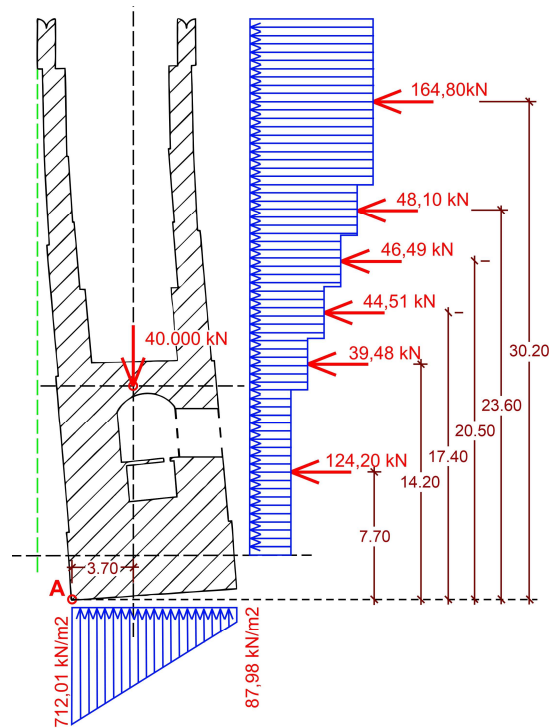
The general verification of the tower's stability with regards to rotation was performed in relation to the most unfavourable point in the structure (point A in Fig. 7) using formula:

Fig. 7. Summary of the forces acting on the object
