Vladimir DEKYS¹, Ondrej DVOULETY²

AN CONTRIBUTION TO THE CONDITION MONITORING OF FANS

Summary. One reason for failure of fan is suppression to float a shaft's bearing in the bearing housings. As a result of this disorder leads to blocking axial displacement of bearing, thrust to the growth of the forces acting on the bearing, and then to his accident. The article deals with the identification of the symptoms of this condition in the data from diagnostic measurements and presents the results of practice.

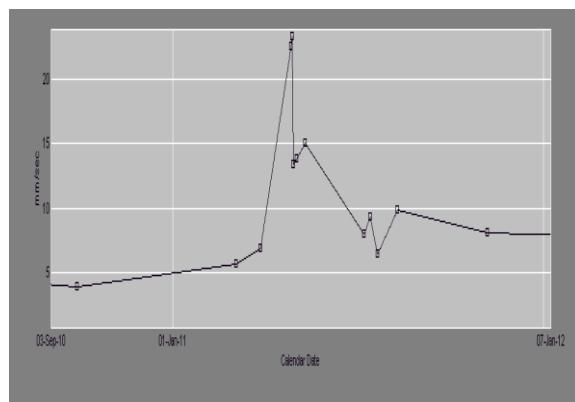
1. Multiple vibration increase of bearings in the axial direction at failure stage. In our case, the increase was approximately four times, in Fig. 2.
 - a. In Fig. 2 is trend of electromotor axial vibration by coupling with increasing vibration in this direction from $5,7 \text{ mms}^{-1}$ up to $23,3 \text{ mms}^{-1}$.

Fig. 2. Trend of electromotor axial vibration by coupling with increasing vibration from $5,7 \text{ mms}^{-1}$ up to $23,3 \text{ mms}^{-1}$

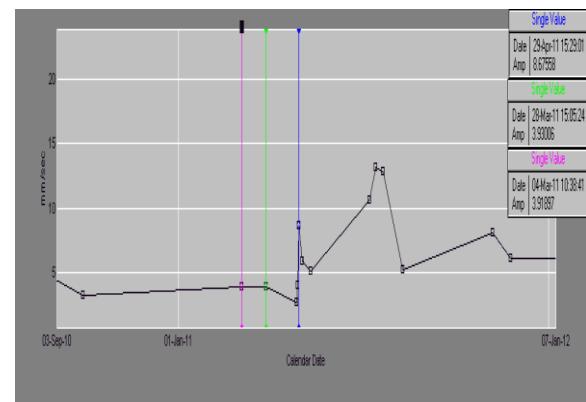
2. The growth of vibration in the rotor bearing houses by coupling other than axial direction is depicted in Fig. 3 and Fig. 4.
 - a. In Fig. 3 is trend of fan bearing vibration by coupling in horizontal direction with increasing from $3,9 \text{ mms}^{-1}$ up to $8,7 \text{ mms}^{-1}$. The increase however is significantly lower in horizontal direction than in an axial direction.

Fig. 3. Trend of fan bearing vibration by coupling in horizontal direction with increasing from $3,9 \text{ mms}^{-1}$ up to $8,7 \text{ mms}^{-1}$

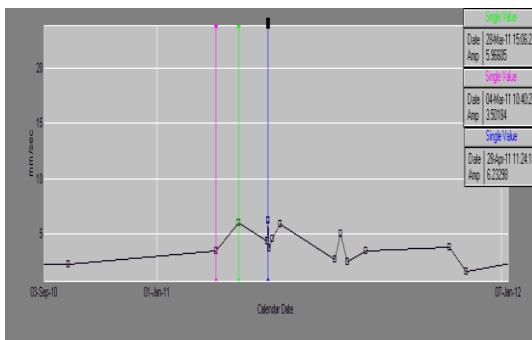
- b. In Fig. 4 is trend of fan bearing vibration by coupling in vertical direction with increasing from $3,5 \text{ mms}^{-1}$ up to $6,2 \text{ mms}^{-1}$. The increase however is significantly lower in horizontal and vertical directions than in an axial direction.

Fig. 4. Trend of fan bearing vibration by coupling in vertical direction with increasing from $3,5 \text{ mms}^{-1}$ up to $6,2 \text{ mms}^{-1}$

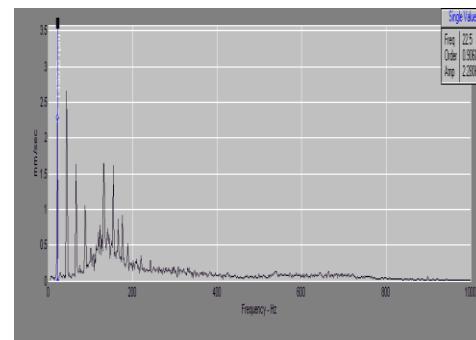
4. A velocity spectrum of fan bearing by coupling in vertical direction at 04/28/2011 is in Fig. 5. The spectrum is interesting occurrence harmonic frequency fan speed. This fact can be interpreted as the growth of vibration in the radial direction (the response of the system) involved non-linear properties and not fan speed frequency as in Fig. 8. This can be regarded as the accompanying symptom of failure.

Fig. 5. A velocity spectrum of fan bearing by coupling in vertical direction at 04/28/2011, failure

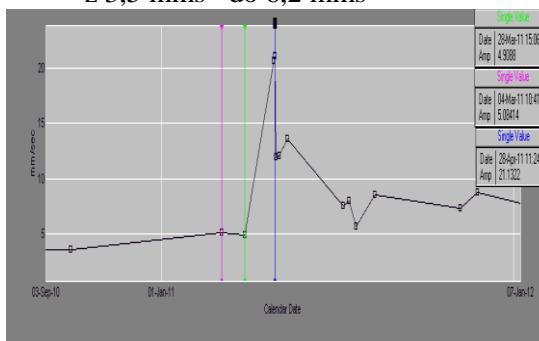
- c. In Fig. 6 is trend of fan bearing vibration by impeller in axial vibration with increasing from $5,1 \text{ mms}^{-1}$ up to $21,1 \text{ mms}^{-1}$.

Fig. 6. Trend of fan bearing vibration by impeller in axial vibration with increasing from $5,1 \text{ mms}^{-1}$ up to $21,1 \text{ mms}^{-1}$

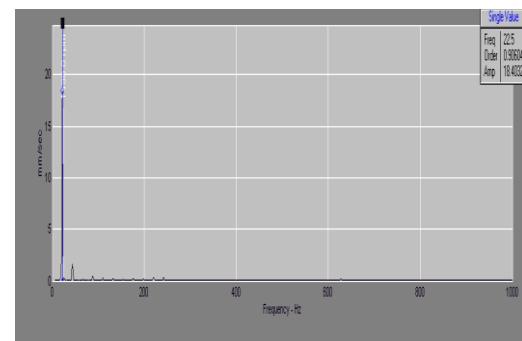
3. A velocity spectrum of fan bearing by coupling in axial direction at 04/28/2011 is in Fig. 7. The dominant peak is at fan speed frequency. This peak has caused an increase in the trend in axial direction.

Fig. 7. A velocity spectrum of fan bearing by coupling in axial direction at 04/28/2011. The dominant peak is at fan speed frequency

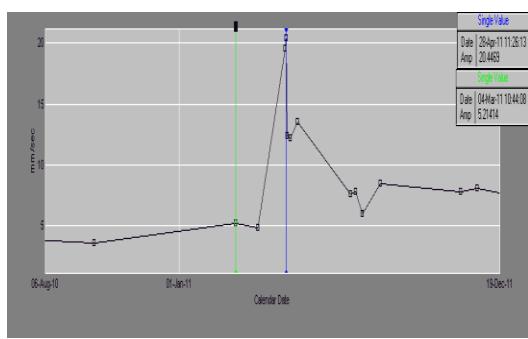
- b. In Fig. 8 is trend of fan bearing vibration by coupling in axial vibration with increasing from $5,2 \text{ mms}^{-1}$ up to $20,4 \text{ mms}^{-1}$.

Fig. 8. Trend of fan bearing vibration by coupling in axial vibration with increasing from $5,2 \text{ mms}^{-1}$ up to $20,4 \text{ mms}^{-1}$

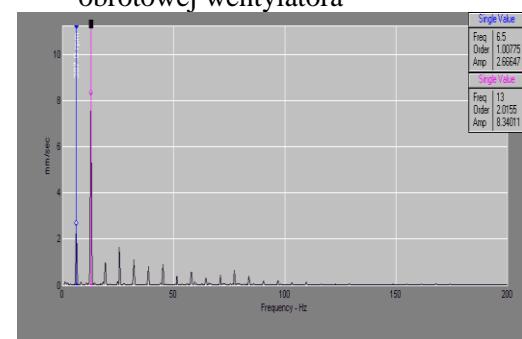
2. For drive end (DE) of crusher are peak at crusher speed frequency approximately the same, different are second harmonics in Fig. 9 and Fig. 10 in axial direction.

Fig. 9. The crusher, spectrum in axial direction of rotor bearing, DE with harmonics, failure

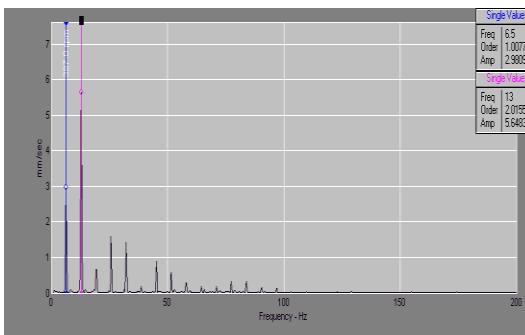
Fig. 10. The crusher, spectrum in axial direction of rotor bearing, DE with harmonics, after failure. Decrease in the second harmonic

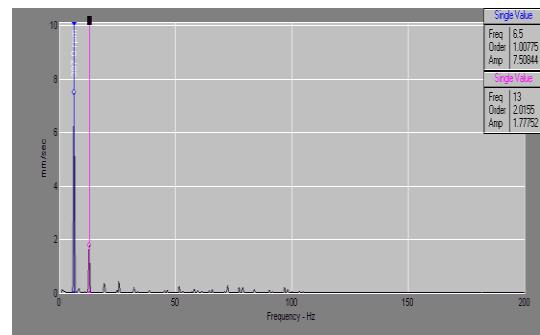
1. The peak at crusher speed frequency (at 6.5 Hz) in axial direction is symptom of described failure, Fig. 11 (failure) and Fig. 12 (after repair) for non drive end (NDE).

Fig. 11. The peak at crusher speed frequency (at 6.5 Hz) in axial direction of rotor bearing, NDE, failure

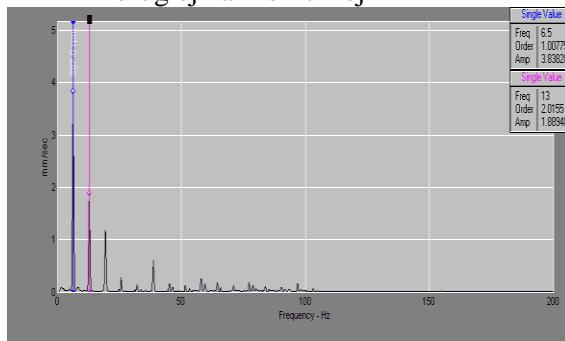
Fig. 12. The peak at crusher speed frequency (at 6.5 Hz) in axial direction of rotor bearing, NDE, after repair

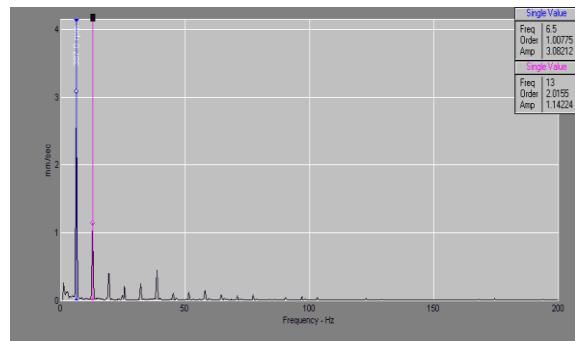
3. In Fig. 13 and Fig. 14 are spectrums for DE and Fig. 15 and Fig. 16 are spectrums for NDE in horizontal direction. The changes of amplitudes at crusher speed frequency are very small.

Fig. 13. The crusher, spectrum in horizontal direction of rotor bearing, DE with harmonics, failure

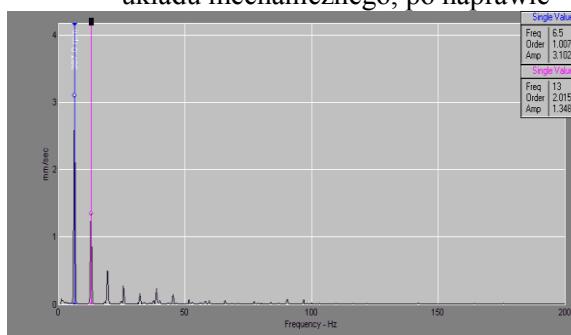
Fig. 14. The crusher, spectrum in horizontal direction of rotor bearing, DE with harmonics, after repair

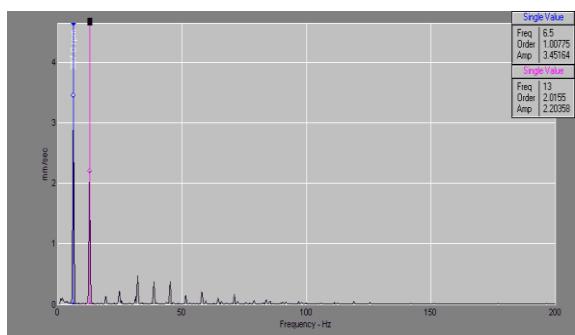
Fig. 15. The crusher, spectrum in horizontal direction of rotor bearing, NDE with harmonics, failure

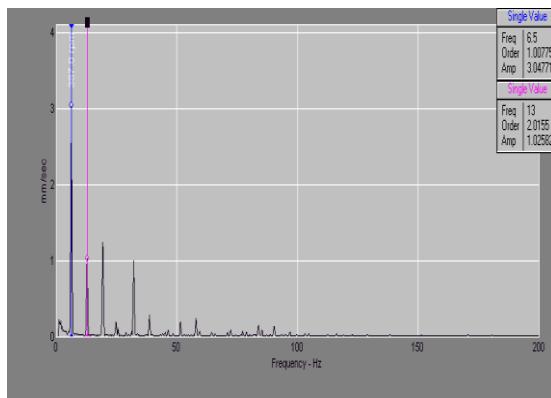
Fig. 16. The crusher, spectrum in horizontal direction of rotor bearing, NDE with harmonics, after repair

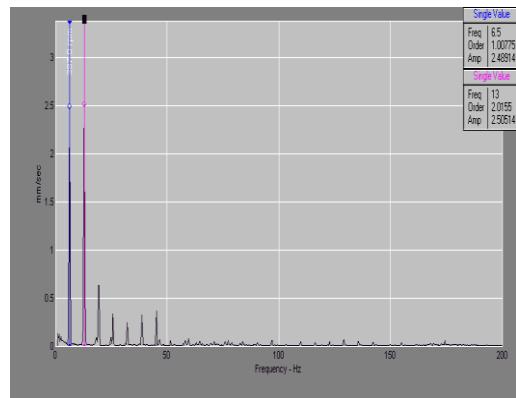
4. In Fig. 17 and Fig. 18 are spectrums for DE in vertical direction. The change of amplitude at crusher speed frequency is very small too.
5. The measurement of phase at crusher speed frequency was done too. These results served to completion information about considered failure of crusher. The results are in Tab. 1. These results can be interpreted as follows.

Fig. 17. The crusher, spectrum in vertical direction of rotor bearing, DE with harmonics, failure

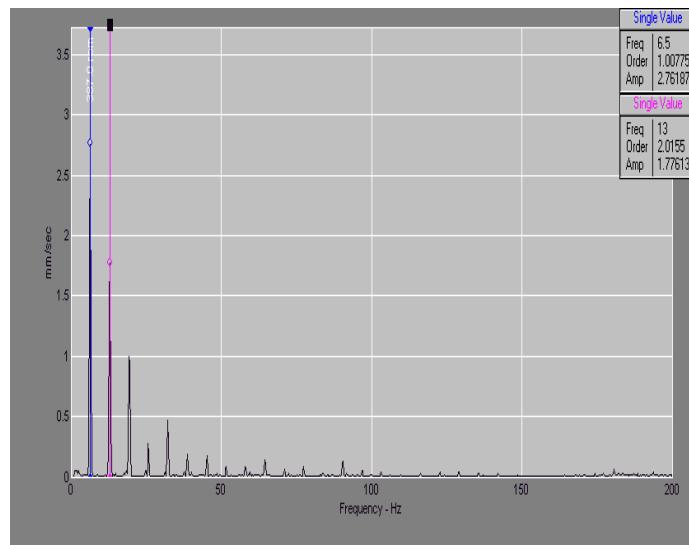
Fig. 18. The crusher, spectrum in vertical direction of rotor bearing, DE with harmonics, after repair.
