STRUCTURE AND MECHANICAL PROPERTIES OF 21HMF STEEL STEAM TURBINE ROTOR MATERIALS AFTER LONG-TERM OPERATION FOR A TIME SIGNIFICANTLY EXCEEDING THE DESIGN TIME

The article presents the results of tests of materials for steam turbine rotors with various degrees of depletion in order to determine the suitability of these components for further operation after significantly exceeding the design working time on the basis of the assessment of the microstructure condition and a set of functional properties.

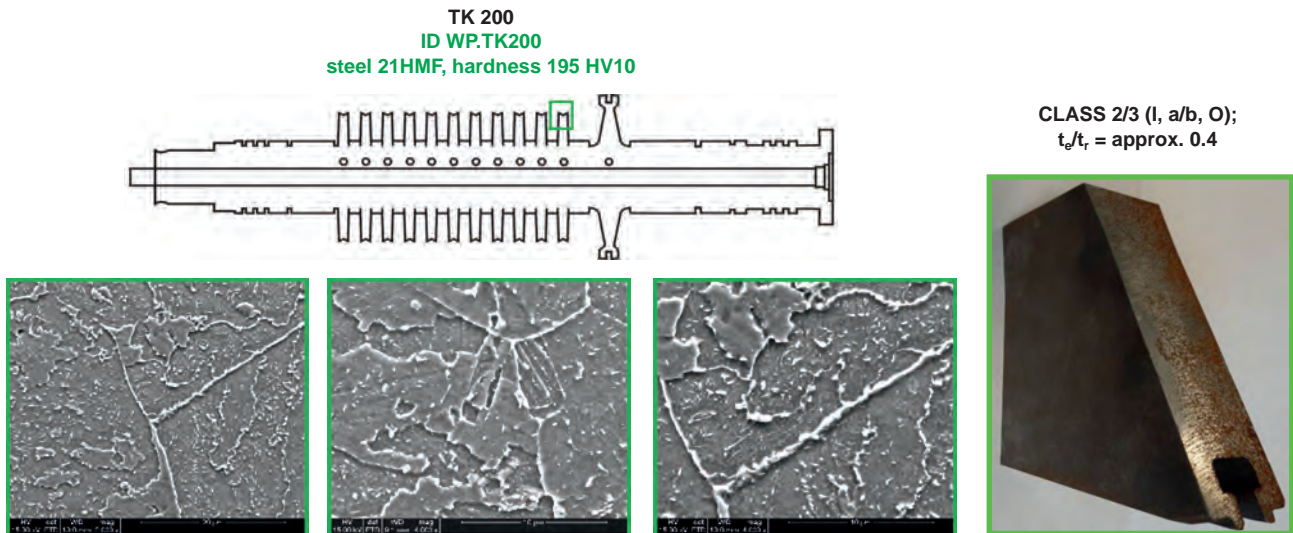
Fig. 3. Microstructure of the material in the area of the outer periphery of the disc of the first unregulated steam inlet stage of the WP high-pressure part of the TK 200 turbine rotor made of 21HMF steel after 200,000 hours of operation, observed on a crosswise microsection using a scanning electron microscope

After approx. 200,000 operating hours, the material of the WP high-pressure part of the 21HMF steel steam turbine rotor of the 200 MW power unit, taken from the area of the outer periphery of the disc of the first unregulated stage of this part of the rotor, where the operating temperature is 530°C, is characterised by bainite with sparse ferrite grains and numerous precipitates at the boundaries of bainite lamellae and inside them. A partial atrophy of bainite lamellae can be observed in the examined area's material. The lower hardness of 195 HV10 confirms the partial atrophy of bainite lamellae. An evidence of the significant advancement of the precipitation process are numerous precipitates of different sizes inside these areas, and fine or small spheroidal precipitates, including MC carbides rich in vanadium. Chain-forming precipitates, probably of the chromium-rich $M_{23}C_6$ carbide, were observed at the boundaries of bainite lamellae. Moreover, inside these regions, a significant amount of precipitates was revealed, which, due to their morphological features, can be identified as Mo_2C , larger and irregularly shaped - as M_6C . (Fig. 3).

The material with a significant degree of wear ($t_e/t_r =$ approx. 0.4) is taken from the outer periphery of the disc of the first unregulated stage (ID WP.TK200) of the high-pressure part of the turbine rotor of the 200 MW unit after long-term operation with an operating temperature of 500°C and taken from the area of the control wheel (ID WP 3.1K360, WP 3.4K360) of the high-pressure part of the turbine rotor of the 3600 MW unit after long-term operation with the operating temperature of 535°C, differing not only in temperature, but also in operating time, by approx. 20,000 hours. These materials are characterised by bainitic structure with a significant disappearance of bainite lamellae are characterised by an advanced precipitation process, which is evidenced by numerous fine precipitates inside these areas. Based on their morphological features, it can be assumed that these are fine spheroidal precipitates of the vanadium-rich MC carbide and elongated precipitates of the molybdenum-rich M_2C carbide. The chain-forming precipitates that occur at the boundaries of these regions are likely precipitates of chromium-rich M_7C_3 or $M_{23}C_6$ carbide. This was confirmed by the results of studies on the isolates of precipitates, the defined sequence of which corresponds to class a of the degree of development of the precipitation processes, and together with the revealed structure image, corresponds to class 2/3. A significant degradation of the structure manifested itself in the level of strength properties lower than the required minimum values for the initial state, in particular tensile strength and yield point at room temperature and yield point at 200, 300 and 450°C for the material from the 360 MW block, ID WP 3.1K360. For the rotor material from the 200 MW unit ID WP.TK200, the actual obtained values of tensile strength and yield strength, both at room temperature and elevated temperature, are much higher than the minimum required for the initial state. This may be due to their baseline level significantly higher than the required minimum values, which resulted in a significant reduction, but to a level above the required minimum baseline values. On the other hand, the results of the impact energy test showed that its level at room temperature for both analysed materials is much below the required minimum value for the initial state and amounts to

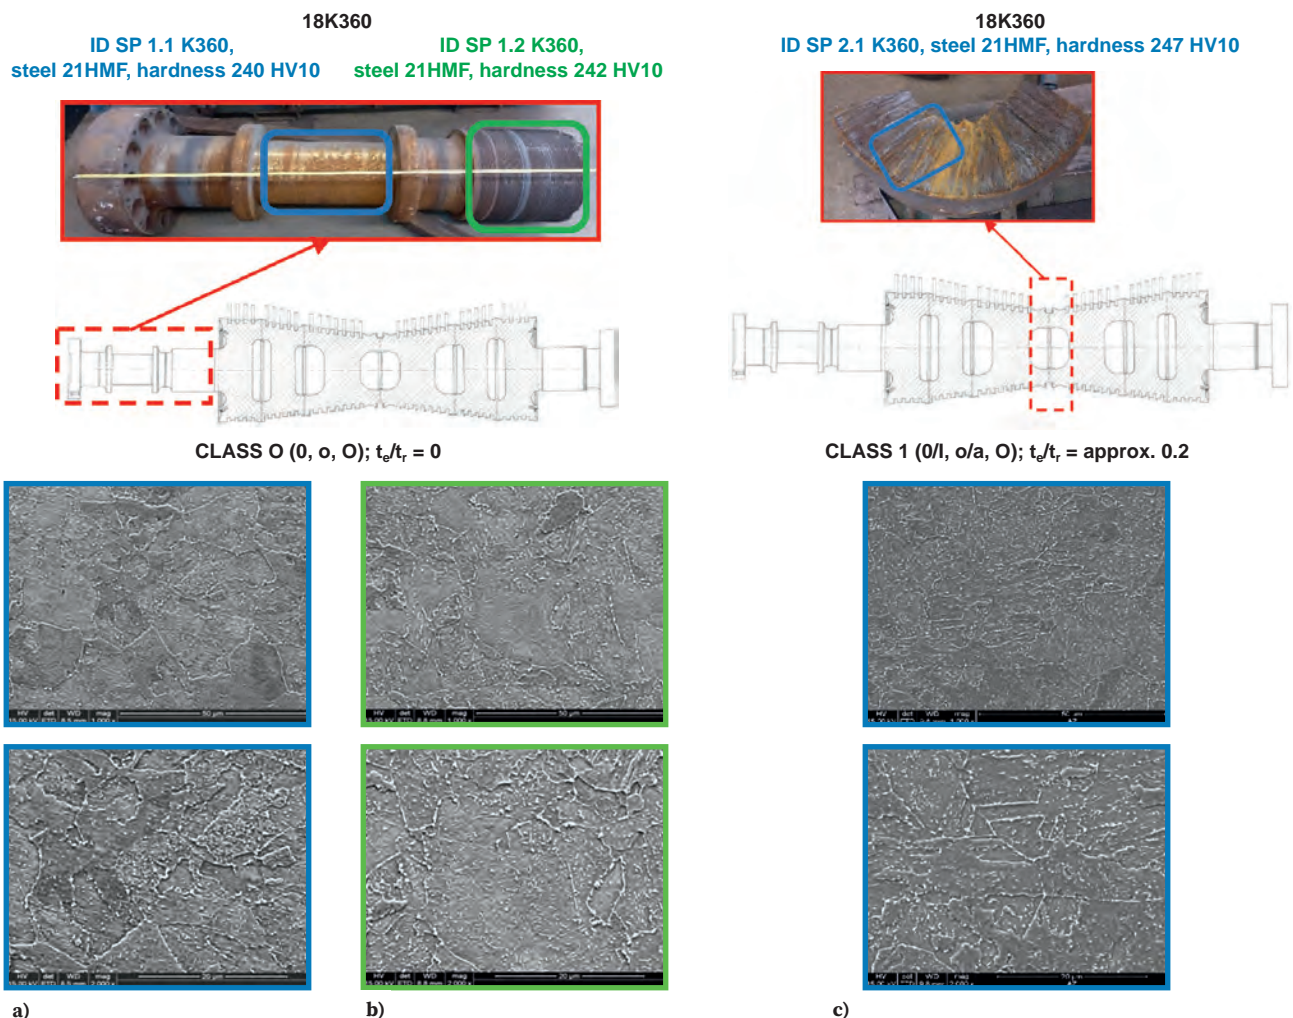
Fig. 4. Microstructure of the material of the SP medium-pressure part of the 18K360 turbine rotor after 220,000 hours of operation observed on etched transverse microsections using a scanning electron microscope: a) in carrier thrust bearing pin (ID SP 1.1 K360), b) in the front of the gland (ID SP 1.2 K360), c) in the drum in the steam inlet region (ID SP 2.1 K360)

SP medium-pressure part of 360 MW unit rotor in the front of the gland (ID SP 1.2K360) Fig. 4b	240 <u>0</u> 220,000	Bainitic-ferritic structure. Bainite with numerous, mostly fine precipitates. Image of microstructure similar to the typical microstructure of the initial state of the rotor material made of the tested steel. The initiation of internal damage processes was not observed. No discontinuities and microcracks were observed in the structure.	(0, o, O) ¹ CLASS 0 $t_e/t_r = 0$	242
SP medium-pressure part of 360 MW unit rotor rotor's SP part drum section in steam inlet area (ID SP 2.1 K360) Fig. 4c	535 <u>3.93</u> 220,000	Bainitic structure with sparse ferrite grains. The material is characterised by bainite lamellae with numerous precipitates on lamellae boundaries and inside them. Precipitates, locally forming chains, were observed on bainite lamellae boundaries. Also inside these areas, a significant number of precipitates were revealed, which can be identified by their morphological features: finely-dispersed as VC precipitates and small elongated as Mo ₂ C. In addition, M ₃ C cementite in the form of larger precipitates were observed in these areas. The initiation of internal damage processes was not observed. No discontinuities and microcracks were observed in the structure.	(0/I, O/a, O) ¹ CLASS 1 $t_e/t_r = \text{approx. } 0.2$	247

The material of the SP medium-pressure part of the 21HMF steel rotor of the steam turbine of the 360 MW power unit after approx. 220,000 operating hours, taken from the carrier thrust bearing pin (ID SP 1.1) of the part of the rotor, where the operating temperature corresponds to the room temperature and amounts to approx. 40°C and the front part of the gland (ID SP 1.2) where the operating temperature is about 240°C, is characterised by bainite with numerous precipitates. The image of the microstructure of these areas of the rotor is similar to the typical micro-

After approx. 220,000 operating hours, the material of the SP medium-pressure part of the 21HMF steel steam turbine rotor of the 360 MW power unit, taken from a drum section of the SP part rotor in the steam inlet region (ID SP 2.1) of this rotor part, where the operating temperature is 535°C, is characterised by bainite with quite numerous precipitates at the boundaries of lamellae and inside them (Fig. 4c). Preserved bainite lamellae can be observed in the examined area's material. Chain-forming precipitates of the chromium-rich M_7C_3 carbide were observed at the boundaries of bainite lamellae. Also inside these regions, a significant number of fine precipitates were revealed, which by their morphological features can be identified as vanadium-rich MC precipitates, M_3C cementite precipitates of a significant size and small, elongated (disc) molybdenum-rich M_2C precipitates. The image of the structure corresponds to the level of hardness which does not differ from the characteristic for the initial state and amounts to

The material with a low degree of wear ($t_e/t_r =$ approx. 0.2) was collected from a rotor drum in the steam inlet region (ID SP 2.1 K360) of the SP medium-pressure part of the 360 MW unit turbine rotor with an operating temperature of 535°C. It is characterised by a bainite structure with a small amount of ferrite with a slight degree of bainite degradation and a moderate development of precipitation processes. Apart from a significant amount of precipitates of M_3C carbides and numerous fine MC and M_2C carbides inside the bainitic regions, as for the material in the initial state, M_7C_3 precipitates were identified at the boundaries of bainite regions and ferrite grains, although with different proportions compared to the initial state. This state corresponds to class o/a of the precipitation process development and structural class 1. The set of mechanical properties also corresponds to values higher than the minimum required for the initial state; the brittle transition temperature is approx. + 5°C and the hardness is 247 HV10.

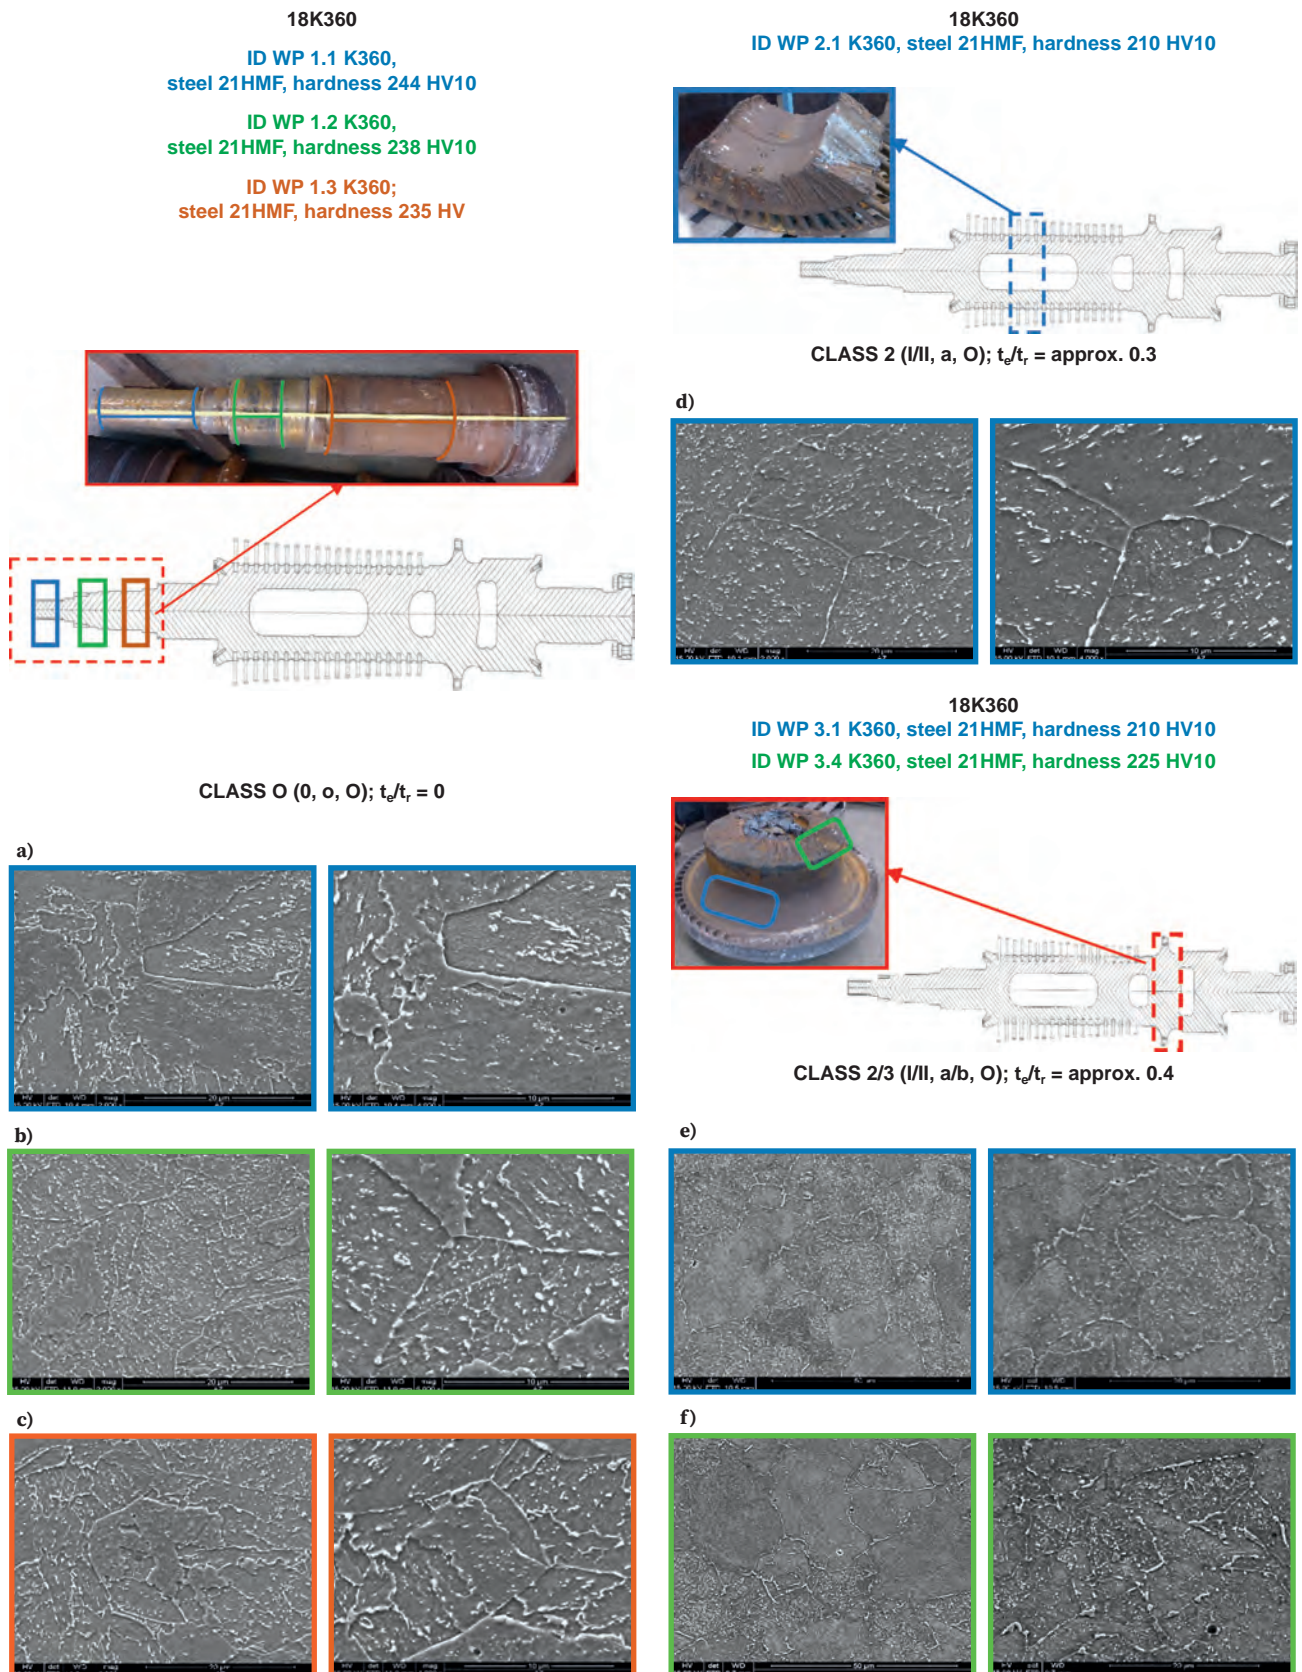
Fig. 5. Microstructure of the material of the 360 MW unit 18K360 turbine rotor WP high-pressure part after 220,000 operating hours observed on a crosswise microsection using a scanning electron microscope: a) in the area of rotor tip on the safety control side (ID WP 1.1 K360), b) in the area of rotor tip on the safety control side (ID WP 1.2 K360), c) in the area of rotor's bearing pin (ID WP 1.3 K360), d) in the drum in the region of stage 12-13 (ID WP 2.1 K360), e, f) in the steam inlet area in the control wheel region (ID WP 3.1K360, WP 3.4K360)

WP high-pressure part of 360 MW unit rotor rotor tip on safety control side (ID WP 1.1 K360) Fig. 5a	RT <u>0</u> 220,000	Bainitic-ferritic structure. Bainite lamellae with numerous fine precipitates. Image of microstructure similar to the typical microstructure of the initial state of the rotor material made of the tested steel. The initiation of internal damage processes was not observed. No discontinuities and microcracks were observed in the structure.	(0, o, O) ¹ CLASS 0 $t_e/t_r = 0$	244
WP high-pressure part of 360 MW unit rotor rotor tip on safety control side (ID WP 1.2 K360) Fig. 5b	286 <u>0</u> 220,000	Bainitic-ferritic structure. Dominating bainite with numerous, rather fine, precipitates. The occurrence of precipitates at the boundaries of bainite lamellae was observed, which may make this material different than the typical rotor material in the initial state. The initiation of internal damage processes was not observed. No discontinuities and microcracks were observed in the structure.	(0, o, O) ¹ CLASS 0 $t_e/t_r = \text{approx. } 0$	238

WP high-pressure part of 360 MW unit rotor steam inlet area in the regulatory wheel region (ID WP 3.1K360, WP 3.4K360) Fig. 5e,f	535 17.1 220,000	Bainite with sparse areas of ferrite. Bainitic areas with a significant disappearance of bainite lamellae are characterised by an advanced precipitation process, which is evidenced by numerous precipitates inside these areas. Based on their morphological features, it can be assumed that these are fine spheroidal precipitates of the vanadium-rich MC carbide and elongated precipitates of the molybdenum-rich M_2C carbide. The chain-forming precipitates that occur at the boundaries of these regions are likely precipitates of chromium-rich $M_{23}C_6$ carbide. No significant differences were observed in the microstructure image on the cross-section from the surface to the rotor's core. The initiation of internal damage processes was not observed. No discontinuities and microcracks were observed in the structure	(I/II, a/b, 0) CLASS 2/3 t_e/t_r = approx. 0.4	211

The material of the WP high-pressure part of the 21HMF steel steam turbine rotor of the 360 MW power unit after approx. 220,000 operating hours, taken from the end of the rotor from the safety regulator side (ID WP 1.1, WP 1.2) of the part of the rotor, where the operating temperature corresponds to a correspondingly similar to room temperature and amounting to 286°C is characterised by bainite with quite numerous precipitates. The image of the microstructure of the rotor tip material is similar to the typical microstructure of the initial state of the rotor material made of the tested steel (Fig. 5a, b). The precipitates present in the structure are mainly M_3C cementite and numerous fine vanadium-rich MC particles, as well as a small amount of molybdenum-rich M_2C carbides.

After approx. 220,000 operating hours, the material of the WP high-pressure part of the 21HMF steel steam turbine rotor of the 360 MW power unit, taken from a drum section from the area of 12–13th stage (ID WP 2.1) of the rotor part, where the operating temperature is 510°C, is characterised by bainite with numerous precipitates at the boundaries of lamellae and inside them (Fig. 5d). A partial atrophy of bainite lamellae can be observed in the examined area's material. Precipitates of the chromium-rich M_7C_3 carbide,

After approx. 220,000 operating hours, the material of the WP high-pressure part of the 21HMF steel steam turbine rotor of the 360 MW power unit, taken from the steam inlet area within the control wheel region (ID WP 3.1) of this rotor part, where the operating temperature is 535°C, is characterised by bainite with numerous precipitates at the boundaries of lamellae and inside them (Fig. 5e). A significant atrophy of bainite lamellae can be observed in the examined area's material. Chain-forming precipitates, probably of the M_7C_3 carbide, were observed at the boundaries of bainite lamellae. Within these regions, a considerable amount of M_3C cementite coagulated precipitates and MC fine precipitates, as well as a small proportion of molybdenum-rich M_2C carbides, were observed. The phase composition determined in X-ray studies, including their type and relative content, confirms a significant degree of

Material with a significant degree of wear ($t_e/t_r =$ approx. 0.3–0.4) is a material collected from a drum fragment in the region of stage 12–13 (ID WP 2.1 K360) of the WP high-pressure part of the turbine rotor of the 360 MW unit after long-term operation with an operating temperature of 510°C. It is characterised by a bainite structure with partial lamellae disappearance and numerous precipitates at lamellae boundaries and inside them. Chain-forming precipitates, probably of the chromium-rich M_7C_3 carbide, were observed at the boundaries of bainite lamellae. Also inside these areas, a significant number of precipitates were revealed, which can be identified by their morphological features as finely-dispersed VC and Mo_2C precipitates. This was confirmed by the results of studies on the isolates of precipitates, the defined sequence of which corresponds to class a of the degree of development of the precipitation processes, and together with the revealed structure image, corresponds to class 2. The consequence of the partial degradation of the structure is the reduction of the basic strength properties, in particular the tensile strength and yield point at room temperature as well as the

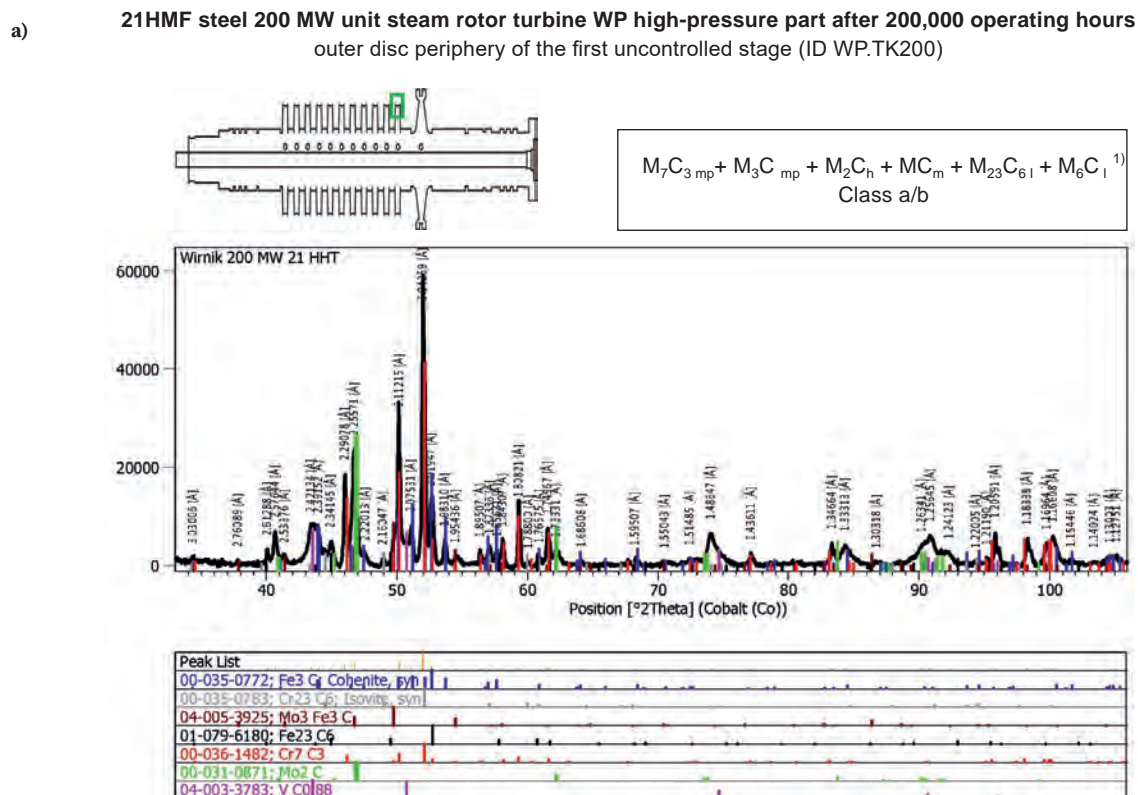
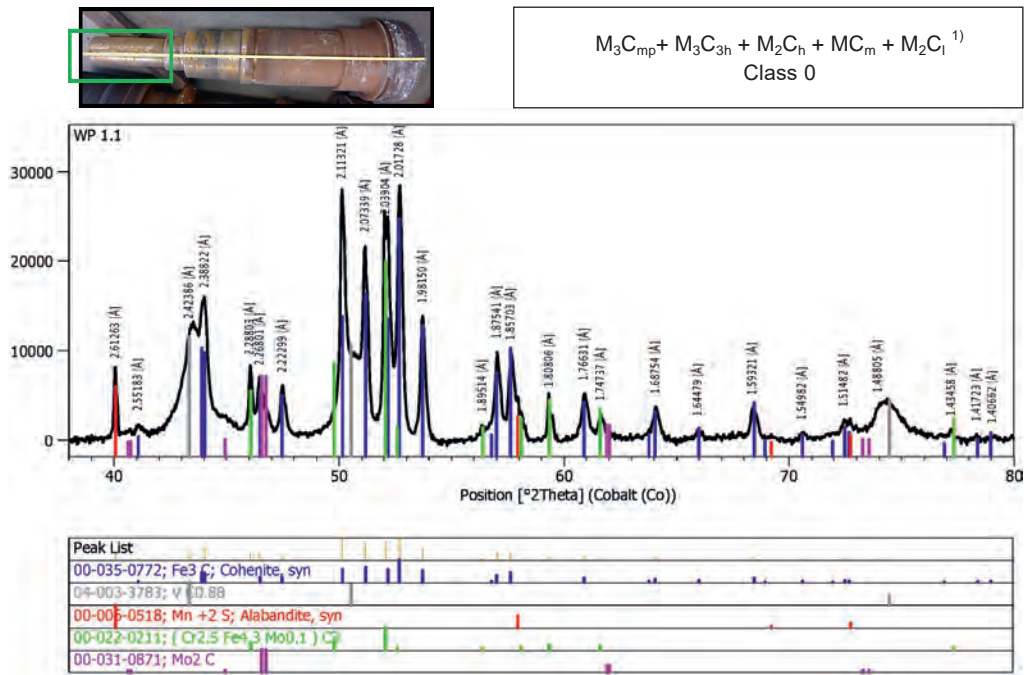
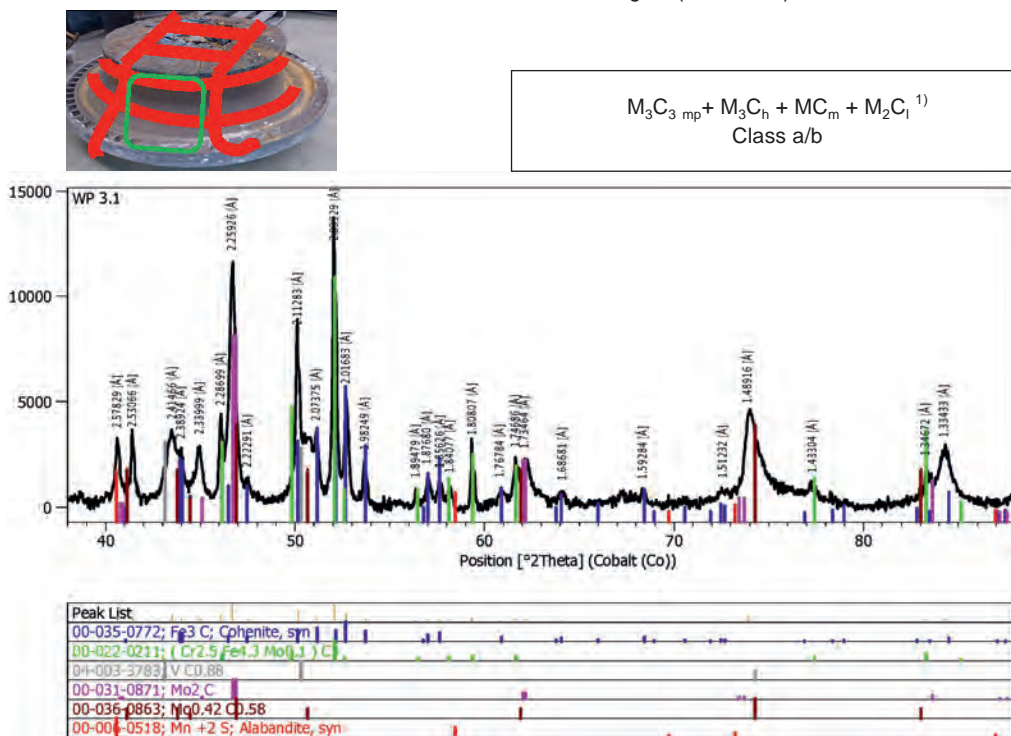
The state of development of the precipitation processes of the outer periphery of the disc of the first unregulated stage of the tested WP part (ID WP.TK200) of the rotor of the 200 MW unit after long-term operation for 200,000 hours corresponds to class a/b and the degree of wear t_e/t_r = approx. 0.4. The state of development of the precipitation processes of the carrier thrust bearing pin material (ID SP 1.1K360) of the SP part of the 360 MW unit rotor after long-term operation for approx. 220,000 hours corresponds to class o and degree of wear t_e/t_r = 0, i.e. the initial value of the tested 21HMF steel. The state of development of the precipitation processes of the rotor's SP part drum material in the steam inlet region (ID SP2.1 K360) of this rotor after long-term operation for approx. 220,000 hours corresponds to class o/a and the degree of wear t_e/t_r = up to 0.2. The state of development of the precipitation processes of the rotor tip on the side of the safety regulator of the tested WP part (ID WP 1.1K360) of the 360 MW unit rotor after long-term operation for approx. 220,000 hours corresponds to class o and degree of wear t_e/t_r = 0, i.e. corresponds to the initial value of the tested 21HMF steel. The state of development

Fig. 6. Examples of X-ray diffraction patterns for isolates of material precipitates from sections of the tested parts of steam turbine rotors: a) of 200 MW unit TK200 turbine WP high-pressure part after 200,000 operating hours, after 220,000 operating hours, along with the phase composition of precipitates and the estimated class of the degree of development of carbide precipitation processes in 21HMF steel after long-term operation above the limit temperature well beyond the design operating time. Notes: ¹⁾ mp – main phase, h – high, m – medium, l – low

of the precipitation processes of the drum's material in the region of stage 12–13 of the tested WP part (ID WP2.1 K360) of the 360 MW unit rotor after long-term operation for 220,000 hours corresponds to class a and the degree of wear t_e/t_r = approx. 0.3. The state of development of the precip-

itation processes of the material in the seam inlet area in the region of the control wheel of the tested WP part (ID WP3.1 K360) of the 360 MW unit rotor after long-term operation for 220,000 hours corresponds to class a/b and the degree of wear t_e/t_r = approx. 0.3-0.4.

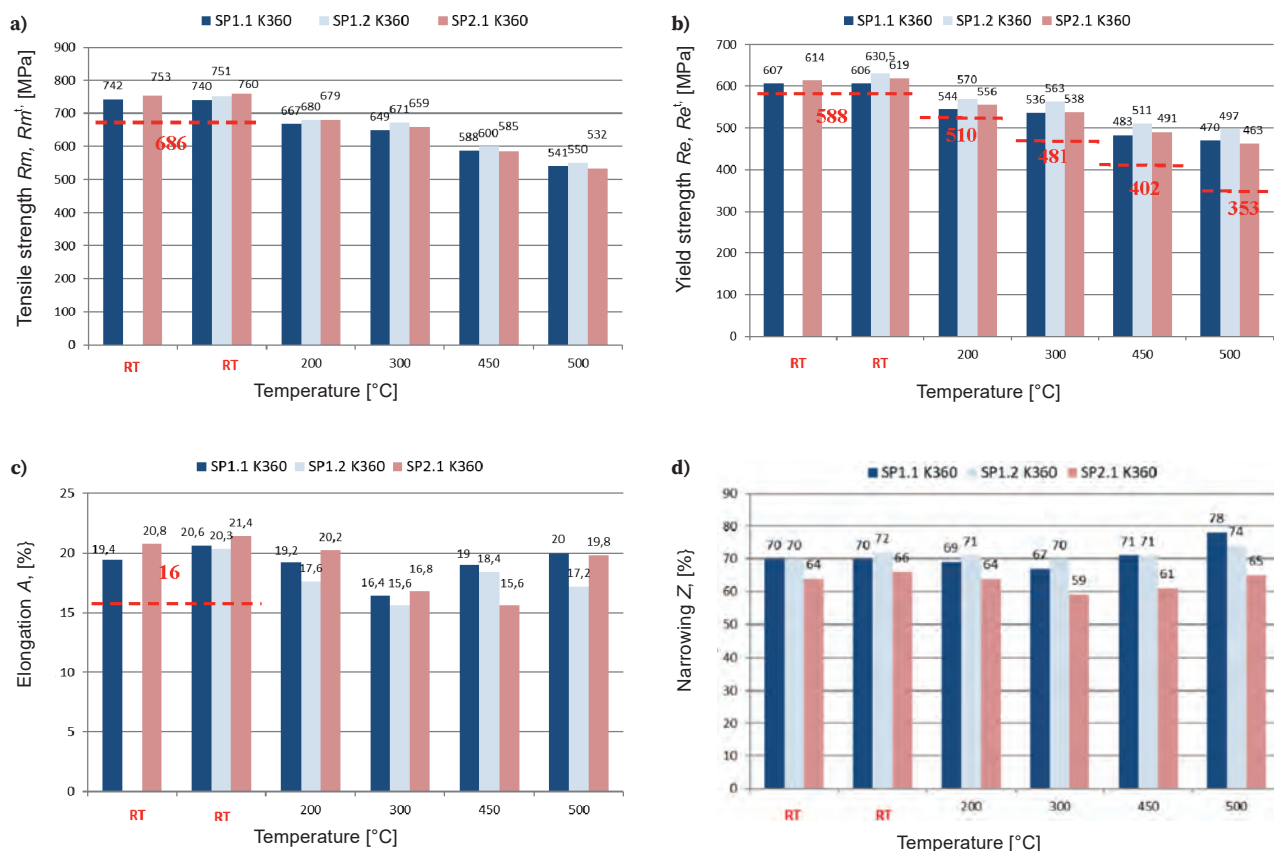
Fig. 7. Strength properties at room and elevated temperature for the material of the SP medium-pressure of the 18K360 turbine rotor after 220,000 hours of operation: a) tensile strength, b) yield strength, c) elongation in tensile test, d) compression in tensile test

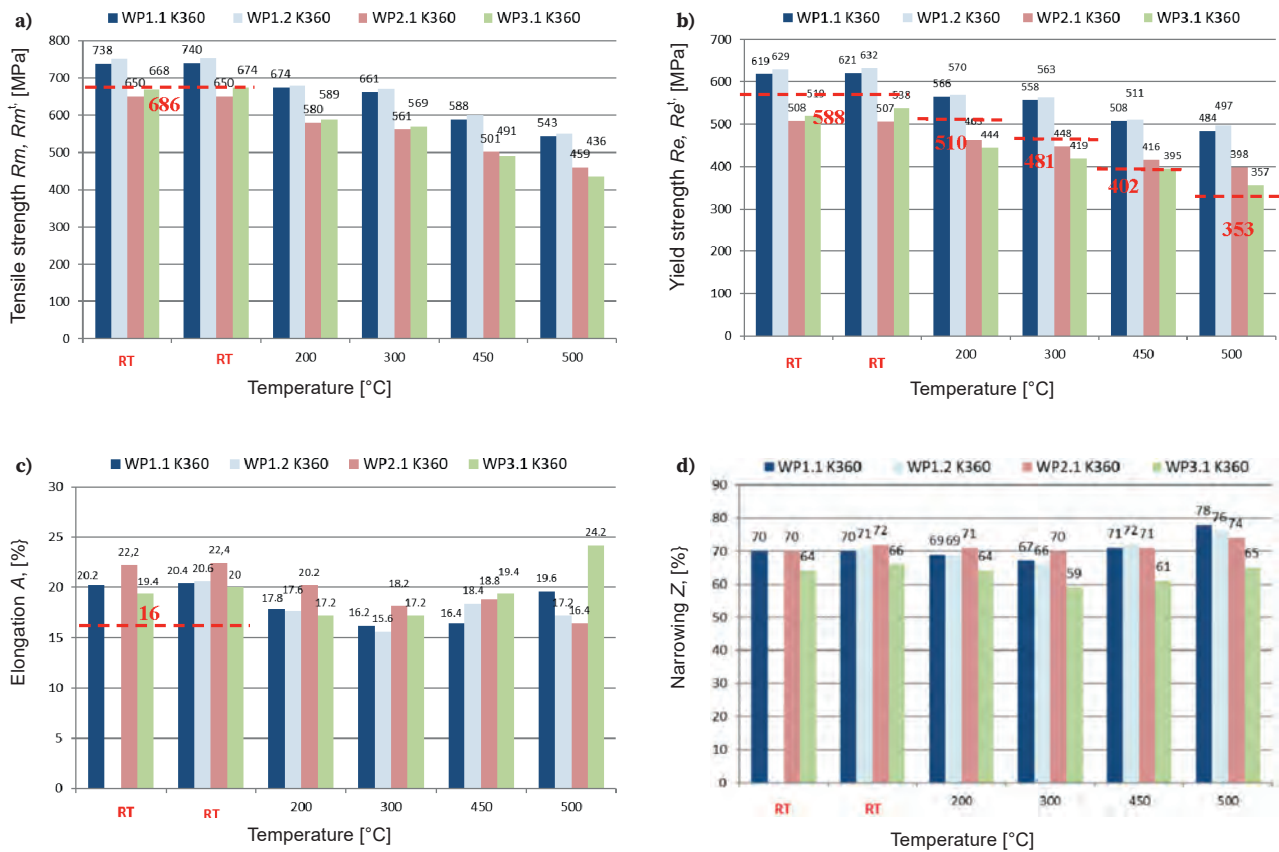
Fig. 8. Strength properties at room and elevated temperature for the material of the WP high-pressure of the 18K360 turbine rotor after 220,000 hours of operation: tensile strength, b) yield strength, c) elongation in tensile test, d) compression in tensile test

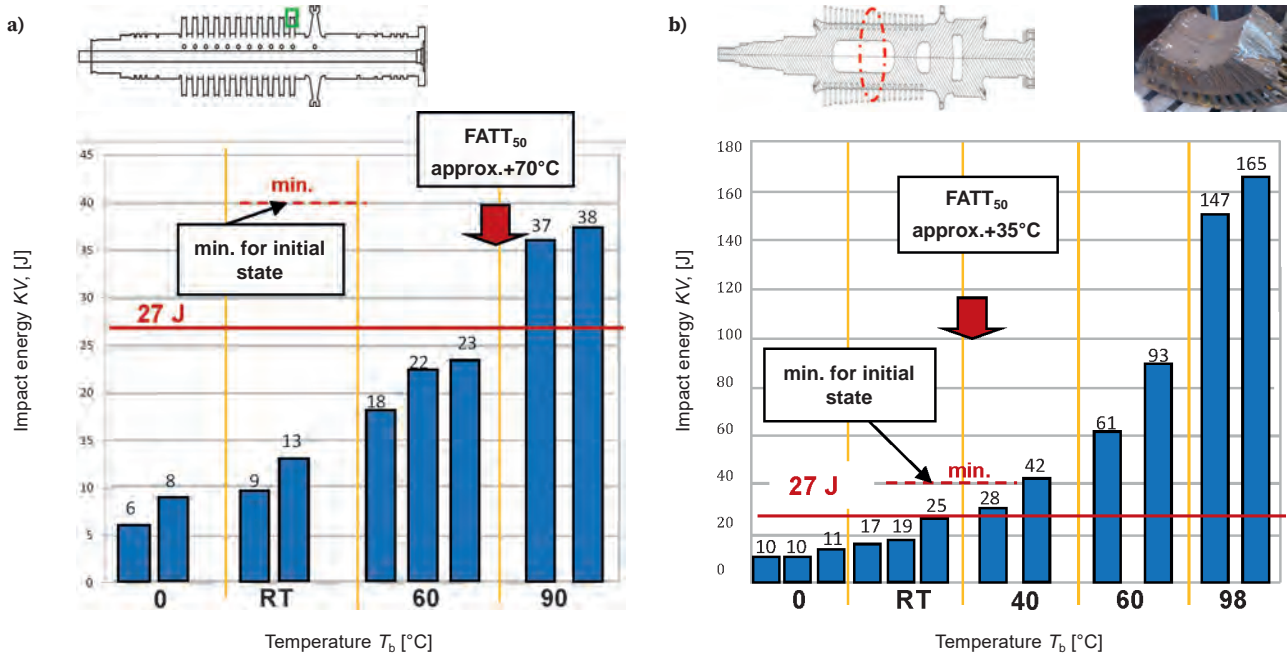
The obtained results of material impact tests for the tested parts of turbine rotors made of 21HMF steel do not meet the requirements for the initial state at room temperature and the expected minimum impact energy of 27 J for most of the tested rotor components. Selected examples in the form of a relationship between impact energy and testing temperature is presented in Fig. 9. In particular, Fig. 9a shows this relationship for the material of the outer periphery of the first stage of the unregulated rotor (ID WP.TK200) of the WP high-pressure part of the 200 MW unit turbine rotor after 200,000 hours of operation, and in Fig. 9b – of the drum material in the region of the 12–13th stage of the WP high-pressure part of the 360 MW unit turbine rotor after 220,000 operating hours.

Fig. 9. Impact energy and temperature of transition into brittle state on the example of materials of selected sections of the WP high-pressure part of 21HMF steel turbine rotors of the 200 MW unit after 200,000 operating hours (ID WP.TK200), b) of the 360 MW unit after 220,000 operating hours (ID WP2.1 K360)

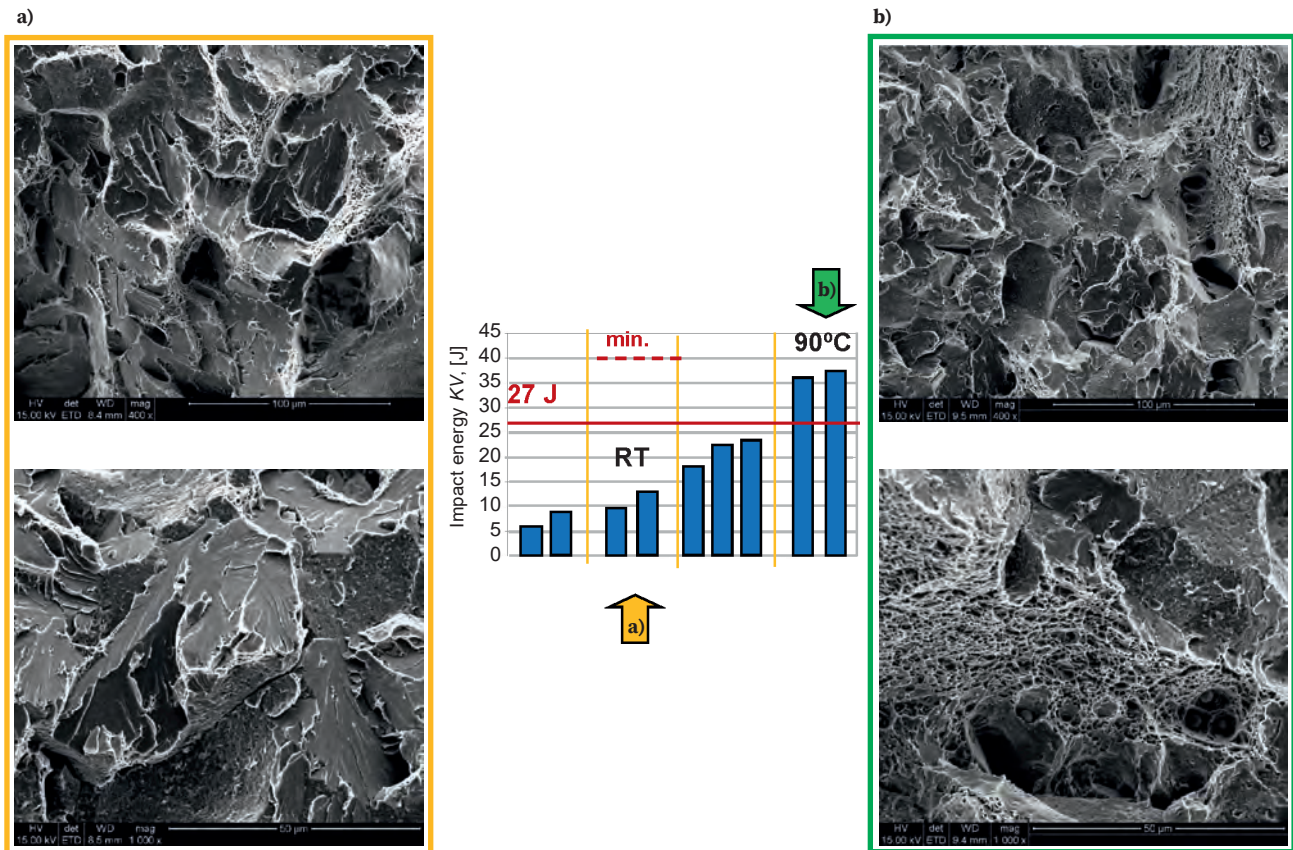
Fig. 10. Fractographic images of fractures of impact samples of the tested material of the WP high-pressure part of 21HMF steel steam turbine rotor of a 200 MW block after 200,000 operating hours: a) impacted at room temperature, b) impacted at +90°C

The fractograph of the fractures on broken impact samples for selected test temperature levels revealed in the scanning electron microscope for a selected representative example, i.e. the material of the WP high-pressure part of the 200 MW unit turbine rotor after 200,000 operating hours is shown in Fig. 10. In particular, Fig. 10a shows examples of the fracture morphology of an impact sample at room temperature with the obtained impact energy value of 9 J, while Fig. 10b shows images of the fracture formed at +90°C with an impact energy value of 38 J. At room temperature, a brittle fracture was obtained with small areas of ductile fracture, while at a temperature of +90°C, a mixed fracture occurred with a predominance of brittle fracture.
