DAMAGES TO INJECTORS IN DIESEL ENGINES

The article describes damages to high pressure injectors used in common rail injection systems. The conducted analysis of their causes includes the diagnosis of injectors on a test bench and the results of microscopic research of damaged components. The tribological damages of high pressure injectors are local and cavitations pitting. The place of cavitations pitting are mainly check valves, where the reduction in the quantity of injected fuel is forming.

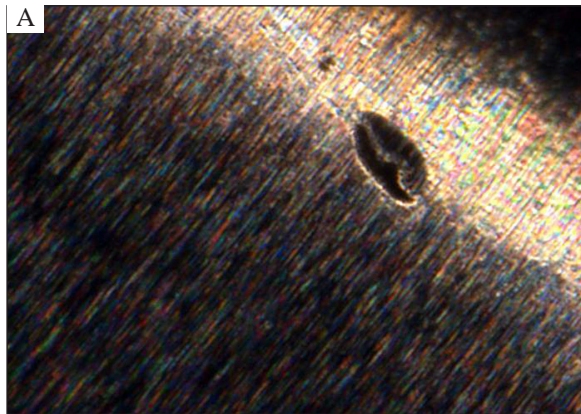
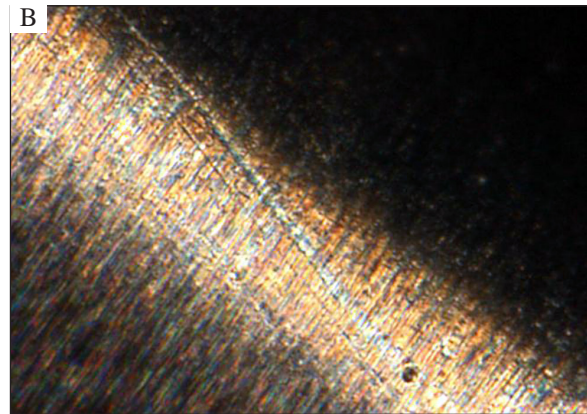
That are usually small grooves and indents on the surface caused by the presence of mechanical impurities. As can be seen, that are local damages not covering the entire surface of the element. Damage to the piezoelectric injector needles also have a similar local character (see Figure 4). In the presented case these are minor scratches and pitting cavitation.

Fig. 3. Damages of the piezoelectric injector plunger: a) indentation, b) groove with a visible imprint of the contamination

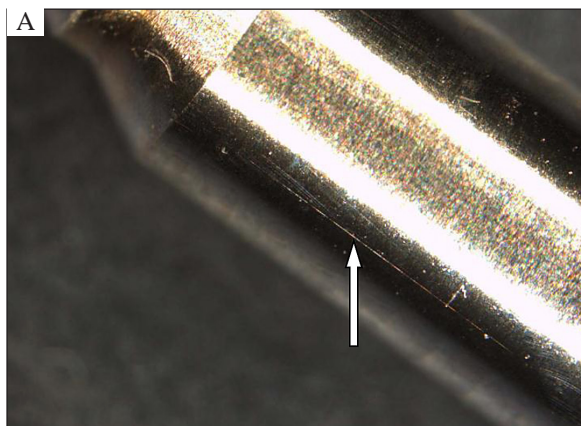
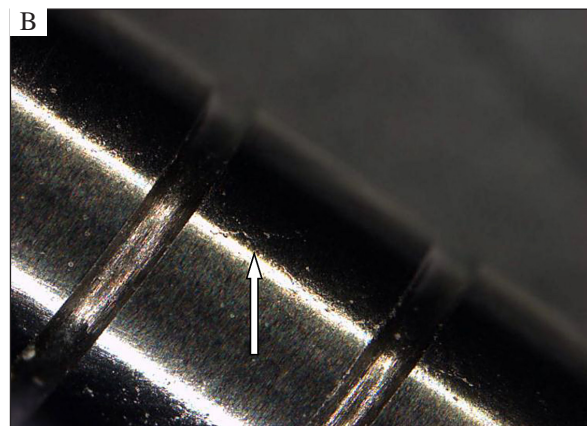
Fig. 4. Damages of the piezoelectric injector needle: a) longitudinal scratch, b) cavitation pitting

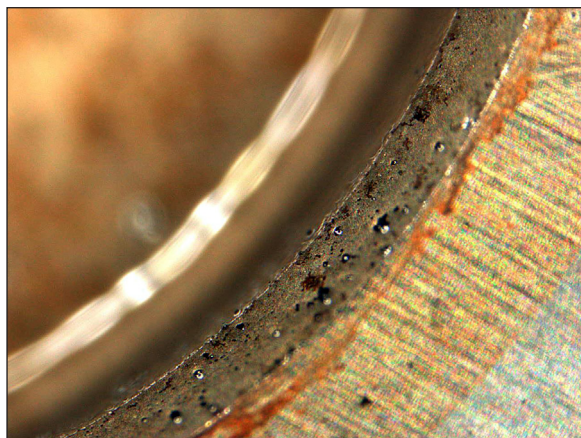
Another type of damage is characteristic for check and switching valves. In Figure 5 one can see distinctly the process of cavitation which started on the edge of valve opening in a piezoelectric injector. The consequence of this phenomenon is deterioration in the injector leak tightness, what with fuel at high pressure causes excessive flow through the overflow port of the

Fig. 5. Cavitation erosion on the edge of the pinhole overflow valve in a piezoelectric injector

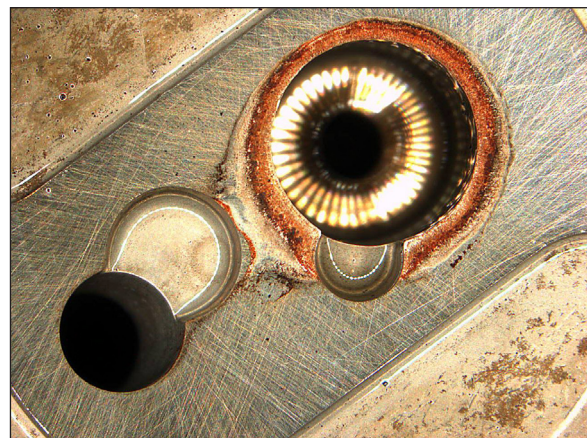
Fig. 6. Developed cavitation on the edges of the pinhole overflow valve in a solenoid injector

injector. Such types of damage result in difficult starting of the engine and uneven idling. Figure 6 shows cavitation damage of the pinhole overflow valve in a solenoid injector. Also in the case of this type of damage the injector is not able to give a sufficiently large amount of fuel, resulting in difficult start-up and a non-uniform work of the engine. Reduction of the dose of injected fuel results in lean fuel-air mixture. In-

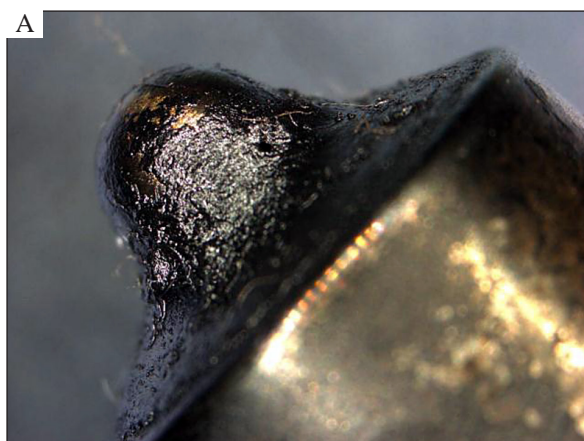
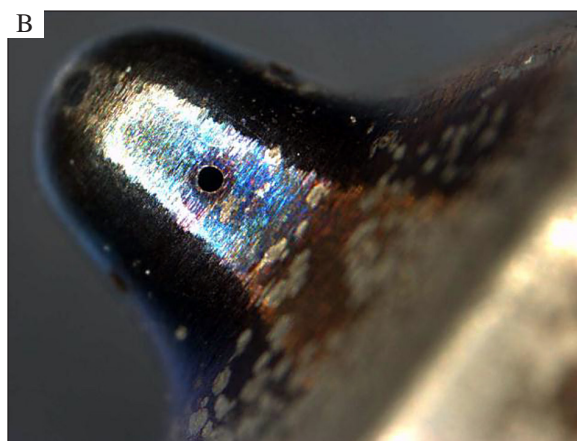
creasing the amount of oxygen relative to the amount of fuel is accompanied by the increase in the speed and temperature of combustion. This is confirmed by the observations – some of the damaged injectors had clear signs of overheating. Figure 7 shows overheated tip of a piezoelectric injector. Figure 8 shows clearly visible thermal discoloration on the needle of of the above injector.

Fig. 7. Tip of the damaged piezoelectric injector: a) appearance after removing
b) appearance after clearing – visible discoloration caused by the impact of high temperatures

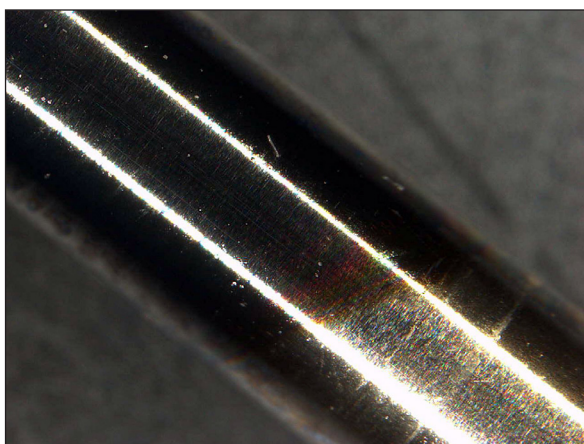
Rys. 8. Thermal discoloration of the needle of the piezoelectric injector
