THE SERVICE LIFE OF THE REPAIR WELDED JOINT OF Cr-Mo / Cr-Mo-V

This paper presents the evaluation of the service life of dissimilar repair welded joint from Cr-Mo/Cr-Mo-V steel after 200,000 h service under creep condition. The investigations of microstructure using scanning electron microscopy, investigations of mechanical properties at room and elevated temperature as well as creep tests of the basic material from Cr-Mo and Cr-Mo-V steel and welded joint from these steels were carried out. The investigations allowed the time of further safe operation of the repair welded joint in relation to the residual life of the materials to be determined. The evaluation of residual life and disposable residual life, and thus the estimation or determination of possible time of further safe operation, is crucial when the elements are operated much beyond the design work time.

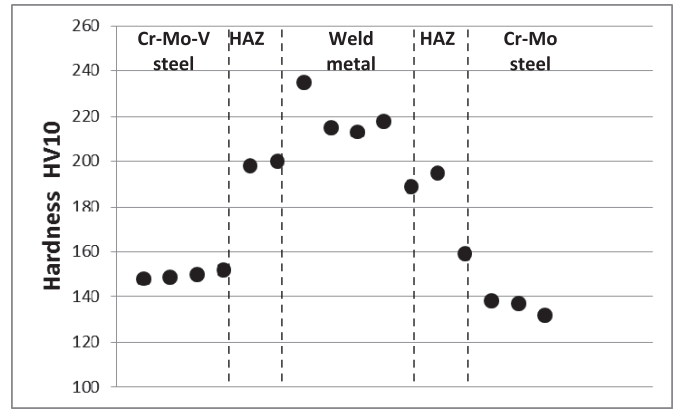
Fig. 1. Results of hardness measurements of dissimilar circumferential repair welded joint (Cr-Mo-V/Cr-Mo)

The hardness measurement through individual zones of the joint revealed no sudden changes. The maximum difference in hardness from Cr-Mo steel parent material through HAZ, weld, HAZ to Cr-Mo-V steel parent material is approx. 110 units and does not exceed the maximum acceptable value of 350 HV10.

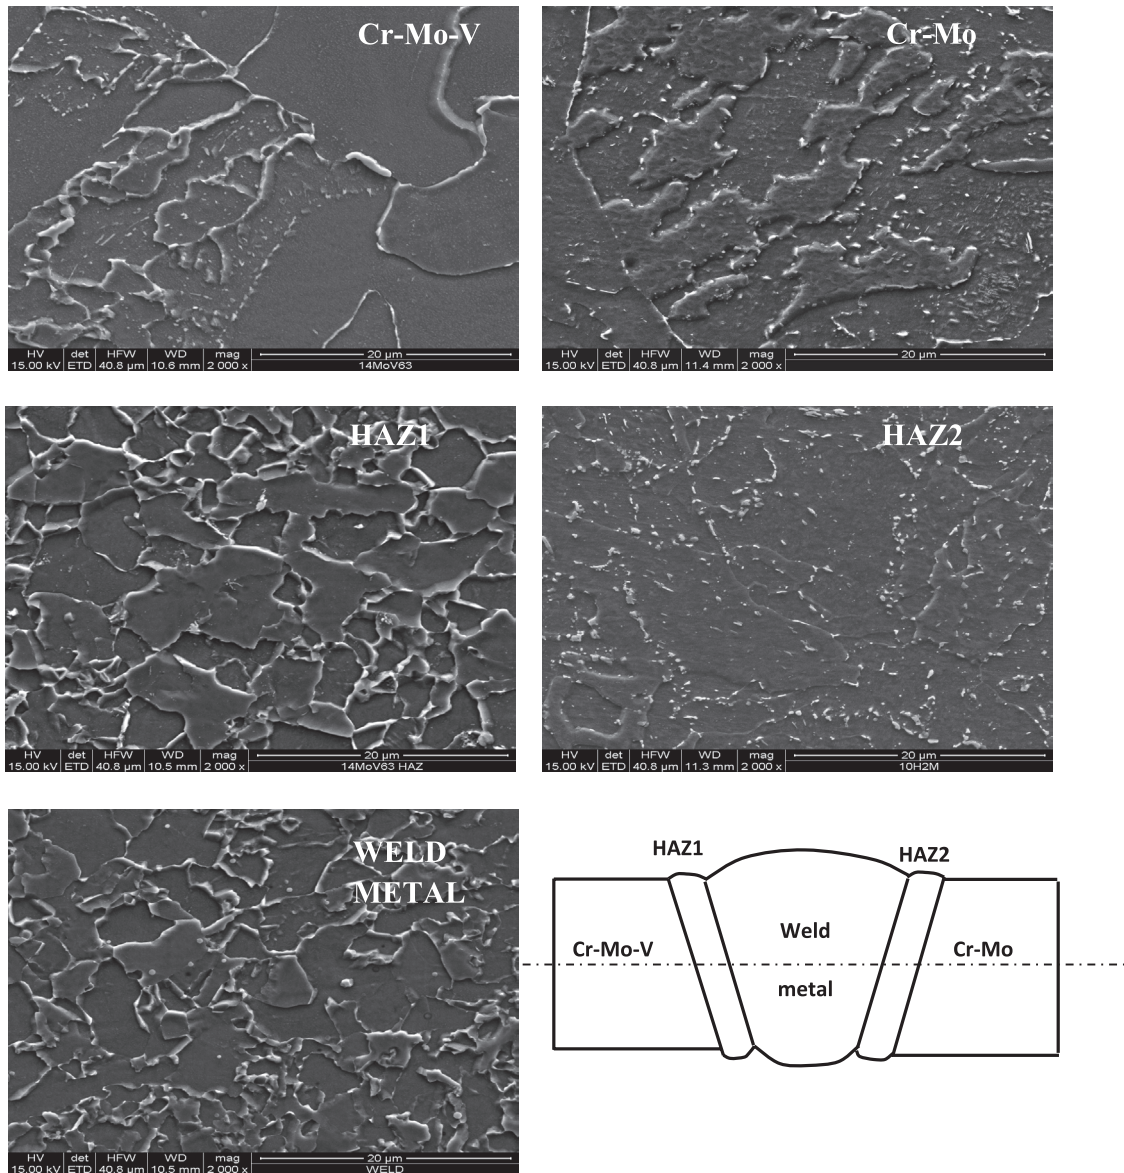
Fig. 2. Microstructure of the material of repair welded joint elements

Test area	Description of microstructure Material condition – exhaustion degree
Parent material 13HMF steel	Ferritic-bainitic microstructure. Partially coagulated bainitic areas. Precipitations of different size at the ferrite grain boundaries. Inside the ferrite grains, there are very fine evenly distributed precipitates. No discontinuities and micro-cracks are observed in the microstructure. No initiation of damaging processes is observed. Bainitic areas: class I, precipitates: class a <u>Damaging processes: class O</u> CLASS 1/2, EXHAUSTION DEGREE: approx. 0.3
Parent material 10H2M steel	Ferritic-bainitic microstructure. Partially coagulated bainitic areas. Fine precipitations at the ferrite grain boundaries. Mostly very fine precipitations inside ferrite grains. No discontinuities and micro-cracks are observed in the microstructure. No initiation of damaging processes is observed. Bainitic areas: class I, precipitates: class a <u>Damaging processes: class O</u> CLASS 1/2, EXHAUSTION DEGREE: approx. 0.3

Heat-affected zone, weld – repair joint	Heat-affected zone microstructure. No discontinuities and micro-cracking are found in the microstructure.

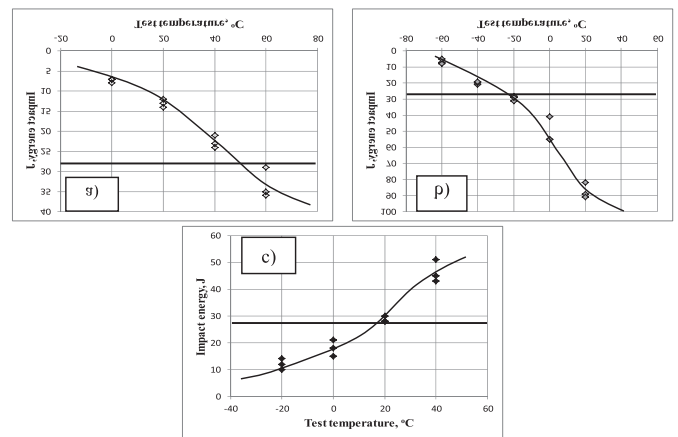
The value of impact strength and brittle fracture appearance transition temperature depends on the condition of microstructure and corresponding exhaustion degree of the examined material. With increase in the degree of degradation, the brittle fracture appearance transition temperature moves towards the higher values. This trend is much more distinct for the long-term service of the Cr-Mo-V steel than of the Cr-Mo one. The brittle fracture appearance transition temperature determined for the examined conditions is +50°C for Cr-Mo-V, -20°C for Cr-Mo and +20°C for the weld material (Fig. 3).

Fig. 3. Brittle fracture appearance transition temperature determined for: a) Cr-Mo-V steel, b) Cr-Mo steel, c) repair weld material.

For the elements from materials that do not meet the requirements for brittleness threshold of 27J at room temperature and strength properties, the appropriately modified procedure for conducting water pressure tests should be used and the necessity of possibly modifying the boiler start-up and shut-down procedure should be considered. This will allow to avoid possible unexpected breakdowns due to the lack of ability to transfer the required excessive loads [25,26].

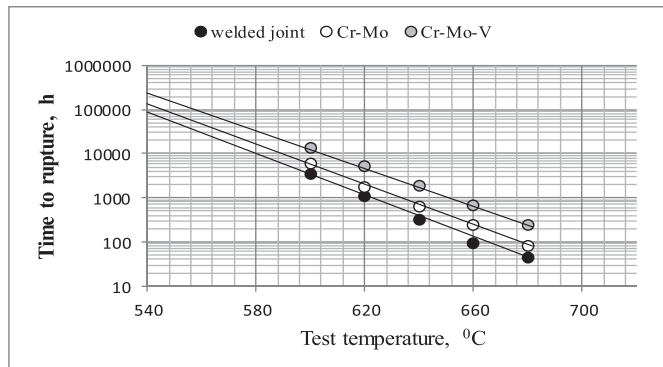
stress level $\sigma_b=55$ MPa, corresponding to the assumed working stress σ of further service. The test results are presented as the relationship $\log tr = f(T_b)$ at $\sigma_b \approx \sigma$, in Fig. 4.

The residual life determined based on abridged creep tests are summarised in column 2 of Table 4, whereas the disposable residual life of the examined elements estimated on this basis for the adopted parameters of further service $Tr = 540^\circ\text{C}$ and $sr = 55$ MPa is summarised in Table 4, column 3, and it represents the forecast of the remained time of further safe operation.

Fig. 4. Characteristics of temporary creep strength for Cr-Mo and Cr-Mo-V steels and repair welded joint after more than 200,000 h service
