Deformation and damage to buildings caused by ground movements in mining areas (case study)

Lucyna FLORKOWSKA*¹, Izabela BRYT-NITARSKA¹, and Janusz KRUCZKOWSKI¹

¹Strata Mechanics Research Institute of Polish Academy of Sciences, Cracow, Poland

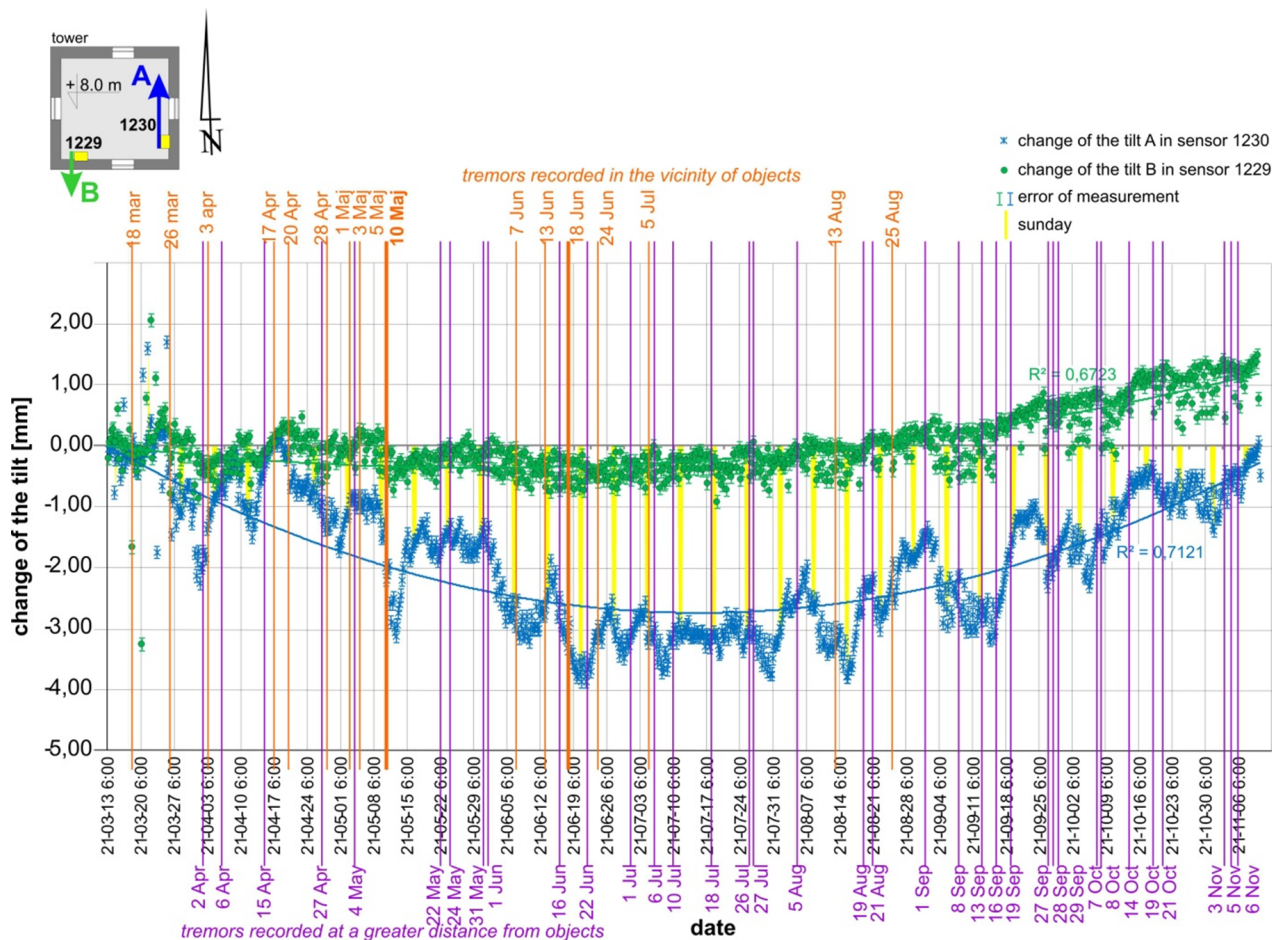
Figure 6. The graph of changes in the tilt of sensors in the N-S plane

The changes recorded by sensor 1229, mounted on the south wall, are small and remain close to zero most of the time. A slight southward tilting of the sensor can be detected from mid-September onwards. In contrast, the 1230 gauge, attached to the eastern wall of the tower, recorded a few millimetres increase in the northward tilt, which increased non-linearly from March to June, then remained constant for about two months, after which it began to decrease. The graph shown in Figure 7 shows the consistent pattern of tilts of both gauges in the E-W plane, from 13 March to 7 June. This is followed by a tilt difference between the sensors, which is then maintained at around 2 mm. The nature of the tilt pattern is similar for both gauges: they tilt westwards, with the tilt increasing non-linearly from March to mid-June, then stabilising before decreasing from mid-August.

In addition to the local deviations from the trend line mentioned above, there are noticeable anomalies occurring irregularly, which cannot be explained by software. These are spikes, reaching a few millimetres within 1-2 days. They were explained by superimposing on the time axis the lines corresponding to the dates of the tremors recorded by the Upper Silesian Regional Seismological Network. They are the structure's response to dynamic actions transmitted from the foundation. The most intense change of this nature was recorded by the instruments on 10 May 2021, corresponding to a tremor of 0.8066 mm/s² (Fig. 6 and 7).

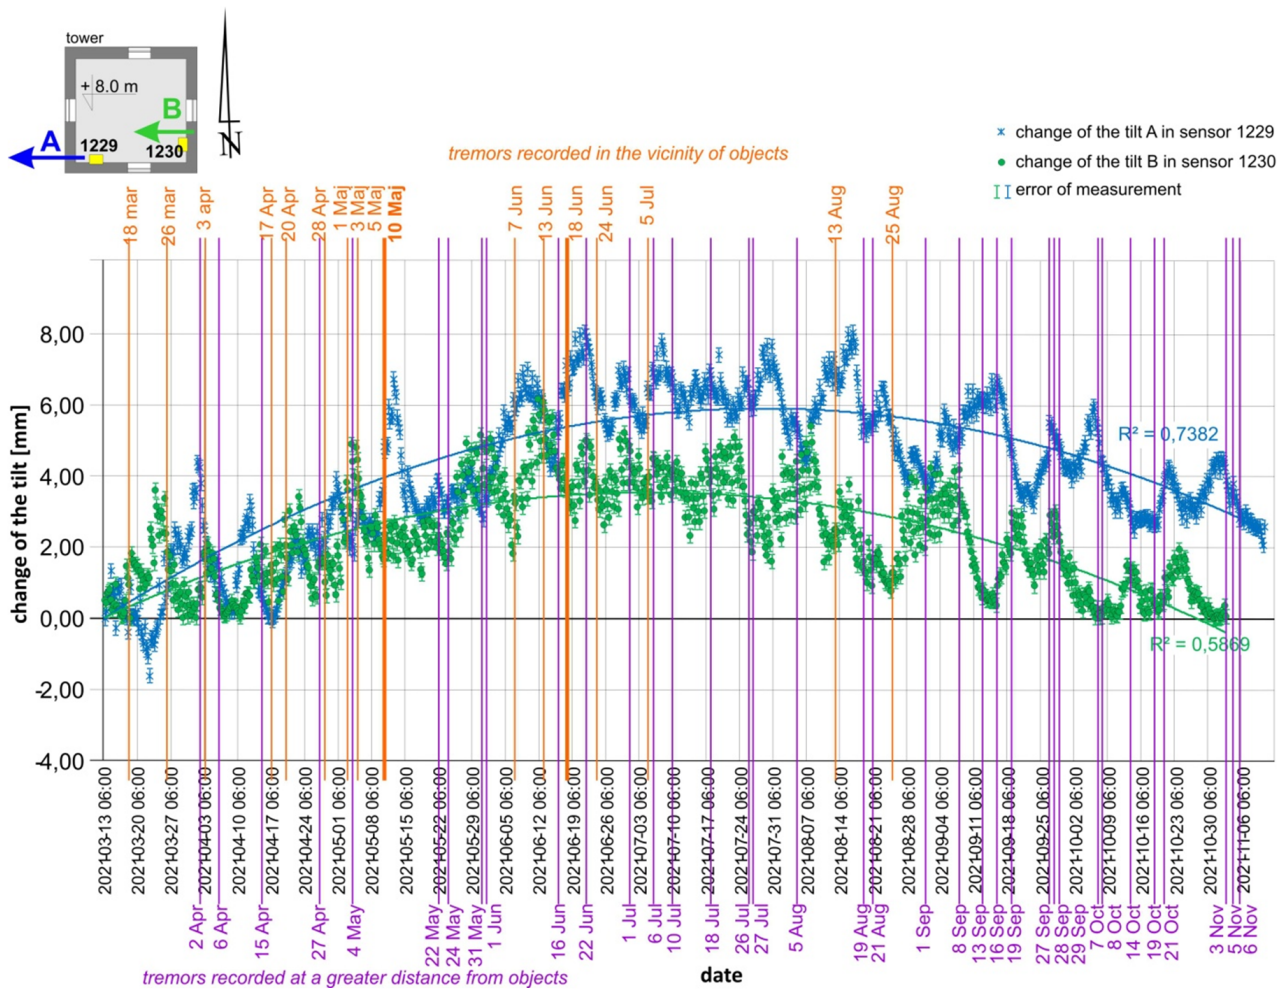
Figure 7. Graph of changes in the tilt of sensors in the E-W plane

The above pattern of tilts of the two sensors indicates that the main directions of the observed impacts do not coincide with the axes of the building plan, which causes twisting and turning of the cross-section of the tower. These directions changed during the observation period.

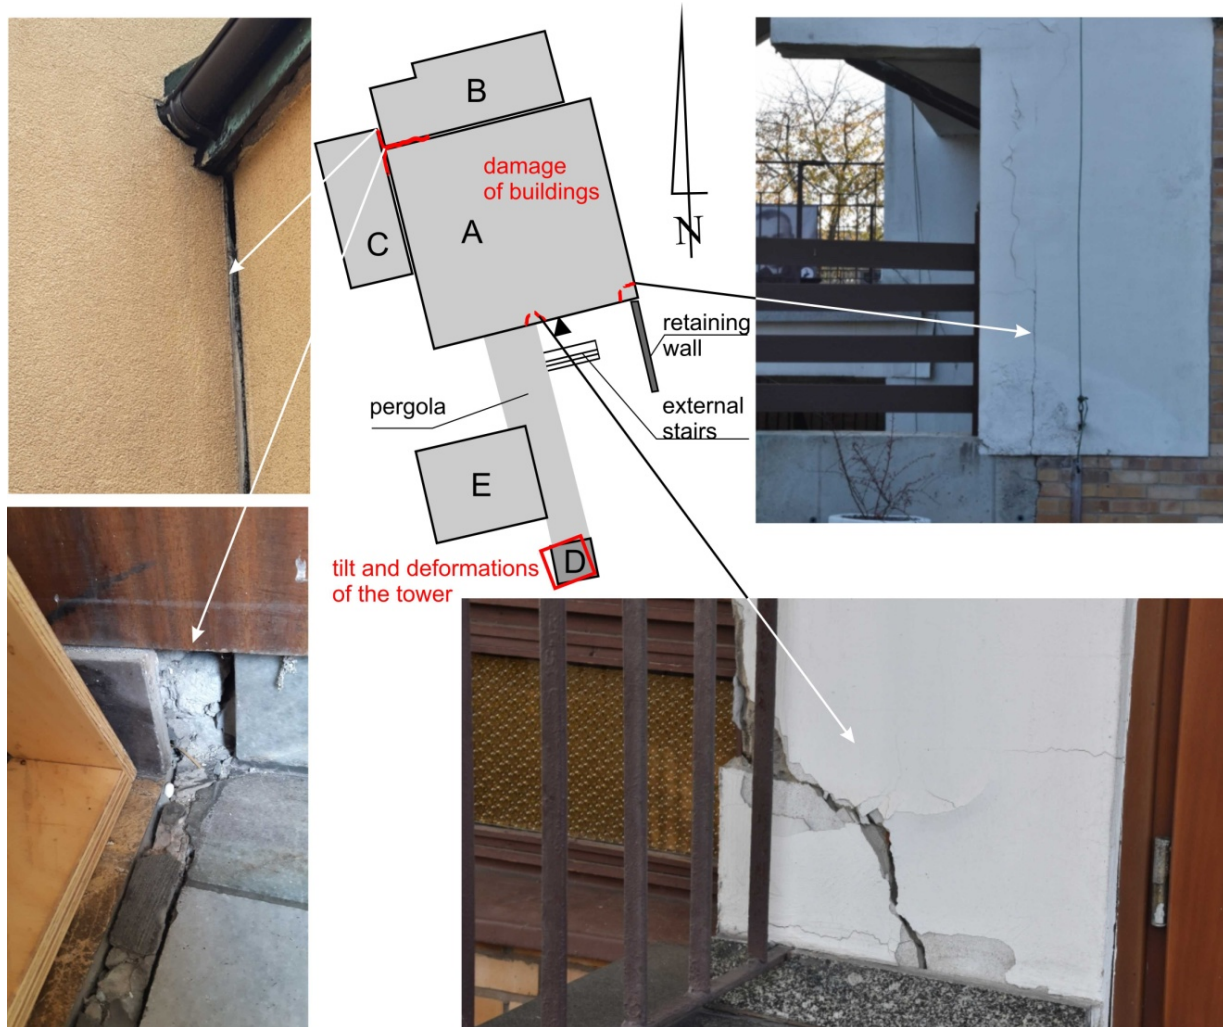
Based on periodic inspections of the structure of segments A, B, and C it was found that the building has a number of local damages, located mainly on the floor and walls, in places of expansion joints (Fig. 8). The nature and progression of the damage suggests that deformation is occurring in the subsoil, causing the structures to move northwards in line with the natural slope of the site. Despite the absence of any present mining works, damage propagation was noted

during the observation period. Analysis of the existing technical documentation has shown that no comprehensive geological prospecting was carried out either at the design stage of the structures (1980s) or during the design of the new retaining wall (2015). Five test holes, 2.5 m deep, were excavated prior to the design of the complex. After exposing about 30 cm of soil layer, small loamy sands, sandy dusts, and dusts in semi-solid and hard-plastic state were observed. These soils may be prone to plasticising under the influence of rainwater. This was considered to be non-hazardous due to the absence of groundwater up to a level of 2.5 m and the natural slope of the site.

Figure 8. Damage and deformation observed in buildings

For the construction of the new retaining wall, two geotechnical boreholes were drilled 3 m deep. In both boreholes, under the layers of non-construction mounds, hard-plastic and plastic dusts were found. In the light of the deformation and damage to the objects, the existing survey should be regarded as inadequate. In order to clarify the causes of the observed processes, an in-depth geological assessment should be carried out, based on test holes located around the building complex, with particular emphasis on the northern side. Cores should be taken from the holes for laboratory testing. It is advisable to consider the use of one or two boreholes for the installation of inclinometer pipes and monitoring of ground deformation. The results of the geological prospecting and inclinometric measurements will also be used as the basis for developing a protection concept for the site.

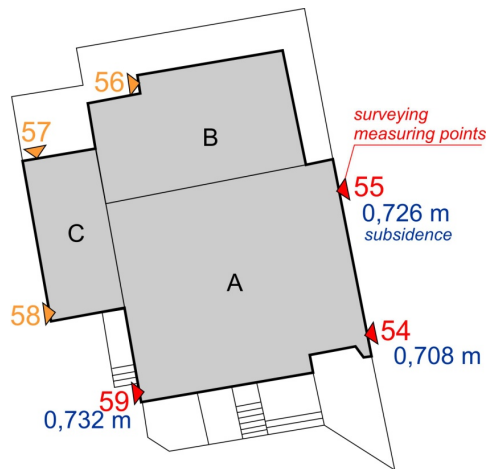
The obtained results of the tilt measurements were additionally correlated with the results of the surveying measurements carried out by the mine's surveyors. Survey measurements of the height of the benchmarks, installed on segments A, B, and C, had been carried out since 2003. Initially, the heights of six benchmarks were measured: 54, 55, 56, 57, 58 and 59, as of 2015, only benchmarks 54, 55 and 59 remained (Fig. 9). The subsidence determined on this basis over an 18-year period is: 70.8 cm for benchmark 54, 72.6 cm for benchmark 55 and 73.2 cm for benchmark 59. It can be concluded that along the contour of the church plan the subsidence is almost uniform; the difference in subsidence between the south-west corner (59) and the south-east corner (54) is 2.4 cm.

Figure 9. Subsidence of measurement points located on the church in the period 2003-2020

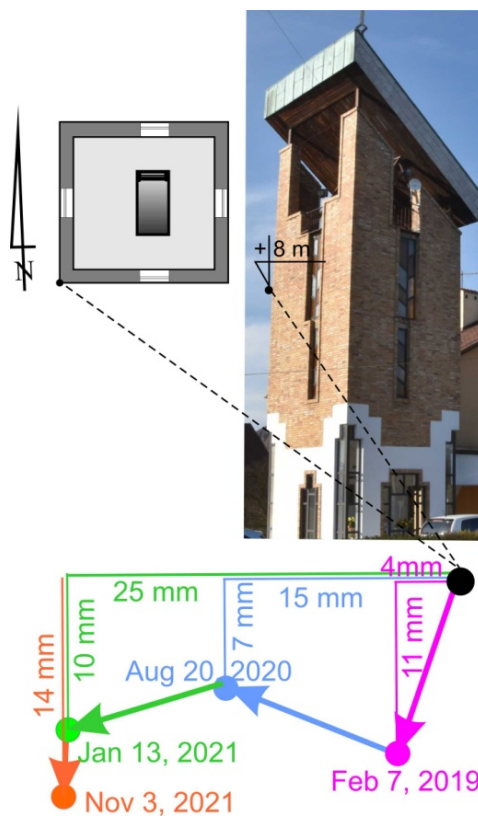
Starting in 2019, surveys were made of the tilt of the south-west edge of the tower. The horizontal displacement of a point, located 8 m above ground level, was measured. The results obtained in the following measurement sessions, from February 2019 to November 2021, are shown in Fig. 10. From the data obtained, it was found that the magnitude of the tower tilt (at 8 m height) changed over 22 months from 11.7 mm to 29.5 mm, which (assuming linearity) corresponds to a change from 1.5 to 3.7 mm/m. The difference in tilt between January and November 2021 (which

roughly corresponds to the period of the measurements in question) is: 1 mm for the N-S component, 4 mm for the E-W component.

Figure 10. Results of surveying measurements of the tower tilt, made from Feb. 7, 2019 to Nov. 3, 2021
