RENOVATION AND MODERNISATION OF A POSTINDUSTRIAL FACILITY IN POZNAŃ

Tomasz BŁASZCZYŃSKI*, Przemysław WIELENTEJCZYK,
Maciej BŁASZCZYŃSKI, Filip PIJANOWSKI
Institute of Building Structures, Poznań University of Technology

The paper presents a renovation process of a historic postindustrial building situated on premises of Gazownia Poznańska. An unprepared team of designers made a lot of mistakes and negligences, which led to additional work, repairs including. The increased scope of work also led to a substantial increase in the cost of the carried out renovations. The modernisation process was realised with the use of modern technologies, some of which for the first time in Poznan.

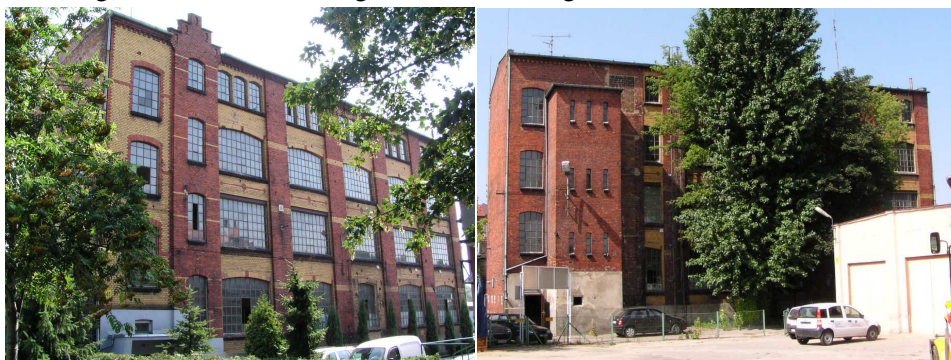
Fig. 1, 2. Dressing room - Bath house before modernisation, the front and back views

Due to the poor technical condition and safety risks of the back staircase (fig. 2), it had to be dismantled and reconstructed conforming to all the requirements of the building conservation officer (fig. 16, 17).

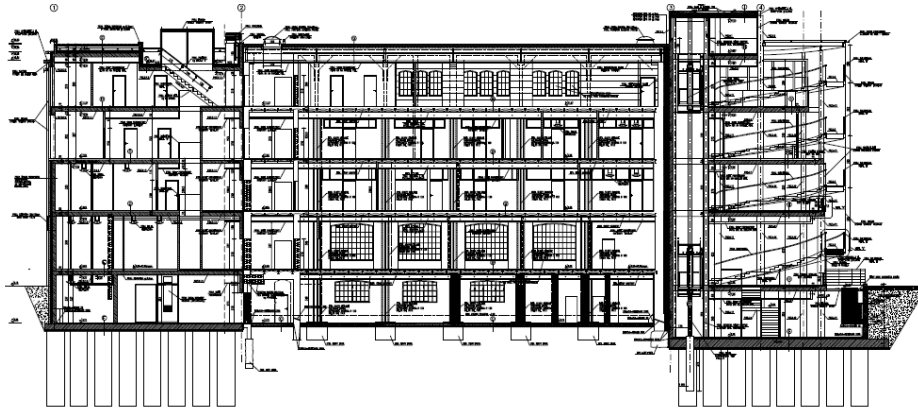
The carried out analysis of the load bearing capacity of the soil under the foundations of Dressing Room -Bath building, the exterior walls including, showed that it is fully or almost fully exploited. Thus, it was not possible to

Fig. 13. Distribution of jet grouting piles under part A and B (cross section)

build the newly designed parts of the building directly on the existing foundations, according to the performed technical design, without causing substantial damages to the existing building of the dressing room – bath. Because of the above, it was necessary to design the way in which loads exerted on the subsoil by the newly designed parts would be transmitted into its deeper layers, to prevent the cumulation of the values of stresses resulting from loads exerted by the existing building (Dressing room – Bath) and the newly designed parts from exceeding the load bearing capacity of the given subsoil layer. In order to ensure it, an indirect foundation was applied to the newly designed parts of the building which would base on jet grouted columns (*Solcrete T*), as the safest and the most efficient solution (fig. 13).

Due to the fact that the subsoil was polluted with oil and phenols at the depths ranging from 6.5m to 12.0 m, it was necessary to consider this fact while producing the *Solcrete* columns, which was realised by assuming the piles to be made of cement CEM I and by using three-stage technology to stiffen the contaminated subsoil.
