## RENOVATION AND RECONSTRUCTION OF A NEOCLASSICAL BUILDING ON THE EXAMPLE OF A PUBLIC CITY LIBRARY IN NOWA SÓL

Anna KUCHARCZYK<sup>1</sup>

University of Zielona Gora, Zielona Góra, Poland

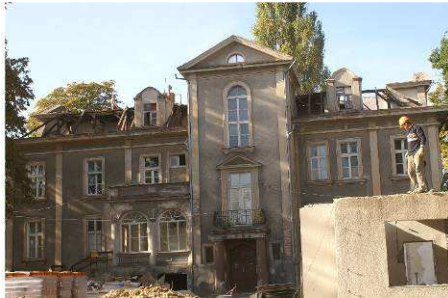
While carrying out the inspection of the roof trusses, lengthwise splitting of approximately 40% of the rafters and posts was confirmed, with 20% in the case of roof purlins and collar ties. Another conclusion was that the cross-sections of purlins spaced 3.5-4.5 m apart are insufficient despite the presence of angle braces. The remaining construction elements, such as the foundation, load-bearing and partition walls, and stairs did not require additional strengthening or replacement.

Fig. 2. Building during the taking apart of roof trusses. Source: MBP archives.

A new roof truss construction was made based on the original, additionally creating two dormer windows on the side of Bankowa Street. Class K-27 wood was used. The cross-sections of the truss elements have been provided in Table 3.

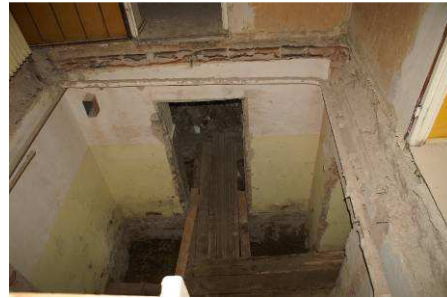
Fig. 3. Removing a part of the old ceiling. Source: MBP archives.

The existing floors were changed to ones of reinforced concrete, 12 cm in thickness, using C12/15 (B15) concrete reinforced with bars Ø8 of A-I steel, spaced 15 cm apart, welded to the middle of the beams, supported by IPE 200 and 180 steel beams for floors characterized by smaller spans.

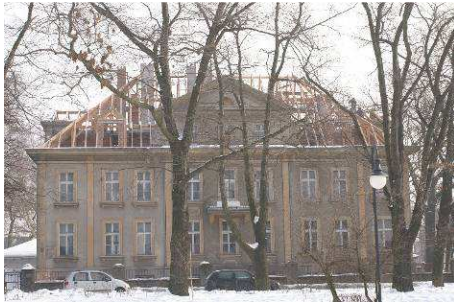
Fig. 4. Replacing the roof truss system  
Source: MBP Archives.

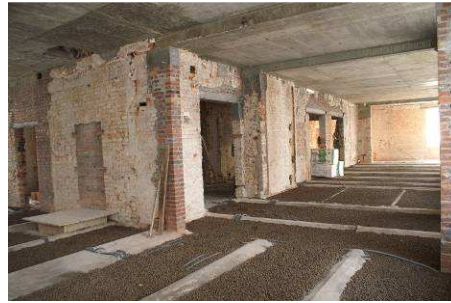
Fig. 5. Construction works on floors.  
Source: MBP Archives.

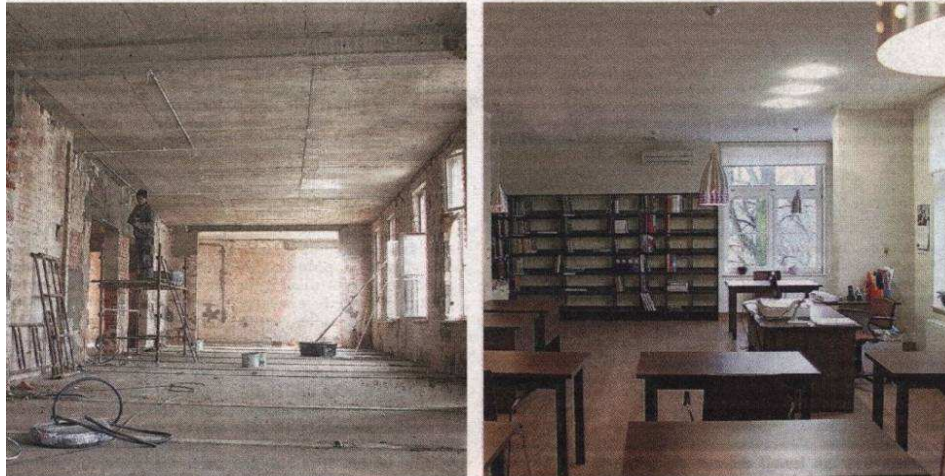
Fig. 6. Reading room at the beginning of construction works (on left) and upon completion (on right). Source: Gazeta Lubuska (Lubuska Newspaper) No. 28, 2011

In addition to renovation works, many demolition works also took place, as the taking apart of interior partitions in order to obtain a bigger surface area, or the outside staircase, which had been added on in the 80's. Some of the inside door openings were walled up and new ones created in order to adapt the building to its new function. All of the wooden doors and windows were replaced. Some windows, as for example the windows in the stairwell, were renovated [4]. A series of moisture and water protection as well as thermal and acoustic insulations were carried out in the walls and floors of the basement. Due to the historical nature of the building, it did not undergo thermorenovation.
