Measurement of surface subsidence and ground collapse caused by underground mining in the Boleo Copper District, Mexico

Jong-Gwan Kim

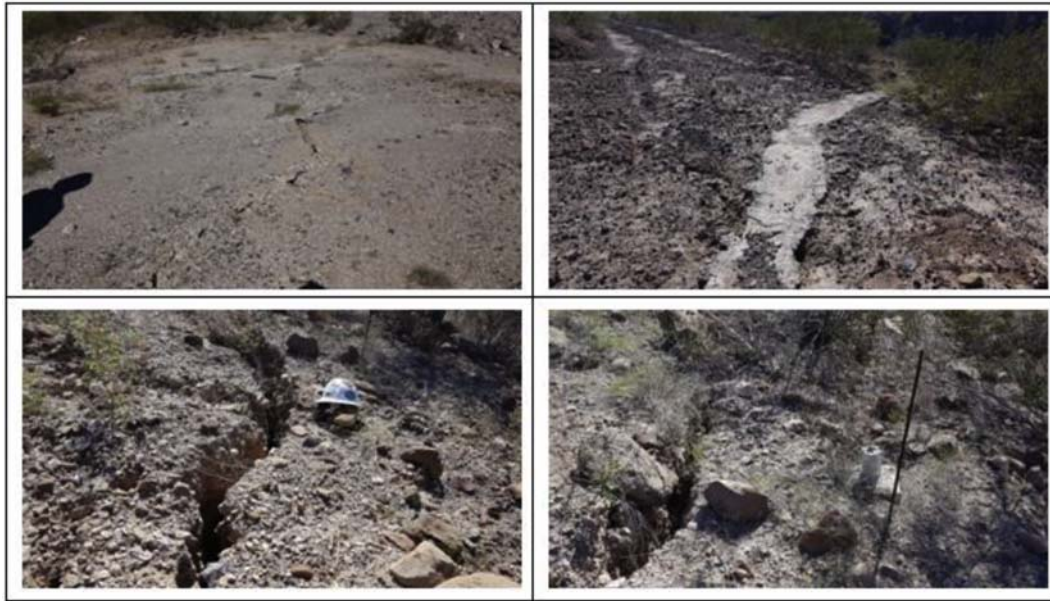
To circumvent the Manto3 area, step mining was applied to reach the ore body after excavating through the upper interburden of Manto3. In the case of conglomerate and repeated grading to support the lateral pressure, severe abrasion and pillar damage was caused. Measurements of crack displacement and cement injection were conducted. In addition, penetration through the cracks during the rainy season was not observed, as depicted in Fig. 2.

Fig. 2. Observed cracks at M303.

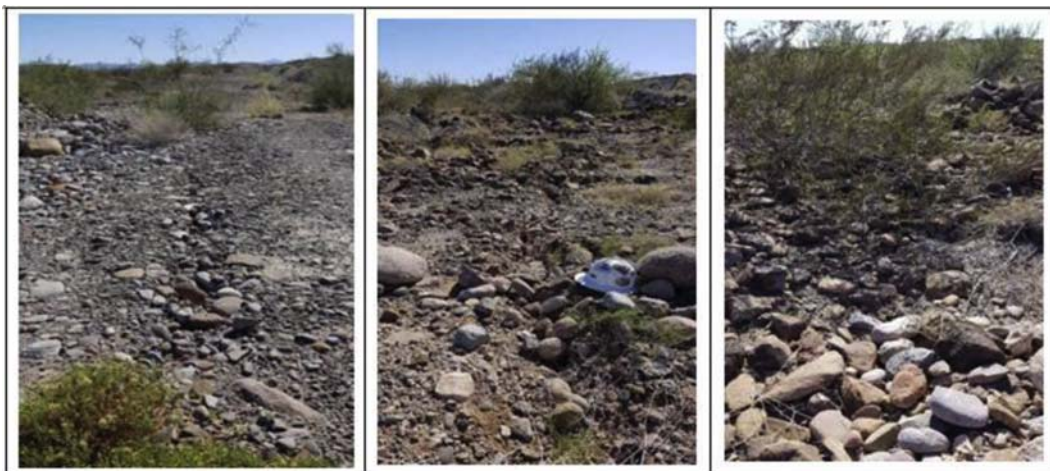
After M303 mine was abandoned, three portals were developed in Soledad valley, south side. Excavation was stopped because of the inadequate effect of rock-bolt support, lack of ability to deal with the Retaque section, excessive layer separation of Manto 3A, and excessive use of wood-log support. As a result, retreat mining was executed. In the case of retreat mining, the surface cracks near the upper road of Mesa Soledad occurred; however, most of the horizontal displacement was not accompanied by severe damage, such as road

destruction. Mine M303S exhibited upper cracks, as illustrated in Fig. 3.

Fig. 3. Observed cracks at M303S.

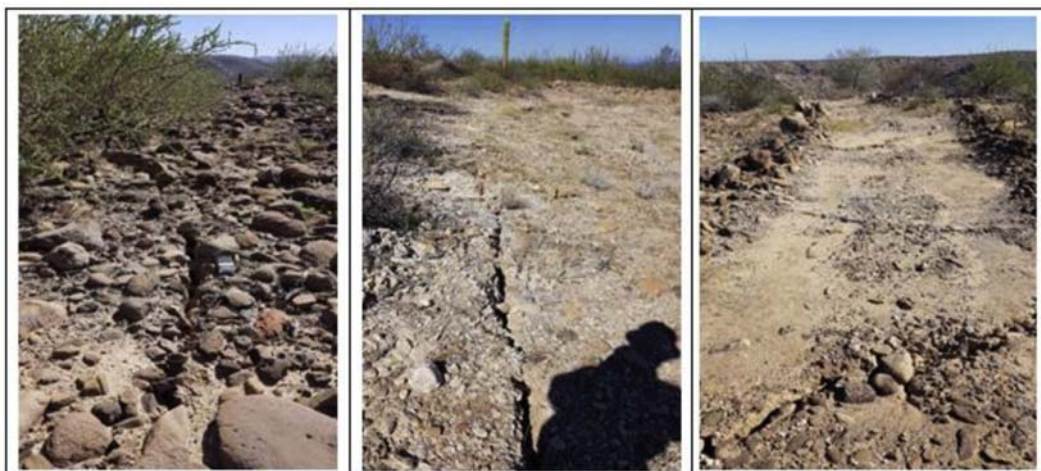
M303S mine site is retreat mining termination opens new portal with two entries. First application of steel arch system, various tests (shotcrete, trimesh, semi-shield, short wall mining, conglomerate excavation, etc.). A large number of cracks, 5–10 cm in size, were observed in the upper part of the pit area using short wall mining. Because these cracks are far from the road, they do not affect the

Fig. 4. Observed cracks at M303C.

equipment or vehicles. Fig. 4 illustrates the view of cracks on site.

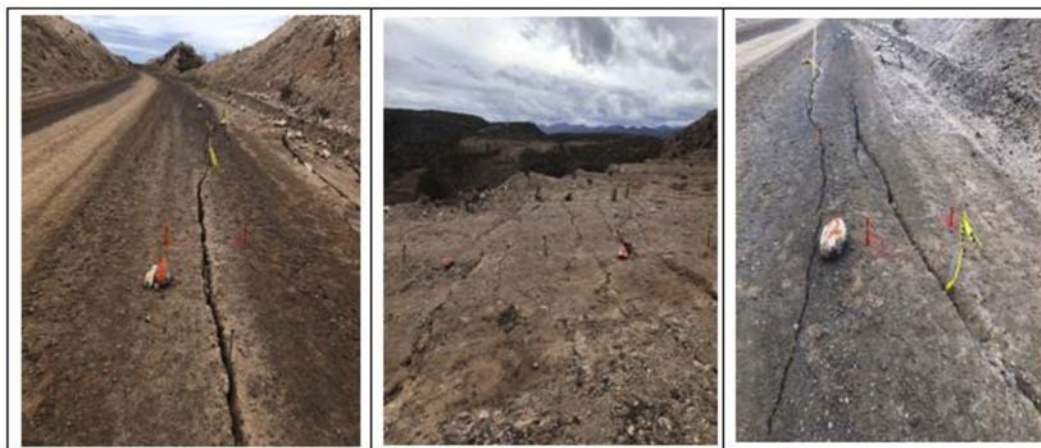
For the purpose of short wall mining, the main gateway is excavated in the Manto3 layer and this mine has two panels. The section of panel SW1 is 80 m and 2.4 m high, and currently has advanced to approximately 90 m, which results in a volume of approximately 17,280 m³ of extracted ore at present. This working face was started on August 6, 2018. As the production of this panel continued, some cracks were observed in the upper transportation road and valley slope. We started monitoring on October 31, 2018 in the area known as “Mesa soledad.” The panel is located at an average depth of 60.68 m from the surface (Fig. 5).

Fig. 5. Observed cracks at M305.

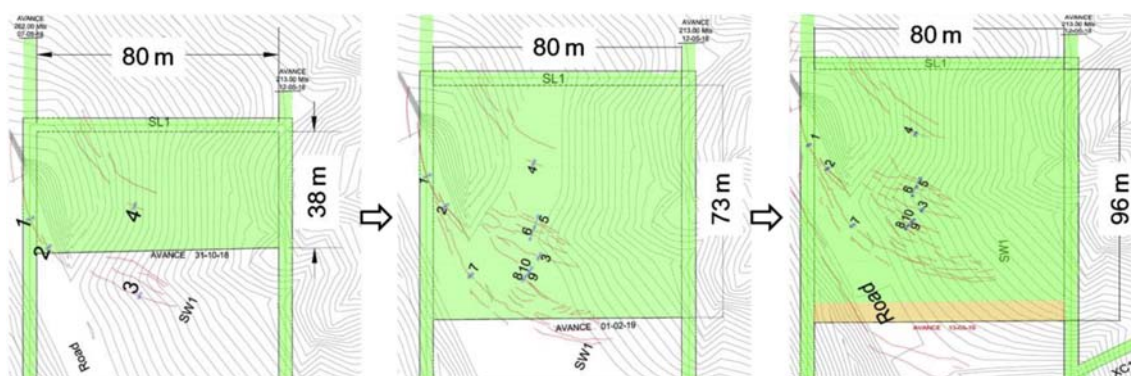
Fig. 7. Crack variation by development progress.

caused by a car. Its new measurement was 1.332 m. Comparing the three stages, we infer that the number and length of the cracks increased significantly, as the mine production continued (Fig. 7).

The measurement of point number 7 in the last monitoring before it was damaged was 1.199 m. The second topographic survey of the cracks and points was conducted on February 1, 2019. The results of the survey established that the total advance of the SW1 panel was 73 m and the quantity of cracks considerably increased. The third survey of the cracks and the points was conducted on March 15, 2019. The result of the third topographic survey demonstrated that the points were displaced toward

the center of the excavated area in SW1, which indicates towards the subsidence of the rock mass due to the excavation on M305 SW1. The three stages of the topographic survey are depicted in Fig. 7. The results of ground monitoring are presented in Table 1.

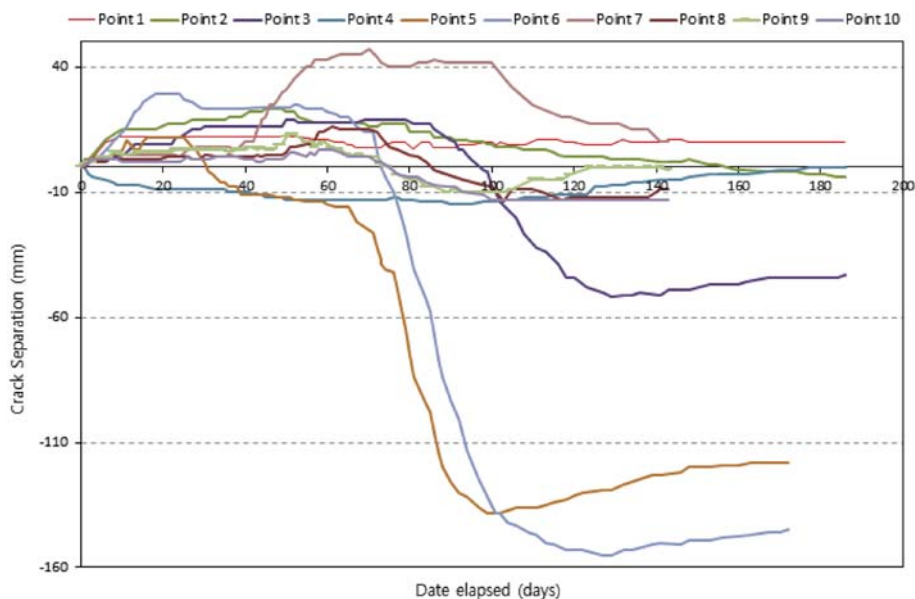
Fig. 8. Ground monitoring graph.

Fig. 8 depicts the total displacement with respect to the number of days passed since the installation of each point. When the third topographic survey was carried out and the points were updated on the map, it was observed that the points moved towards the central area of the mined area in M305 SW1.

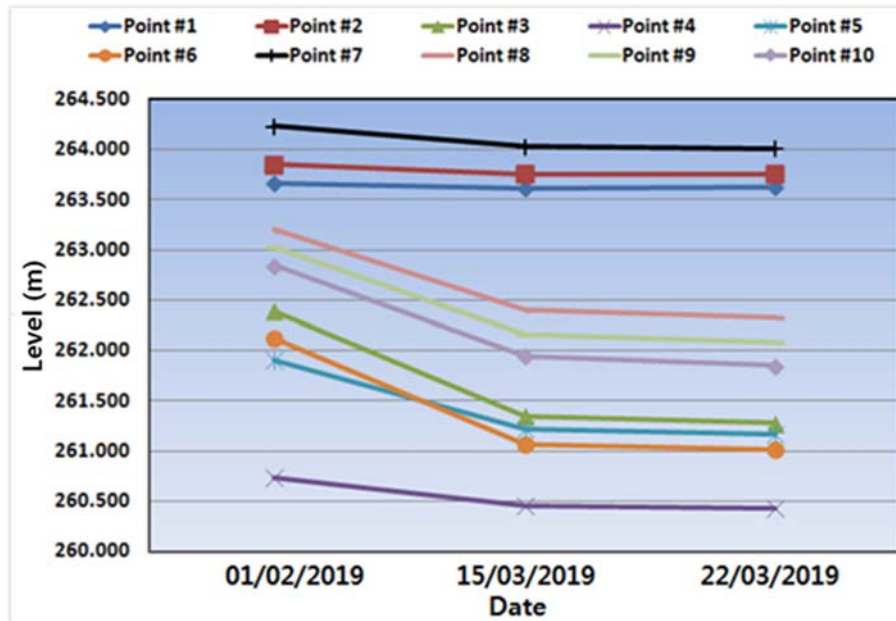
Fig. 9 depicts the subsidence status of each point; the total subsidence has a value between 40.5–1,114 mm and the maximum subsidence rate is 22.7 mm/day.

Fig. 9. Level of points plotted with respect to the number of days.

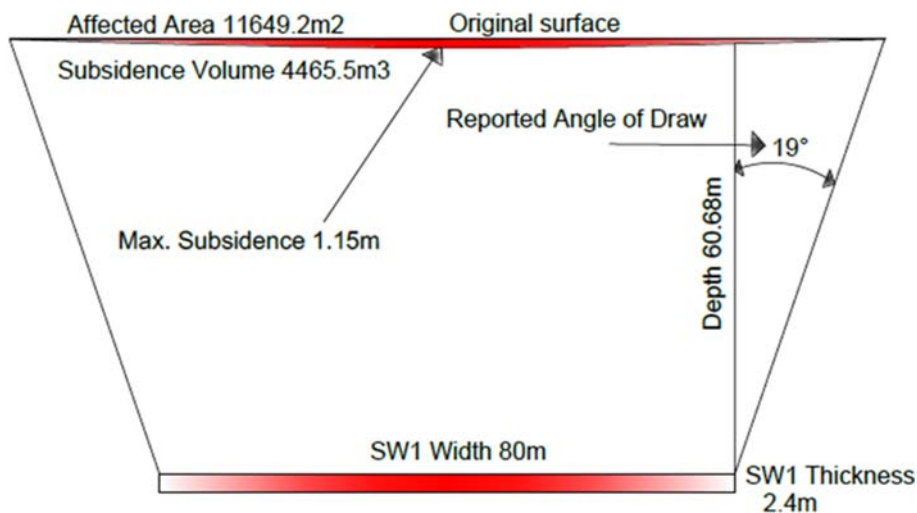
Fig. 10. True scale subsidence of M305 SW1 using a reference angle of draw.

with a diameter of 121.78 m, as SW1 is 60.68 m deep and 80 m wide, resulting in an area of 11,649.2 m² (see Fig. 10). Using the data obtained from the subsidence monitoring, cone geometry was assumed to calculate the subsidence volume as 4,465.5 m³. As the ore density is 1.41 tones/m³, the approximate subsided weight is 6,296.35 tones. By taking as reference the most remote cracks on the monitored area, it was assumed that the affected area is a 110 m diameter circle, resulting in an area of 9,503.03 m². As the SW1 depth is 60.68 m, the obtained angle of draw of the subsidence is 14° and

the subsided volume is 3,642.9 m³. As the ore density is 1.41 t/m³, the approximate subsided weight is 5,136.5 tons.
