Assessment of the quality of the repair process of local roads in the rural areas of the Częstochowa and Kłobuck poviats in the context of road safety

Natalia Brycht¹

¹ Czestochowa University of Technology, Faculty of Civil Engineering, Dabrowskiego 69 Street, 42-201 Czestochowa, Poland
Correspondence: natalia.brycht@pcz.pl

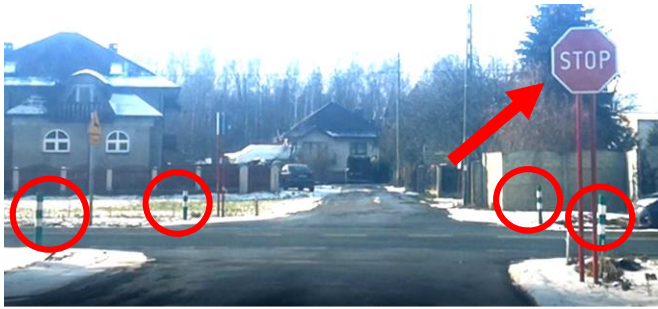
Figure 6 shows an example of conflicting road markings at an intersection with a minor road. The white and green „U-2” edge posts (in a circle) are used at equivalent intersections, where the right-of-way vehicle has priority to the right. In this example, setting the prohibition sign „B-20” "STOP" (marked with an arrow) is correct because it introduces the obligation to stop before the road with priority. Therefore, the installation of edge posts at the junction with the minor road is incorrect, because the driver of the vehicle on the minor road, approaching the intersection, receives a contradictory right-of-way message, which implies a high risk of road accidents. In this

Fig. 6. Incorrect vertical signage at the intersection with a minor road

case, the best solution is to remove unnecessary vertical markings.

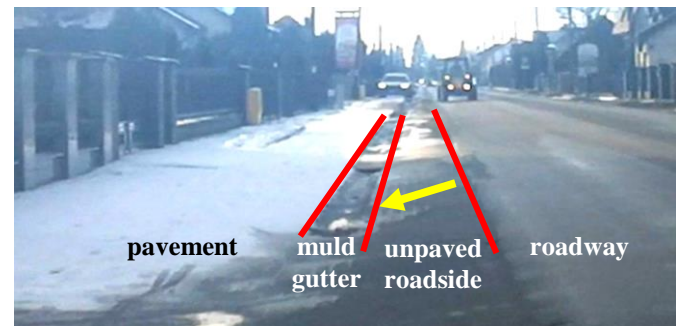
Road safety largely depends on the influence of rainwater. Penetrating into the cracks in the road surface resulting from various breaks, they imply further damage, from cavities to corrosion of the material of substructure. For this reason, the main task of road managers is to prevent the destructive effects of rainwater (Respondek, 2019). For this purpose, modern drainage systems are made. However, the correct way of making them and adjusting the appropriate type of devices to the prevailing conditions guarantee the fulfillment of their protective functions. Figure 7 shows an example of incorrectly interconnecting drainage devices. Muld gutters, serving as drainage of excess water from the roadway, were made in the wrong place on the road. The sewage should be carried out directly at the edge of the road, and the water in it should be transported to drainage wells. Unfortunately, in a situation where an unpaved roadside is made between the muld gutters and the roadway, the water from the road surface along with the material from the roadside flows into the drain (arrow), causing its pollution and blockage. As a result, water that is not drained

remains on the roadway, creating a layer that reduces the adhesion of the vehicle wheels to the road surface, which results in skidding.

Fig. 7. Incorrect connection of drainage devices

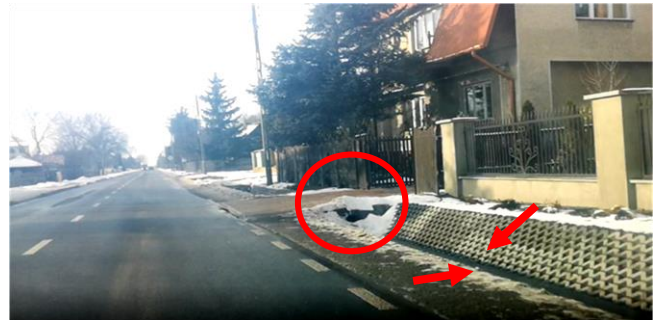
In addition to negative trends, it is also worth mentioning the positive aspects that have become visible recently. Figure 8 shows an example of a modernized roadside ditch. Before the renovation, the technical condition of the road was described as unsatisfactory. The main problem was, apart from the contaminated drainage device, numerous damage to the road surface in the form of mesh cracks and material chipping. Incorrect maintenance of the roadside ditch led to clogging of the culvert and, consequently, to a long retention of rainwater. In this case, the modernization activities included: replacement of the surface course, the use of horizontal markings in the form of lines separating opposite traffic lanes and the line marking the edge of the roadway, as well as a thorough replacement of the existing drainage device. The roadside ditch

has been cleared, deepened and reinforced with openwork concrete slabs (arrows), thanks to which the risk of soil landslide was reduced. The culverts under the entry to the property were also renovated (in a circle).

Fig. 8. An example of the correct application of drainage devices

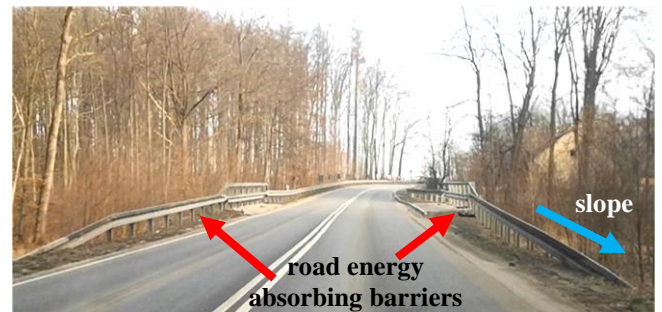
Fig. 9. An example of increasing the safety of vehicle drivers through the use of energy absorbing barriers

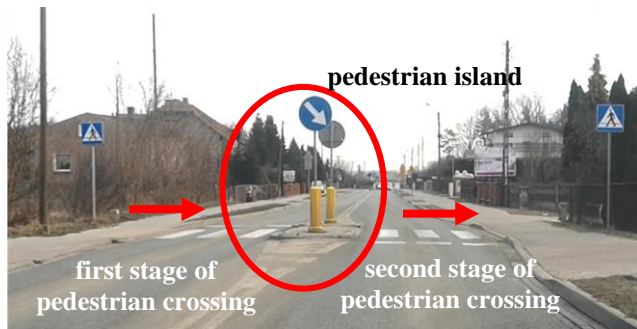
The last example of a technical device is the use of "pedestrian islands" (Fig. 10), which were located in twenty-two places in the analysed area. They are designed to make it easier for pedestrians to cross to the other side of the roadway. By dividing the passage into two stages, the safety of pedestrians is increased, as they can observe the road more precisely. Secondly, the implementation of the pedestrian island prevents drivers from exceeding the permissible speed at which they can travel on the road and hinders the overtaking maneuver, which also increases the safety of vehicle drivers.

Fig. 10. An example of increasing pedestrian safety through the use of pedestrian islands
