Żaneta Anna MIERZEJEWSKA
Paulina KUPTTEL
Jarosław SIDUN

ANALYSIS OF THE SURFACE CONDITION OF REMOVED BONE IMPLANTS ANALIZA STANU POWIERZCHNI USUNIĘTYCH IMPLANTÓW KOSTNYCH*

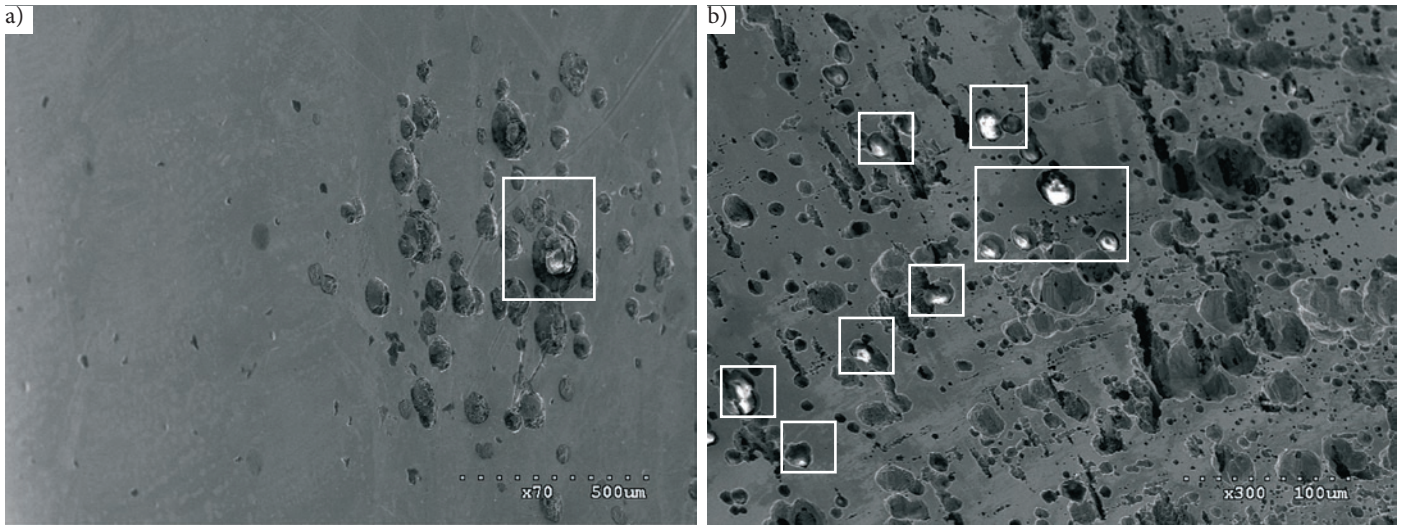
Observation of the plate's surface under a microscope revealed visible corrosion pits formed due to the interaction of bodily fluids with the material of the implant. Furthermore, the presence of degradation products was observed on the plate's surface. These products were formed as a result of the reciprocal interaction of the surface of the plate's seat with the screw head during the implant's presence in the body. Adhesion of wear products to the implant's surface is the result of adhesive interactions (Fig. 2).

Fig. 2. Photograph of POLFIX plate surface, a) mag. x70, b) x300. Areas where metal particles formed during the wear process, adhere to the implant surface are marked on photographs

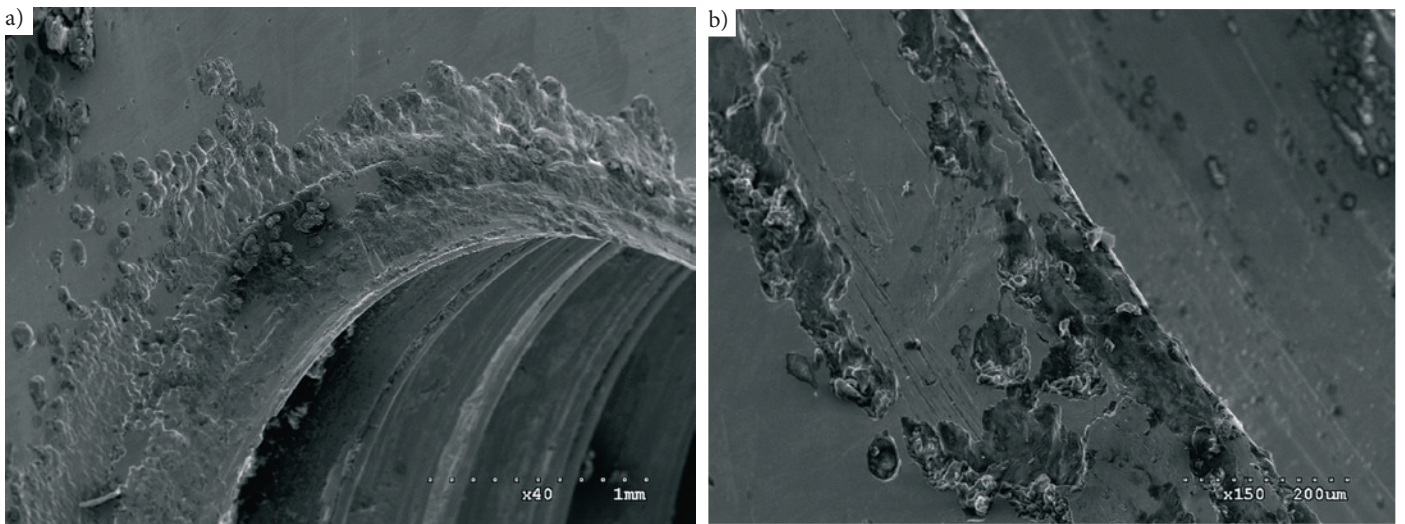
In implants used to stabilize bone fractures, such as plates, openings serving to fasten screws are particularly exposed to damage. In the case of the investigated plate, these are both threaded and tapered seats. Fretting was observed on the thread, as shown in the photographs below (Fig. 3). Characteristic pits and areas where fine micro-cracks are present are indicative of this.

Fig. 3. Photograph of the surface of a threaded seat on the plate, mag. x40, mag. x150

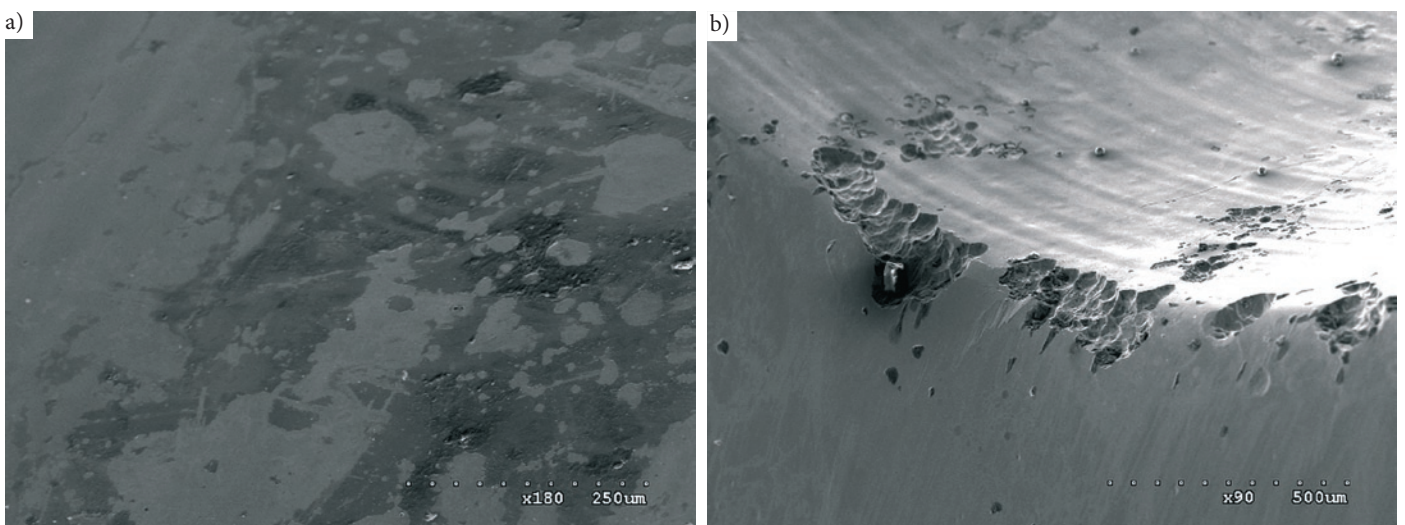
Corrosion has developed near openings as a result of the impact of the body's aggressive environment on the implanted metal. Numerous corrosion pits are visible on the surface (Fig. 4a) along with discolorations indicating the initial stage of corrosion development (Fig. 4b). Traces of abrasive wear can also be found near openings. In addition, slight deformation of the shape of openings also took place. Both processes usually occur as a result of mechanical wear occurring when the screws are being fastened and during further exploitation of the implant.

Fig. 4. View of the surface of the plate's tapered seat: a) corrosion pits (mag. x90), b) discolorations (mag. x180)

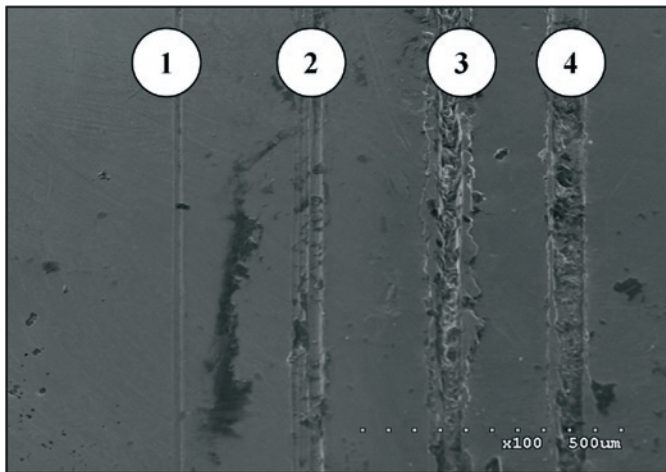
Fig. 6. View of the surface of a cortical screw with the development of successive stages of crevice corrosion, mag. x100

Microscope observations of a cortical screw revealed traces of crevice corrosion on its surface. It developed in areas where the implant was scratched as it was fastened in the plate. Scratches occurred as a result of intensified friction between these components. The passive layer of the screw's material was damaged during installation

of the implant, which initiated the development of crevice corrosion. The progression of expansion of this type of damage has been presented on the microscope photograph below (Fig. 6).

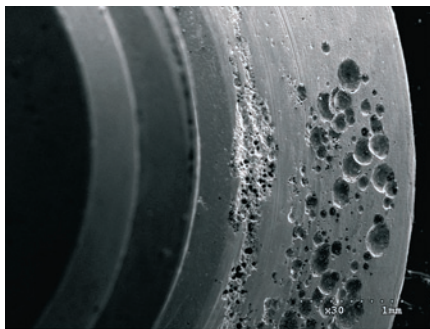
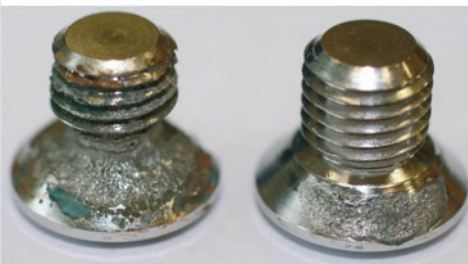
Fig. 8. View of the surface of the POLFIX fastening screw head: a) mag. x30, b) mag. x50

Microscope photographs of the investigated screws display the extent of destruction of their surface layer. Traces of abrasive wear were formed as a result of the mechanical interaction of the cortical screw head with the plate, initially at points of contact. As operating time increased and micromovements caused by variable loads took place, an increase in surface coarseness occurred. In the later period of fretting wear, recesses were formed in the material of screws. These changes, typical for fretting, are presented in figure 8.

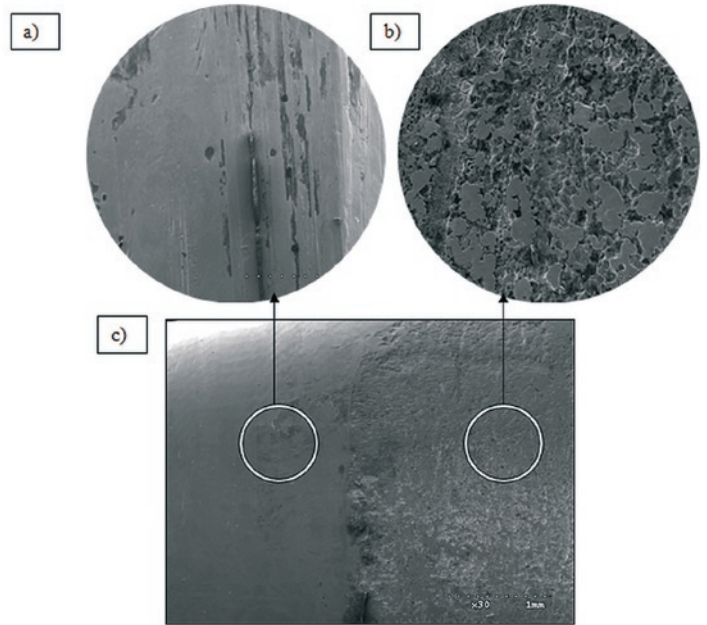
Fig. 7. View of the surface of a long POLFIX screw, a) mag. x100, b) mag. x200, c) mag. x30

Fretting is another type of wear that was observed on screws. Due to micromovements with the involvement of elastic deformations occurring between the stabilizer's components, losses of material have developed on the screw's surface. These are characteristic pits. This damage of the material is visible in figure 7b.

In addition, discolorations have formed and the pitting corrosion process has been initiated in areas on the screw's surface where there was intensive contact of the metal implant with bone tissue. The factor initiating pit development was the action of the surrounding environment with reduced pH relative to the proper acid-base equilibrium in the human body.

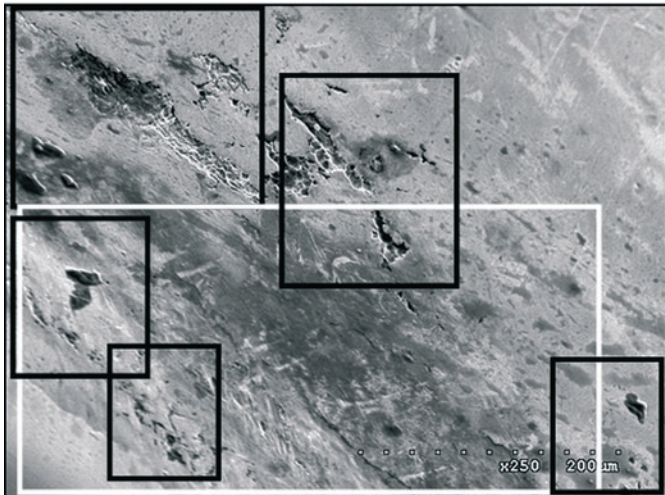
Changes in areas where there was less interaction with the plate were also observed during investigations (Fig. 9). Discolorations and breaches of the continuity of the implant's surface layer were observed in the form of small corrosion pits. These pits were most likely

Fig. 9. View of the surface of the joining screw, mag. x250 (areas of visible corrosion pits marked in black frames and discolorations in white frames)

formed as a result of a breach of the metal's passive layer, maybe even during implantation. The corrosion process was initiated as a result of the action of the tissue environment, with a pH lower than 6.8, on the metal. The surroundings of the pit are a cathode, and oxygen reduction takes place there. During the first stage, discolorations are formed, and then an increase in the concentration of aggressive ions and significant pH reduction occur inside the pit. A layer of corrosion products is formed at the bottom of the pit. Exchange of electrolyte between the pit and surroundings takes place through openings and pores in the passive layer. The composition, thickness, and porosity of this layer have an impact on the quantity and size of pits and on the rate of their development.

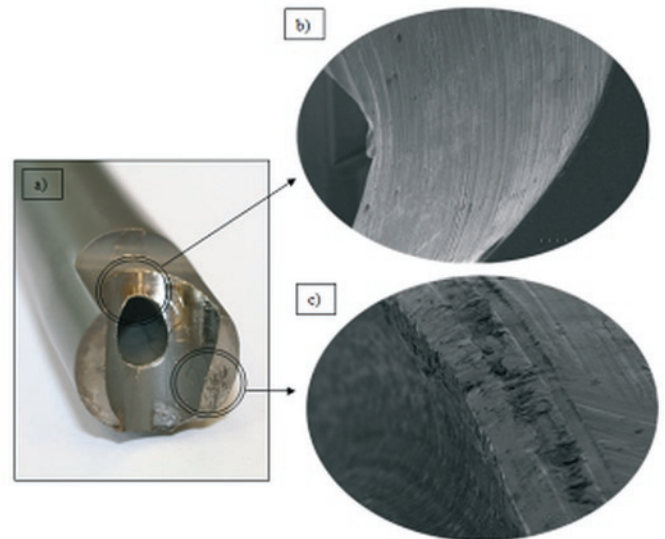
An intramedullary nail is an implant that is subjected to the enormous loads resulting from human locomotion as it performs its stabilizing role. The examined nail was damaged during exploitation – it was broken due to material fatigue.

Macroscopic observation was already sufficient to observe some changes that occurred in the implant during its time in the tissue environment. Traces of abrasive wear and the development of corrosion processes can be observed at the fracture point of the intramedullary nail (Fig. 10a).

Scratches on the interior surface of the nail, visible on the microscope photograph (Fig. 10b), were formed during fastening of the reconstruction screw. These scratches were created

Fig. 10. Blocking screw, a) fracture, microscope photographs showing characteristic damage: b) mag. x30, c) mag. x300

The destruction of the fracture surface by corrosion is visible in figure 10c. This surface has increased coarseness and bears visible traces of corrosion pits. Damage of the reconstruction screw has the nature of abrasive wear. Scratches formed on its surface can be observed macroscopically (Fig. 11). The grooves visible on the surface were formed as a result of screw rotation while it was pressed to the surface of the nail seat. A slight loss of material is also visible (Fig. 11). The reconstruction screw was also mechanically damaged. Its surface was deformed during installation, and this deformation progressed over the course of further installation, as shown in the figure below (Fig. 12).

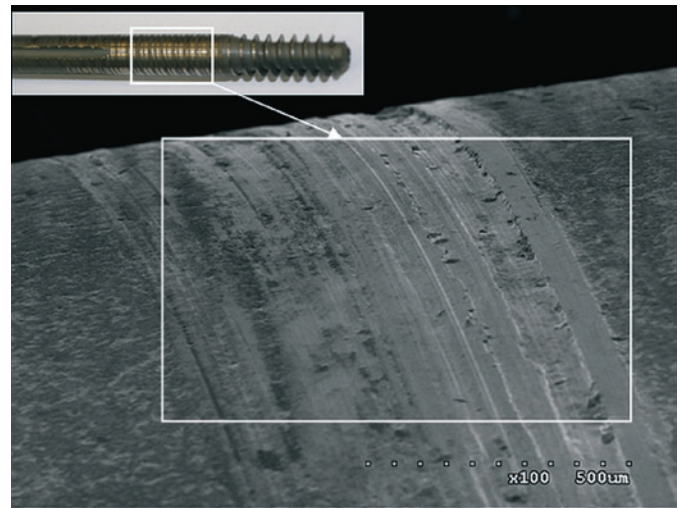
Fig. 11. Photograph of the reconstruction screw surface, showing scratches on the surface, mag. x100

as a result of friction between the screw surface and the nail surface. Moreover, plastic deformation of the seat resulting from cyclically variable loads occurring between these components is also visible. This deformation was caused by clearance between the screw and the nail, leading to micromovements.

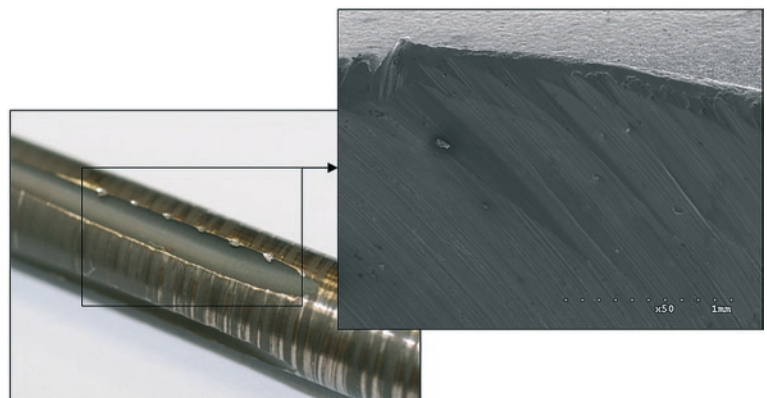
Fig. 12. View of damaged reconstruction screw surface, mag. x50.

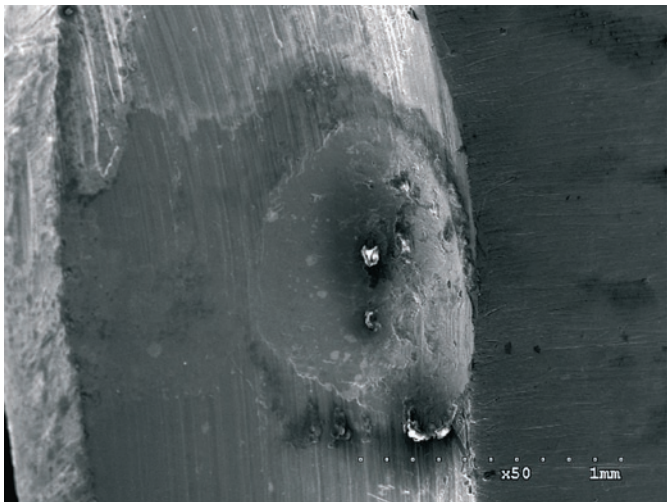
The results of microscope observations showed that the plate's surface underwent significant changes despite the application of additional protection against destruction. The presence of discolorations over a significant area and the initiation of corrosion pitting in the largest areas of discoloration were observed (Fig. 13). The aforemen-

tioned processes most likely took place as a result of elevated concentration of Cl^- ions on the surface layer of the implant material, which was in contact with electrolytes found in the bodily fluids surrounding it. The concentration of Cl^- ions has an impact on the incubation time of pitting corrosion. The greater the concentration and the higher the critical potential of pit nucleation, the shorter the incubation time.

Fig. 13. Corrosion damage on the surface of the reconstruction plate

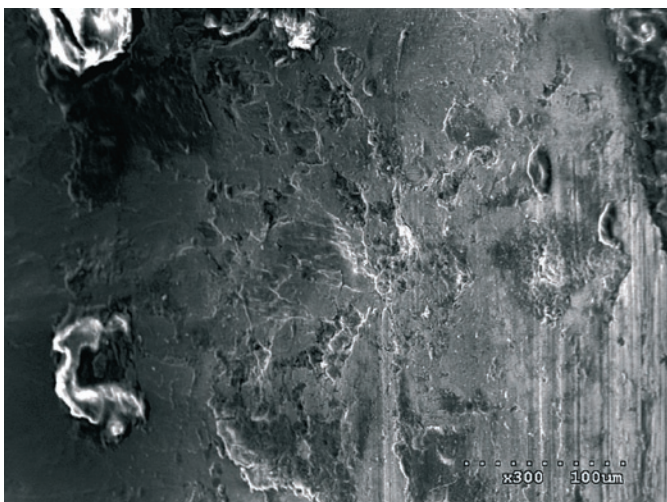
Moreover, at greater magnification, increased coarseness of the plate's surface layer was also observed. Despite cleaning in an ultrasonic cleaner, the plate's surface bore contaminants in the form of irregular particles. Clear contamination sometimes remains on certain surfaces of implants implanted into a living organism. This contamination is sometimes difficult or even impossible to remove due to the presence of strong adhesive interactions. In this case, the adhering particles may be residue of peri-implant tissue (Fig. 14).

Fig. 14. View of the plate surface with visible irregular particles, mag. x300

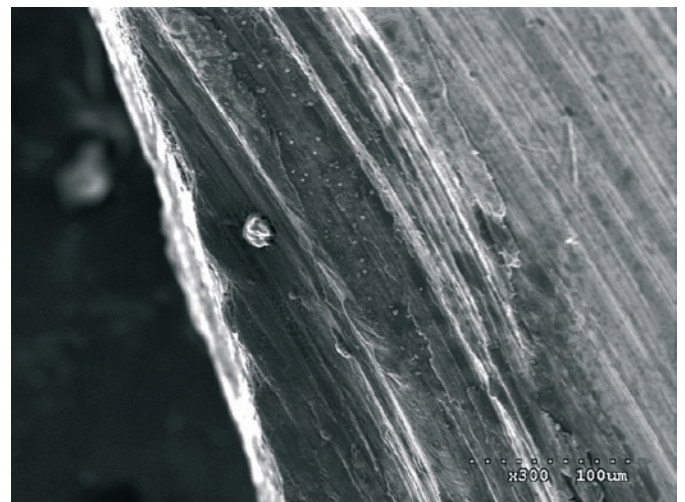
Observation of the plate's seat revealed damage of its surface layer in the form of abrasive wear. The scratches and grooves visible in the photograph (Fig. 15) are indicative of this. The plastic deformation that was observed most likely took place during the installation procedure, where a screw was inserted into the seat in order to fasten the plate.

Fig. 15. Photograph of the surface of the seat in the anodized plate, mag. x70. Scratches formed during implantation of the component are marked in the photograph

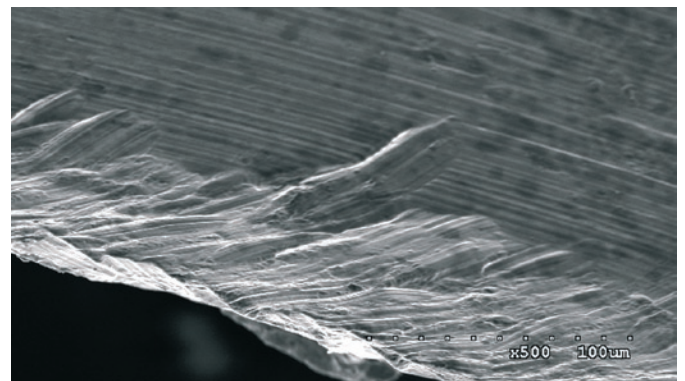
Traces of fatigue wear of the reconstruction plate's seat are visible in the following figure (Fig. 16). Visible grooves were formed as a result of cyclically variable loads acting on components of the stabilizer and reciprocal interactions between the screw head and the surface of the seat in the plate. The cause of such deformation may have been clearance between the screw and the plate, which leads to micromovements of both components.

Fig. 16. Photograph of the surface of the seat in the anodized plate, mag. x500.

Because high loads are carried, this clearance may increase, making the entire system more susceptible to damage.

Both of the types of damage on seat surfaces in the anodized plate described above lead to a change of seat shape. Deformations of a plate's seats take place as a result of reciprocal interaction between the screw head and the plate. Deformation of an opening may occur as early as at first contact of the plate with the body, or during its installation, due to rotation of screws while their heads are pressed into seats in plates. Moreover, improper positioning of a screw may also cause deformations. In such a case, the micromovements taking place during exploitation are intensified as a result of the action of variable loads. This, in turn, exacerbates deformations of openings. It should be emphasized that deformation of plate seats is an undesirable process because it may lead to instability of the entire implanted stabilizer system.
