Difficulties related to the renovation of the reinforcement of the V shaft at PGG Oddział KWK Ruda Ruch Bielszowice

The article presents an analysis of the possibility of carrying out repairs of shaft reinforcement without limiting its transport tasks, with operating parameters in accordance with the technical documentation of the shaft hoist, specified technical condition of the girders and guides, using the capital of knowledge and experience in maintaining the required level of safety for guiding the extraction vessels in conditions of the acceptable wear of guides and girders included in the mine shaft hoist documentation.

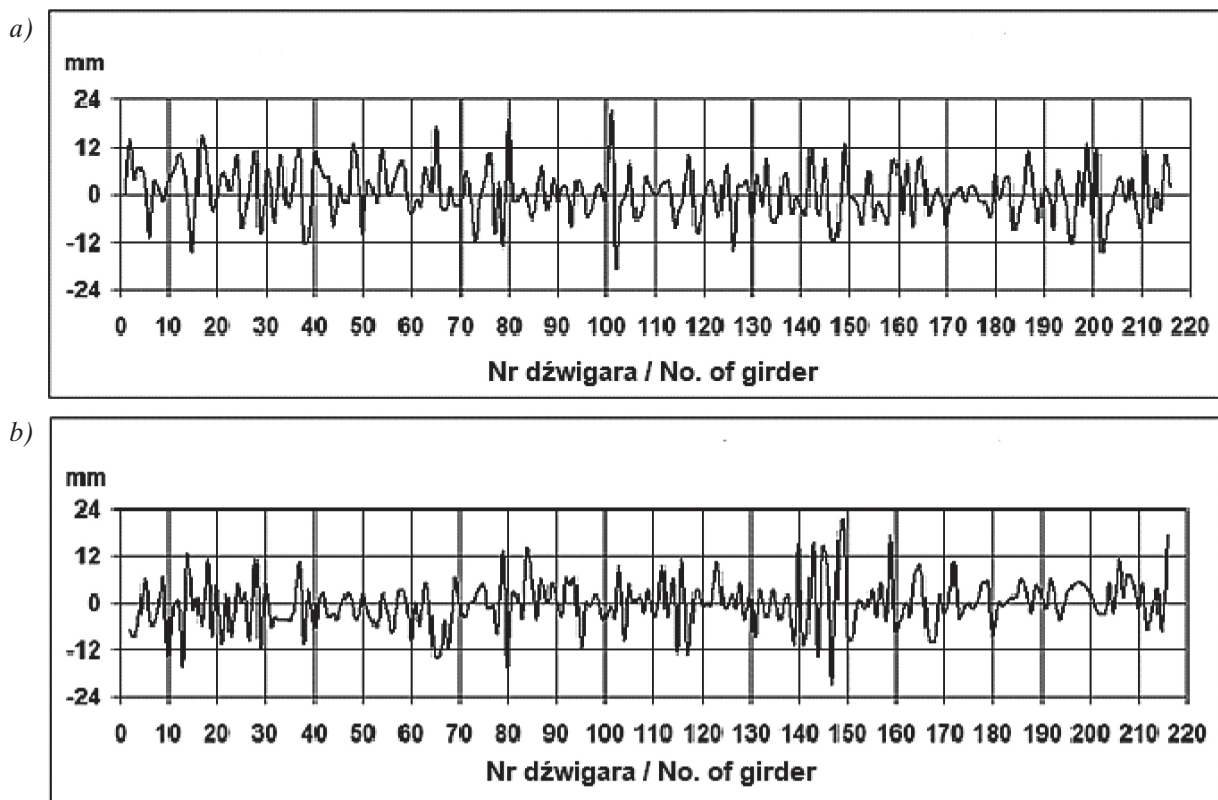
On the basis of the measurement survey [7], for all guide tracks in the V shaft, diagrams were developed reflecting the distributions of differential frontal and lateral deviations from the straightness of the tracks leading the extraction vessels along successive main girders in the shaft. Figure 2 shows, as an example, graphs representing one of these distributions. Each of the discussed distributions was then subjected to the mentioned statistical analysis. It showed that for each of the guide tracks in shaft V, the proportion of the corrosive component in the extreme values of these deviations is not less than 50%. On this basis, it was decided to carry out an inventory of fissure disappearances in the assembly of individual sequences in shaft V, and then to take steps to remove the identified clusters of these disappearances.

Fig. 2. One of the distributions – along the successive main girders – of differential frontal (a) and lateral (b) deviations from the straightness of the tracks leading to the hoisting vessels of the eastern southern ski-frame track in shaft V, developed on the basis of the measurement survey [7]

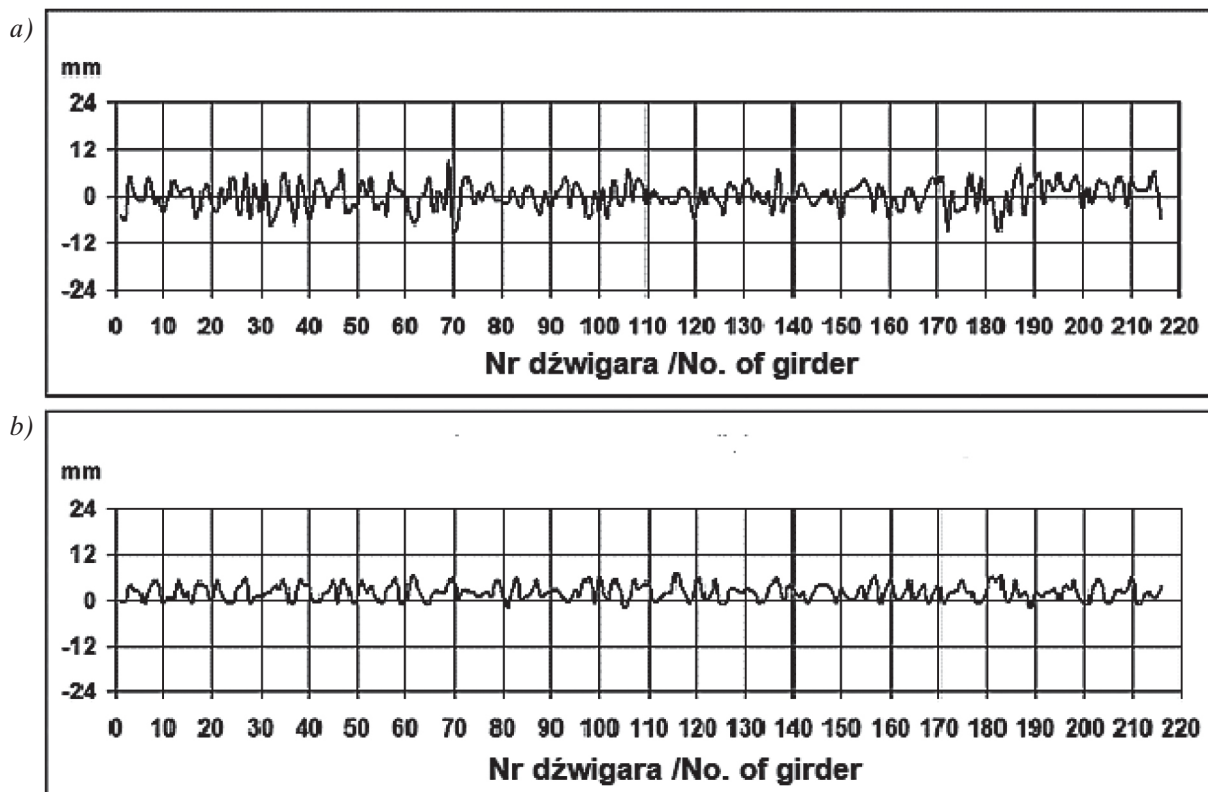
Approximately 3 months after the removal of the largest clusters of gap disappearances on the assembly of the chain of individual track guides, straightness measurements were made again and, based on the measurement frame [8], graphs were again developed reflecting the distribution of differential frontal and lateral deviations from straightness along successive main girders in the V shaft, illustrating effect of actions taken. These charts (Fig. 3) were drawn on the same scale as the previous ones (Fig. 2), which was meant to facilitate the perception of the obtained effect. This effect, in the case of the eastern southern snap-shot guide, is to reduce the greatest frontal deflections from 21 mm to 9 mm and the greatest lateral deflections from 20 mm to 7 mm. As a similar effect was obtained for the remaining lead tracks in the northern section of shaft V, it was not only found that the assumptions made were correct, but also the action taken and implemented was justified.

Fig. 3. One of the distributions developed on the basis of the measurement [6] – along the successive main girders – of differential frontal (a) and lateral (b) deviations from the straightness of the traction vessel tracks of the eastern southern ski-cage track in shaft V – after removing the largest clusters of gap disappearances on folding the chain of guides

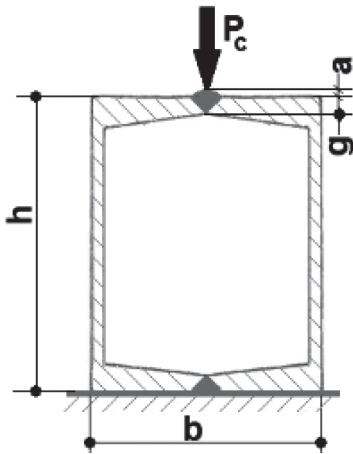
Fig. 4. Calculation diagram for stresses in the weld connecting the chain sections

a – joint convexity defined in the BN-78/1727 [1] standard as $a \leq 1.5 \text{ mm}$, b – the width of the front wall of the chain equal to 150 mm, g – joint thickness defined in [9] as 7 mm, h – side width guide walls equal to 200 mm, P_c – girders calculation force

Using formulas (1) and (2), it was calculated that when the actual force of the extraction vessel on the shaft reinforcement reaches the value of the force P_c , the stress σ_s may have a value of approx. 530 MPa, which means that it will be greater than the immediate strength R_m of the material guides of 380 MPa. Therefore, it was found that the direct cause of cracking of the weld connecting the chain sections is the convexity of this weld, although such convexity is accepted by the standard BN-78/1727 [1].

- Each fracture of the weld has a tendency to propagate along the weld in both directions, and therefore in the conditions of shaft V it will endanger the safety of the chain when it reaches the length of 0.5 m. Then, the chain with such damage may experience a rapid loss of lateral stiffness, which –

- with a probability significantly greater than zero – may lead to the suction vessel falling out of its guide tracks. Any chain in the V shaft showing a weld fracture of a length equal to or greater than 0.5 m should therefore be replaced immediately.

- The guides in the V shaft which show a weld fracture less than 0.5 m in length may be operated if:
 - show wall wear lower than acceptable;
 - this consumption is controlled in accordance with the requirement of point 3.13.7.4.1 of Annex 4 to the Regulation [6];

- the ends of the weld crack are protected against its propagation, e.g. by drilling an appropriate hole;
 - records of chains showing both existing and newly formed cracks in joints are verified at least every 6 months;

- the records, in addition to the number of the girder closest to each fracture, contain information on the length of the recorded fracture and the absence or occurrence of its propagation beyond the securing holes.

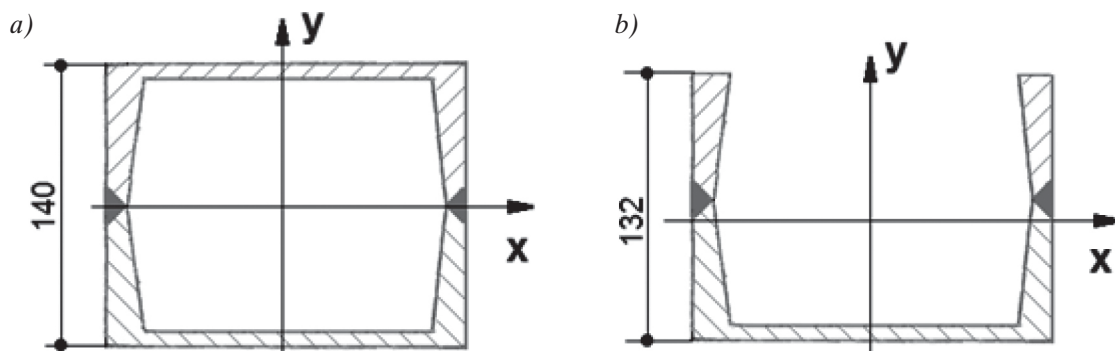
The third and final step in the scope of the research undertaken was to determine the impact of the perforation of the upper walls of the main and strut girders on the safety of the guide tracks. For the main girders, this influence was determined by comparing the bending strength indices calculated – according to the diagram in Figure 5a – for the cross-section of the main girder without perforation of its walls with such indices calculated on the basis of the diagram shown in Figure 5b. The comparison was made using the graphs in Figure 6, which show the results of the calculations performed. On this basis, it was determined that the perforation of the upper wall of the main girders in the V shaft reduces their strength by approx. 16%, therefore the main girders in this shaft showing such damage can be safely used, as long as their wear outside the perforation area is not greater than 84% of the permissible wear of girders without perforation.

Fig. 5. Calculation diagrams of the cross-section of the main girder in the V shaft for the girder case: a) without perforation of its walls; b) with perforation of its upper wall

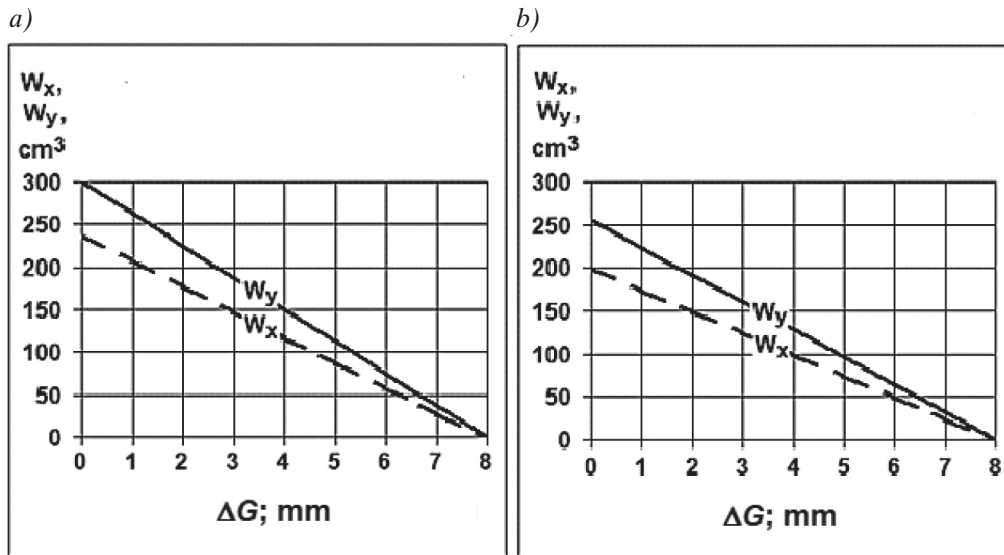
Fig. 6. Influence of the decrease in thickness (ΔG) of the walls of the main spar in shaft V on its bending strength indexes (W_x , W_y) in the absence of (a) or presence (b) of perforation of its upper wall

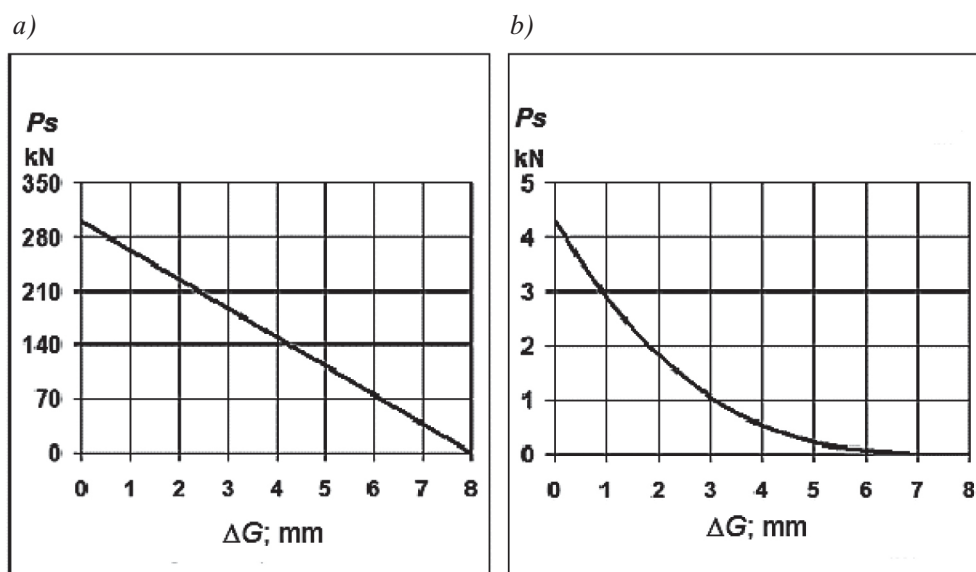
On the other hand, for the spreader beams, it was assumed that, before formulating the analysis scheme that would enable the determination of the impact of the perforation of their upper walls on the safety, calculations of the permissible compressive force of these beams were made. Their results (Fig. 7) showed that the perforation of the upper wall of the expansion beams in the V shaft significantly reduces their allowable compressive force that in strength calculations of the V shaft reinforcement, the perforated span beams cannot be considered as rigid supports of the main

Fig. 7. Influence of the thickness loss (ΔG) of the walls of the expansion girder in the V shaft on the allowable compressive force (P_s) of this spar in the absence of (a) or the presence (b) of the perforation of its upper wall

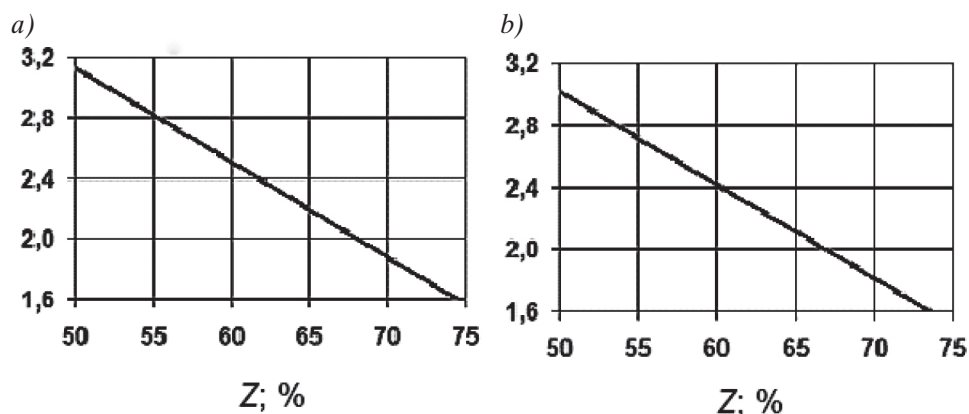
Based on the results of the discussed comparison, it was found that the perforation of the upper walls of the strut girders in the V shaft did not have a significant impact on the safety of the tracks of the exhaust vessels in the shaft. This is due to the fact that the loss of the expansion girder – due to the perforation in question – of its ability to perform the function of a sufficiently rigid support of the main girder causes a reduction in the structural rigidity of the main girder as a support for the guides attached to it. As a result – in the elastic range of the material – also the maximum frontal forces absorbed by the main girder from the suction vessels are proportionally reduced. Then the guidance track safety coefficient does not experience any significant reduction, nor does the deflection of this track increase significantly.

An equally important finding resulted from the evaluation of the values of both variables appearing in the graphs in Figure 8. With the wear of the walls of the guides and girders equal to 50% of the initial thickness of their webs, the smallest excess of the calculated value of the safety factor of the tracks leading the exhaust vessels in the V shaft, in relation to the required value of this coefficient as it amounts to approximately 67%. This statement indicated that with the current technical condition of the reinforcement of the V shaft, it is possible to maintain the required safety of the tracks of the extraction vessels during the renovation of this reinforcement with an increase of over 50% of the permissible wear of the guides and girders. On this basis, the user of the shaft in question decided to take action in this regard, in accordance with § 536 par. 1 lit. h of the Regulation [1] and with the recommendations given in the publication [2, 11].

Fig. 8. One of the sets of results for the calculation of the safety coefficients of the southern ski-cage guides in the V shaft, corresponding to the stretchers without (a) and (b) with wall perforation, depending on the wear (Z) of the walls of the guides and main girders
