STANISŁAW BARYCZ*, KAROL FIREK*, WOJCIECH KOCOT*,
AGNIESZKA MALINOWSKA*

**THE EFFECT OF PREVENTIVE CONSERVATION MEASURES ON THE TECHNICAL CONDITION OF
A RELIGIOUS BUILDING LOCATED IN THE MINING AREA**

* AGH UNIVERSITY OF SCIENCE AND TECHNOLOGY, AL. A. MICKIEWICZA 30, 30-059 KRAKÓW, POLAND

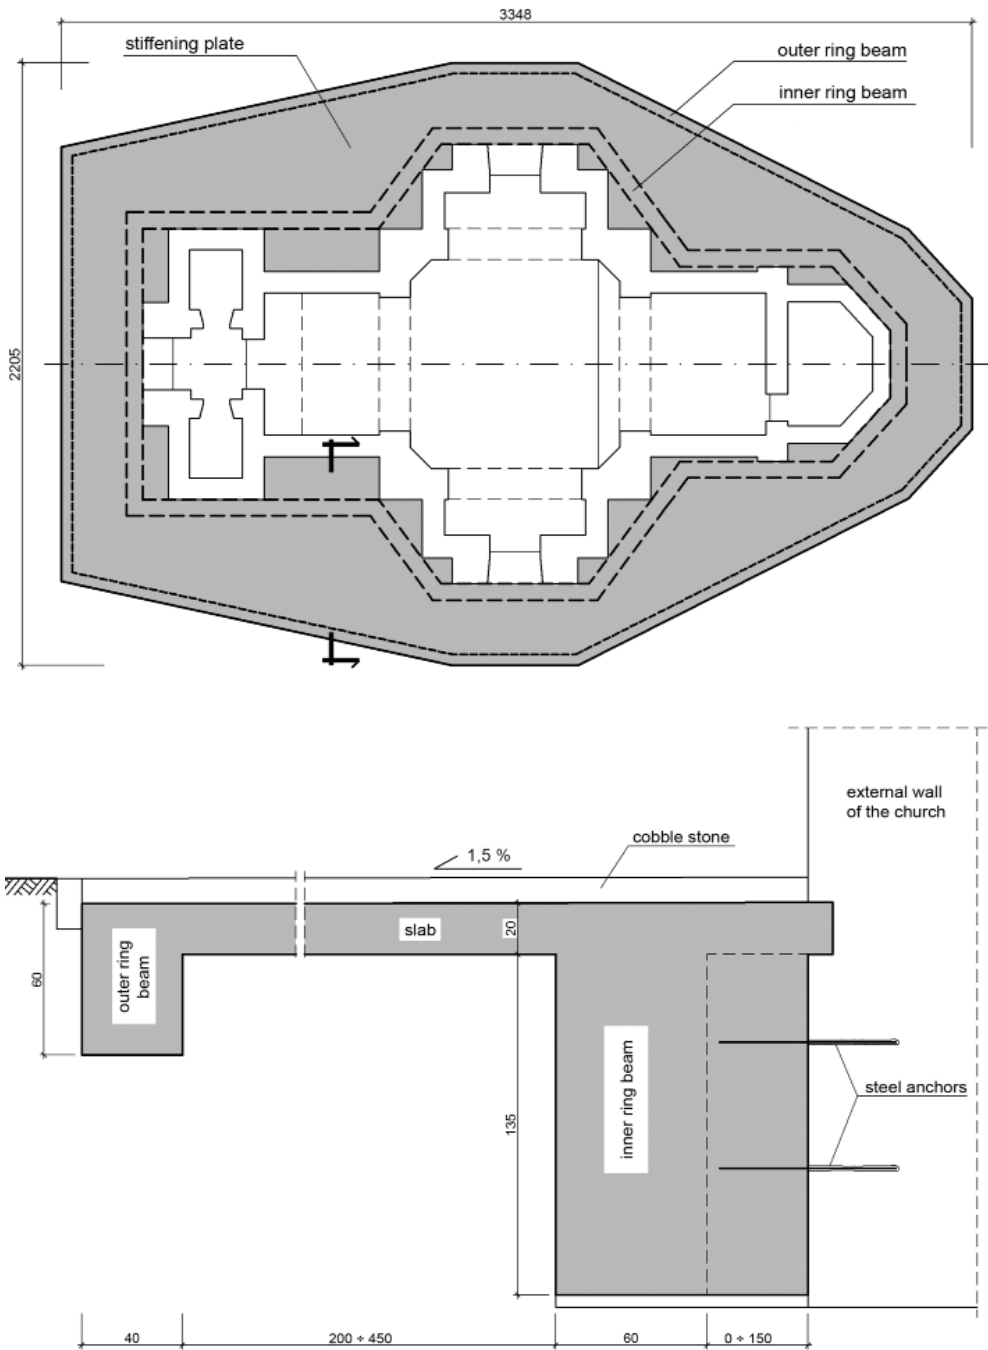
Fig. 4. Scheme of preventive conservation of the structure with reinforced concrete stiffening plate – a horizontal projection and cross section of the stiffening plate.
 Source: Own study based on Szczepaniak and Wach, 2002

The task of the plate was to receive all the horizontal surface deformations and to ensure geometric invariance of the horizontal projection of the building at the ground level. The plate was designed as a wide reinforced concrete band embracing the whole projection of the church building and a directly adjacent to the external walls. The plate was composed of three basic elements combined into one monolithic whole (Fig. 4):

- reinforced concrete slab, 20 cm thick,
- inner reinforced concrete ring beam with cross-sectional dimensions of 60×155 cm,
- outer reinforced concrete perimeter ring beam with cross-sectional dimensions of 40×60 cm.

In the sections where the inner reinforced concrete ring beam runs at a certain distance from the wall (e.g. in the inner corners), the space between it and the foundation wall was filled with concrete during the concreting of the ring beam. Therefore, the inner ring beam (or the concrete spacer) adheres tightly to the foundation walls of the structure, at their entire height. In addition to the concrete adhesion to the masonry wall, the connection of the ring beam with the foundation walls is ensured by steel anchors $\phi 20$ mm, embedded in these walls every 0.5 m. Due to its considerable structural height and the resulting rigidity, the inner ring beam also stiffens the structure in the vertical direction, thus partially protecting it as a whole against deformation resulting from the curvature of the area. The outer edge of the plate is stiffened with a perimeter ring beam, which in a plan has the shape of a convex polygon. To execute all the elements of the plate, concrete B20 was used, with F100 degree of frost resistance and W4 water resistance, as well as stainless steel of A-II class and 18G2 type.

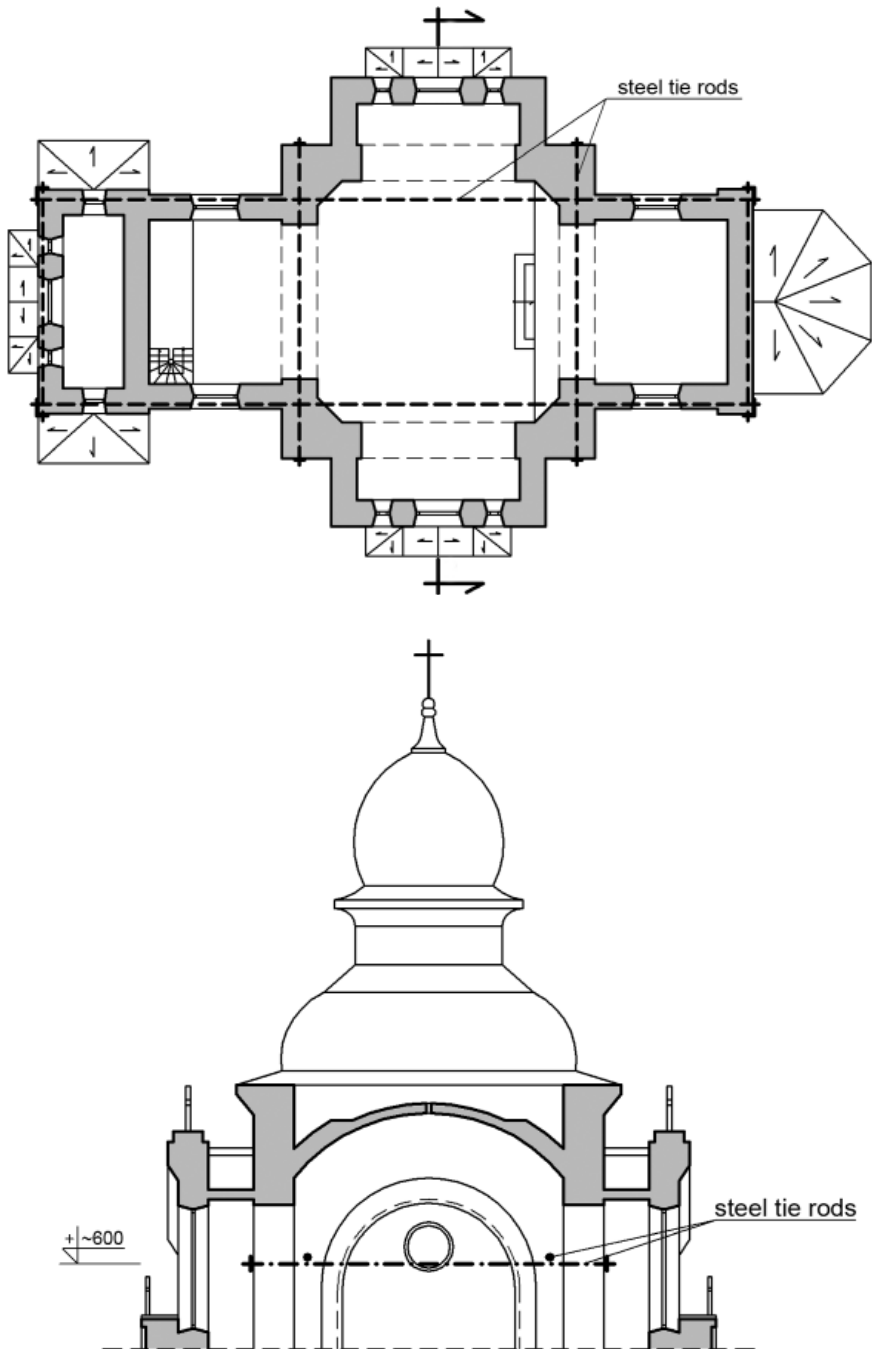
Fig. 5. Arrangement scheme of steel tie rods (anchoring) at the level of +6.00 m – a horizontal projection and cross section of the stiffening plate.

To ensure invariable support for the vault arches construction of the roofing, anchoring of the walls was used (Fig. 5). For this purpose, on the outer side of the walls at the level of +6.00 m, steel tie rods $\phi 30$ mm in grooves were mounted. The nave with the bell tower, the central part (without the extreme parts of the transept) and the chancel were secured by this system.

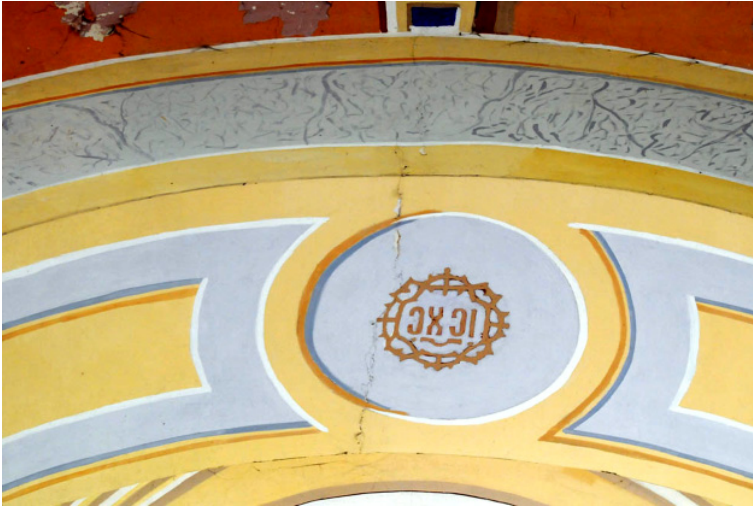
Since the interior of the building had not been renovated, a comparison of the status quo with the condition observed in 2001 was made. Detailed examination revealed the existence of exactly the same damage as before. These included scratches and minor cracks of the arches (buttresses) crowning the chancel, of the nave and the transept, as well as of the lintel bows over window and door openings. Their width usually did not exceed 0.5 mm, and only in two cases it reached 1 mm (e.g. Fig. 10, 11). Scratches of the lintels over side entrances to the church (in the transept gable walls) run up until they reach the window openings located above. Inside the building, traces of dampness of the walls, exfoliation of paint coatings and corrosion of plaster occurring in the places of leaks (mostly old) caused by the leaking roof were found. It should be emphasized that there were no new cracks or scratches, and the width of the existing ones remained unchanged.

Fig. 10. Scratches of the arch crowning the nave from the side of the main entrance (unchanged).
Source: Own study

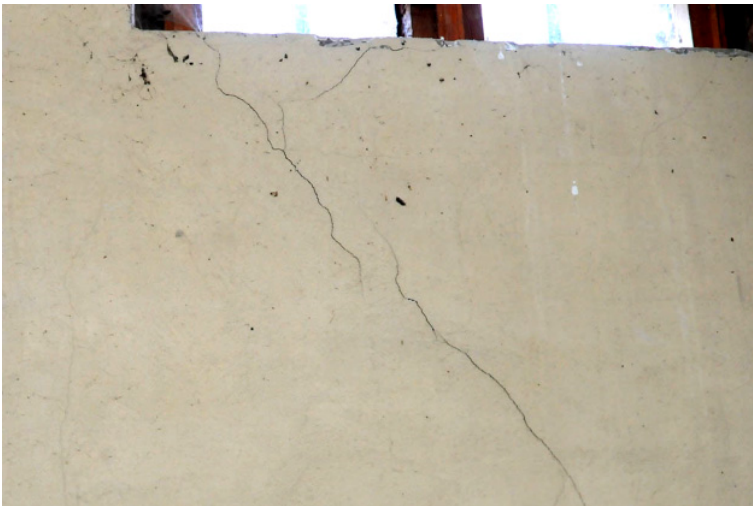
Fig. 11. A scratch, 1 mm wide (the largest in the building) extending from the door lintel to the window above the western entrance (unchanged).
Source: Own study

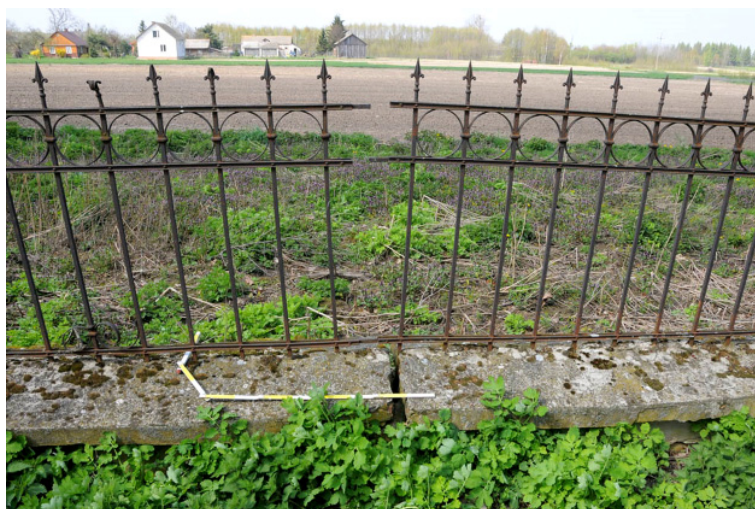
During the on-site inspection, evidence was found demonstrating the occurrence of mining impacts in the area. They resulted in significant cracks of structural elements of the fence

around the building, both in its brick and stone foundations and in steel elements above the ground (e.g. Fig. 12). It may be argued that in the event of a failure to carry out preventive conservation works, or in the case of a less decisive action in this regard, the walls and vaults of the church building would crack as well.

Fig. 12. One of the cracks in the construction of the fence around the church building on the north-east side (present situation).
