Internal Corrosion Damage Mechanisms of the Underground Water Pipelines

Desalegn A. Yeshanew¹, Moera G. Jiru¹, Hirpa G. Lemu^{2*}, Mesay A. Tolcha³

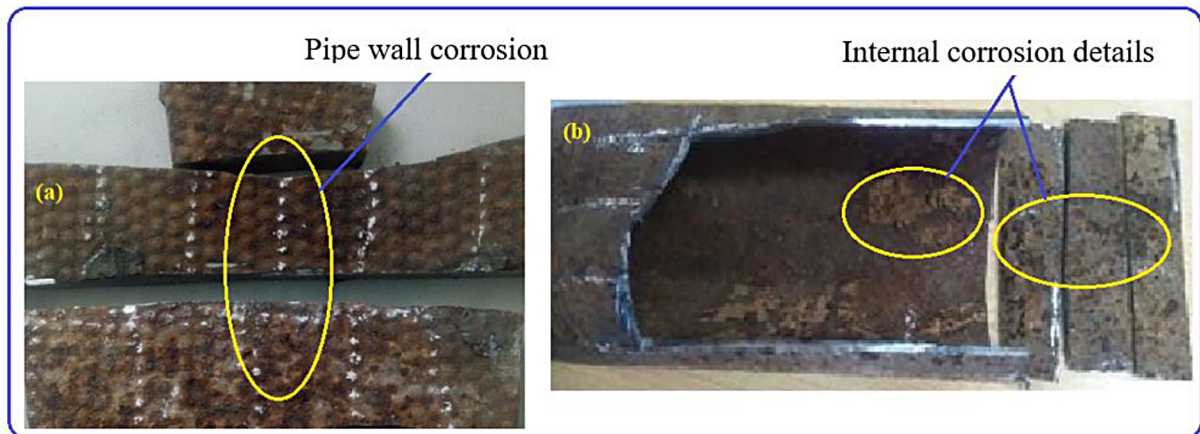
Figures 2a and b show internal corrosion patterns of ductile cast iron and galvanized pipes respectively. Compared to the two pipes, more corrosion damage was observed on the galvanized pipe wall. In addition, corrosion scale and localized pitting corrosion were detected visually at the macro level.

Fig. 2. Photographs of internal pipe corrosion morphology: (a) Ductile cast iron pipe and (b) Galvanized steel pipe

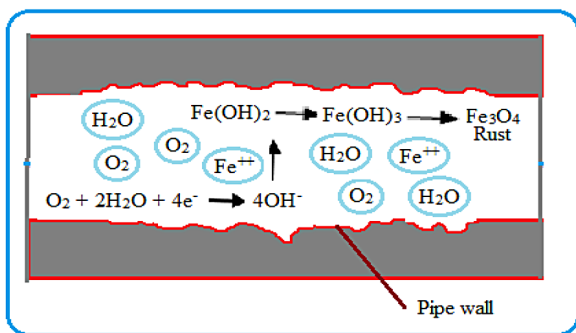
but the solids were able to develop deposits on the pipe wall over time during water stagnant condition and damages pipe surface Fig. 3. Additionally, water electrical conductivity (EC) in Table 4 shows from (157.8–493.4 μS/Cm). The EC depends based on the amount of iron released and total dissolved particles in the water. The presence of EC indicates the potential of water able to pass the flow of electric current from the pipe is being higher which enhances the rate of internal corrosion. Table 4 also presents the lab result of ferric ion (Fe³⁺) ranging from 0.05–0.55 ppm in the analyses. The result obtained from the site of 02, 03, and 05 indicate the release of ferric oxide is at normal condition whereas sites 01 and 04 observed a higher amount of ferric ion; in turn, which shows the rate of internal pipe corrosion condition enhanced by dissolved oxygen. As the attack of ferric oxide increases, it has great potential to form magnetite (Fe₃O₄) corrosion scale which leads to change in water taste and color. The other factor of internal pipe corrosion is water hardness caused by dissolved calcium ions which form protective scales on the pipe wall. As the size of scale increases during the stagnant condition of water flow, it creates turbulent and develops erosion-corrosion.

Fig. 3. Schematics of pipe wall corrosion formation process

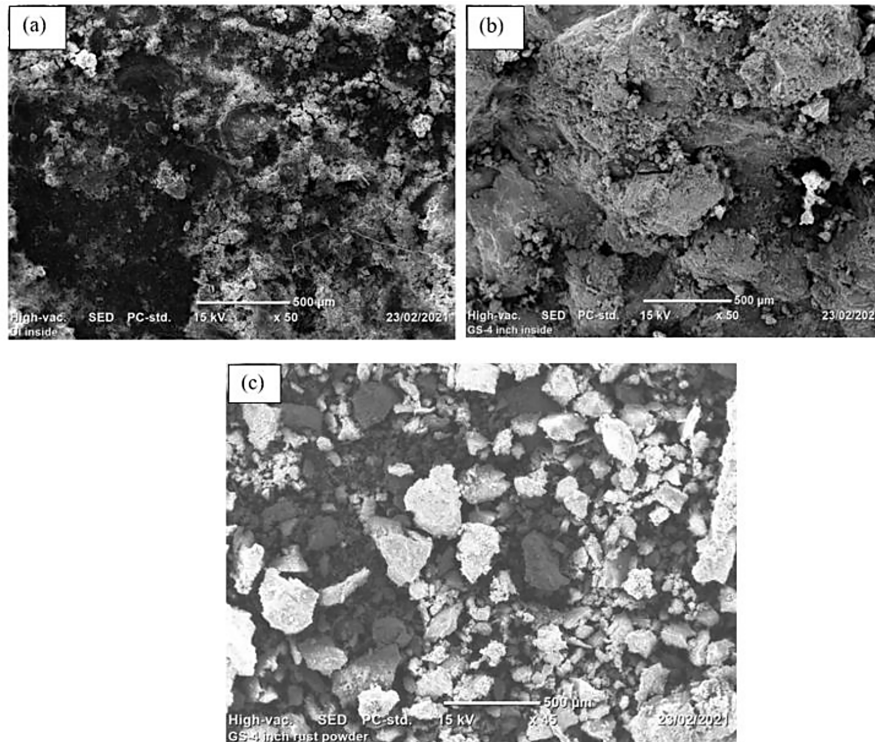
Several SEM photos sizes were taken including (50, 100, 200, 500) μm & 1 mm. For this study, 500 μm is used with a magnification of X50 as shown in the figure below. Figure 4a–c depicts the morphologies of internal corrosion in SEM images. Figure 4a shows the SEM image of the DCI pipe wall which was damaged by the uniform and localized corrossions during the service years with operating water pressure of 150–350 kPa. Similarly, Figure 4b presents the corrosion damaged surface of galvanized pipe. The surface is deteriorated as a result of pitting corrosion growth caused by the deposits, dissolved oxygen, long time water conveying service, and alternating of water pressure. Perforation and tubercles of iron pipes depend on the pipe material, and the variety of corrosion products that affect service lifetime. Similarly, Figure 4c shows the corrosion crystals of GS pipe having irregular shapes and porous textures due to the formation of pitting at random locations which breaks corrosion films.

Fig. 4. Micrographs of SEM internal pipe corrosions: (a) ductile iron; (b) Galvanized steel pipe and (c) corrosion crystals of GS pipe

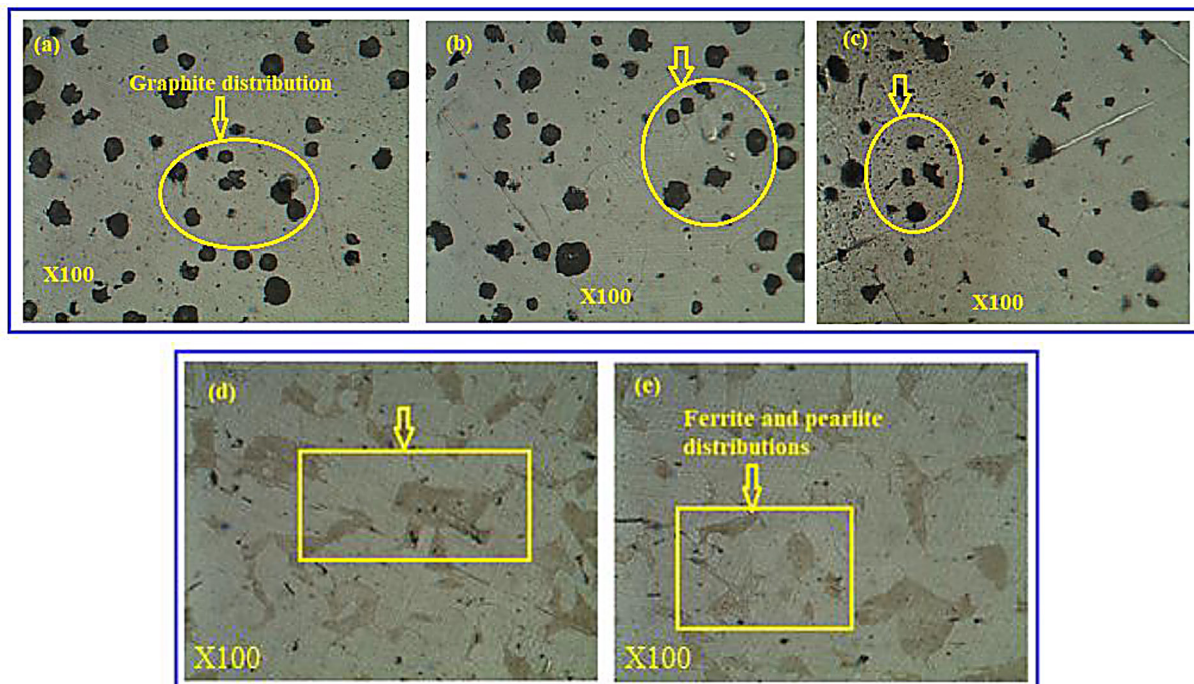
The microstructural analysis is crucial to investigate the presence of defects, inoculants, compositions, and inclusions during manufacture. Figure 5 a–c shows a micrograph of a DCI

pipe consisting of black circles of graphite and white pearlite structures. The tendency of pitting and intergranular corrosion occurring on the surface of DCI, according to OM’s image analysis, is between the surrounding graphite nodules. Similarly, Figure 5d & e depict the microstructure of

Fig. 5. Microstructures: (a–c) Ductile cast iron and (d and e) Galvanized steel pipe

GS pipe, which consists of white pearlite and gray ferrite structures separated by grain boundaries. The carbon content of the tested galvanized steel was 0.087 wt.% presenting ferrite-pearlite microstructures with dominant ferritic structure. Similarly, the tested pipe sample has 0.117% silicon by weight, which improves the tensile strength of the pipe. The grain size and boundaries of the samples were observed as uniform distributions of alloying elements based on optical microscope (OM) analysis. The OM images of X100 magnification present the patterns and distributions of microstructures of the samples. Different magnification can be used to observe more clearly the internal structures, but in this study, X100 was used to investigate distributions of ferrite-pearlite structures.

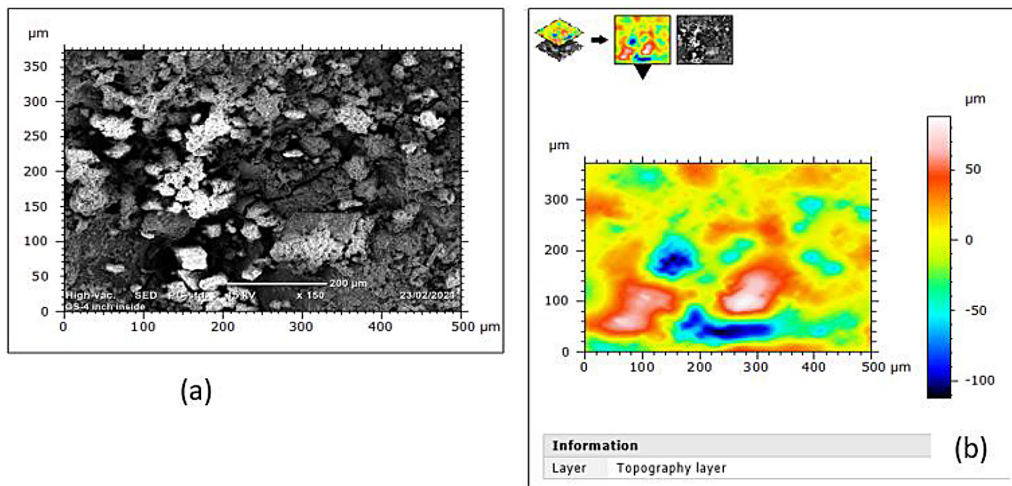
form, and volume based on the watershed segmentation. Figure 6a shows the SEM image morphology of corroded galvanized steel pipe, which was used as the source of image processing to determine pit depth, area, and volume using the software. Similarly, Figure 6b depicts the topography of corrosion-degraded pipe surface filled watershed segmentation with particle boundary in pseudo-color of the surface, which is ready for image processing analysis at the particle level. The blue color represents a more damaged localized surface. Similarly, the red color depicts the top layer of the pipe surface which is going to be damaged layer-by-layer.

Fig. 6. Image processing: (a) true color of SEM view, (b) topography layers

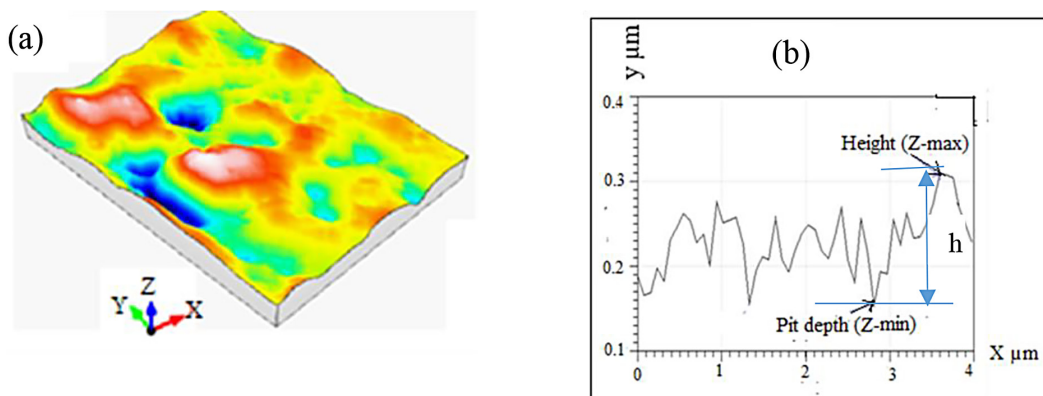
Figure 7a presents a 3D image of corrosion-damaged topography whereas Figure 7b shows the cross-sectional of the sample having details of pit depth. The image processing results produced from Mountains 9 surface analysis software are shown in Figures 8a and b. The result shows that maximum pit depth equals the sum of the maximum peak (Z-max) and valley (Z-min) values, which is 200 μm

Fig. 7. Corrosion morphology characterization of GS pipe: (a) 3D image of watershed segmentation of corroded surface and (b) cross-section of corrosion damaged surface

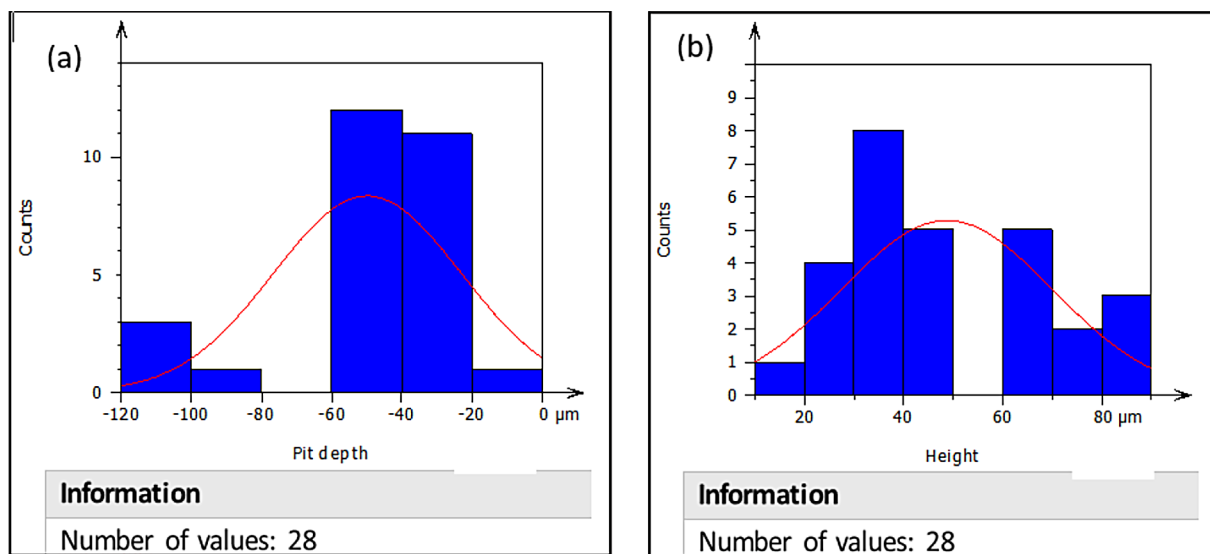
after a 30% loss of original pipe thickness of 5 mm Figure 8. The average pit depth that existed on both internal and external surfaces was evaluated using Eqn. 8 to determine the remaining pipe thickness.

Fig. 8. Result of image processing: (a) pit depth, (b) height (Z-max)

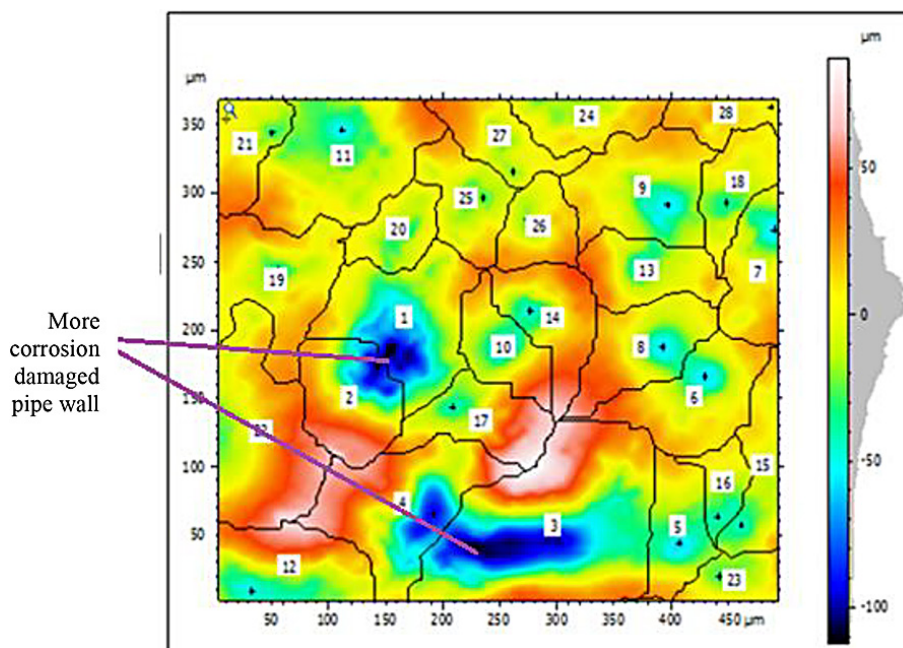
Figure 9 shows watershed segmentation of internal pipe corrosion damage which was generated from the SEM image. The entire surface of the sample is filled with watersheds and divided into

several particles with their boundaries. This is an important condition of image processing to characterize corrosion-damaged surfaces at the particle level. The Figure shows a corrosion-damaged surface that was filled with watershed and studied at the particle level. The particles are colored automatically and divided by grain boundaries. The surface colored with blue, red, and yellow represent the decreasing order of corrosion damage. This method of corrosion characterization is used for determining the state of corrosion on metallic materials at any given time and aids to make decisions to apply corrosion-prevention strategies.

Fig. 9. Watershed segmentation of corrosion damaged GS pipe surface

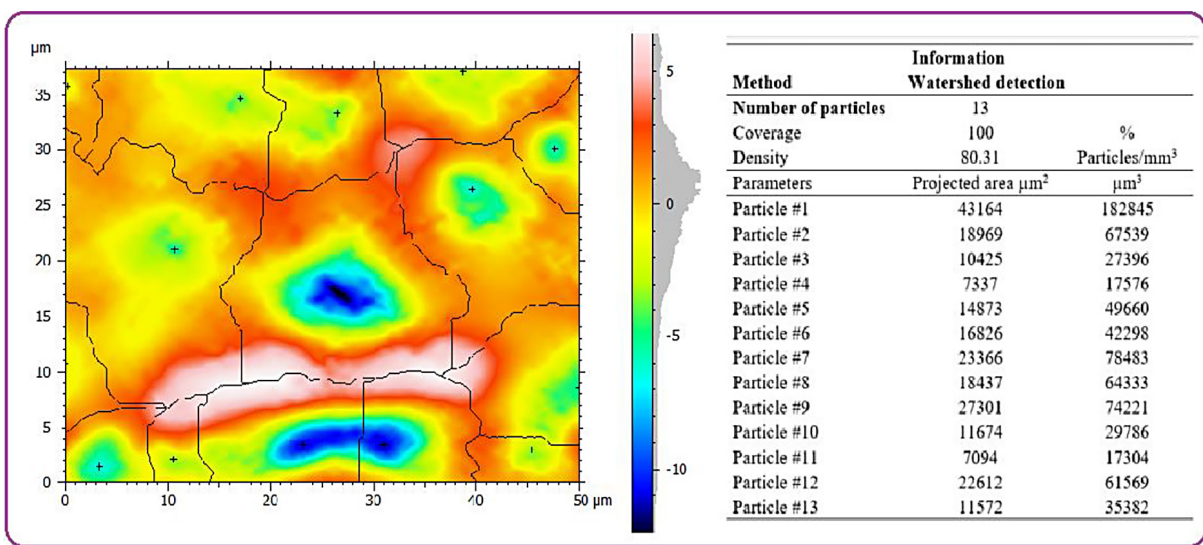
The SEM image was automatically divided by the software into several particles for detailed analyses of corrosion at the particle level. Based on the image processing result, maximum pitting corrosion area and volume are (43164 μm^2) and (182845 μm^3) respectively reported as the rate of corrosion as shown in Figure 10 at particle #1.

Fig. 10. Corrosion pit area and volume per particle (GS) pipe

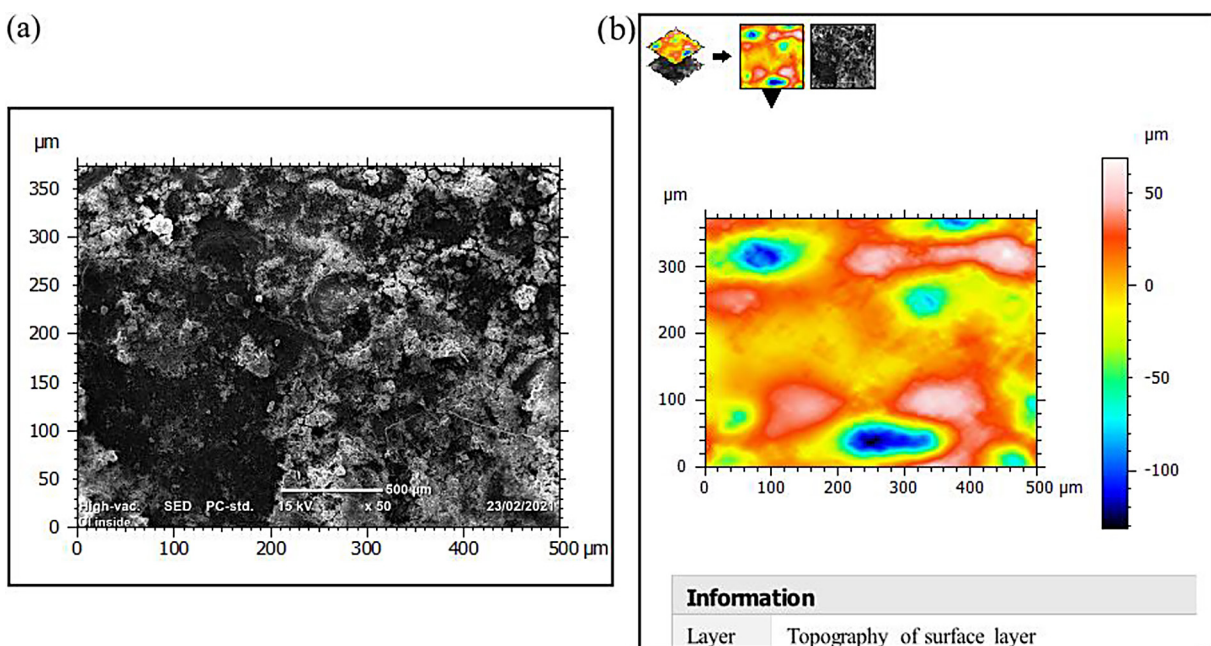
Figures 11 to 14 present corrosion characterizations of ductile cast iron using image processing to investigate corrosion morphology and pitting characteristics. Figure 11a is the SEM image source of the sample with its true color and Figure 11b depicts the topography of corrosion

damaged surface filled by watershed and the status of corrosion damaged surface is isolated by different colors to show that the sample is ready for corrosion characterization. Similarly, Figure 12a shows the 3D form of the watershed surface which describes the loss of the pipe thickness while Figure 12b presents the cross-sectional details of the sample to demonstrate the depth of pit and maximum height remaining on the pipe surface. Figure 13 and 14 also show that the results obtained from image processing in the form of table and bar graphs respectively. The particle analysis of watershed segmentation

Fig. 11. Corrosion characterization of DCI: (a) true color of SEM view, (b) topography layers

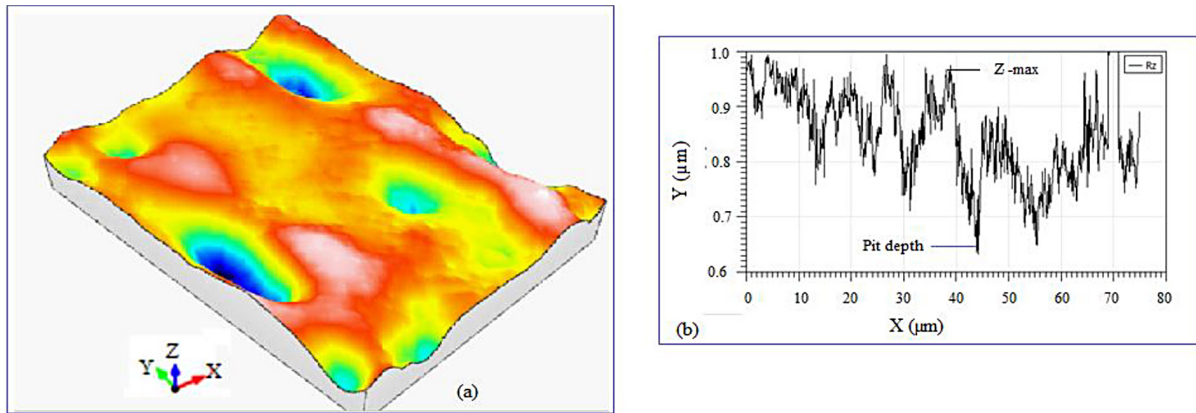
Fig. 12. Corrosion morphology analysis of DCI: (a) 3D image of watershed segmentation of corroded surface and (b) cross-section of corrosion damaged surface

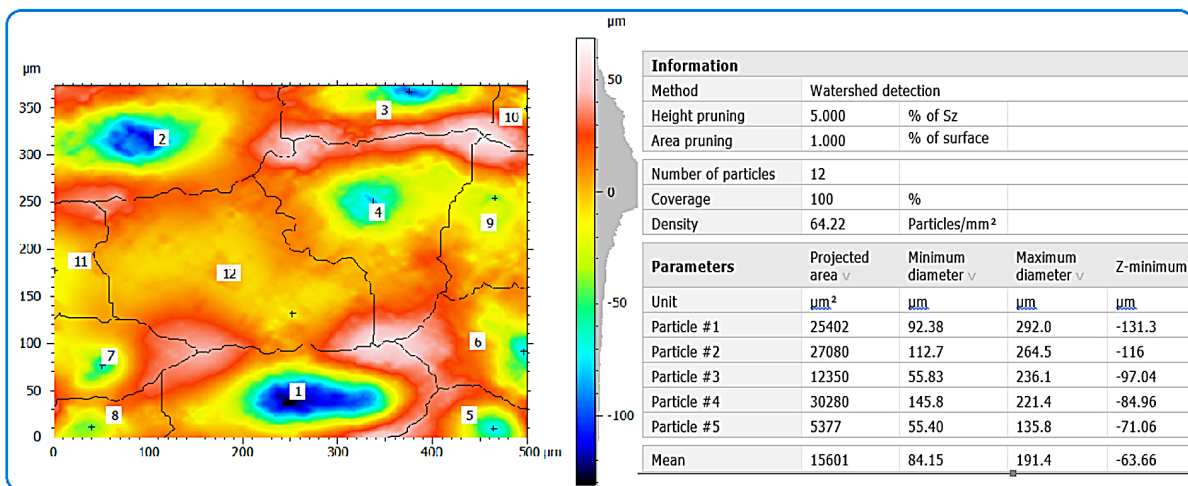
describes the threshold condition of pitting features. The depth of corrosion is 190 μm which is the threshold value after a 30% thickness loss of 8 mm original thickness.

Fig. 13. Watershed segmentation of corrosion showing pit area and depth per particle (DCI)

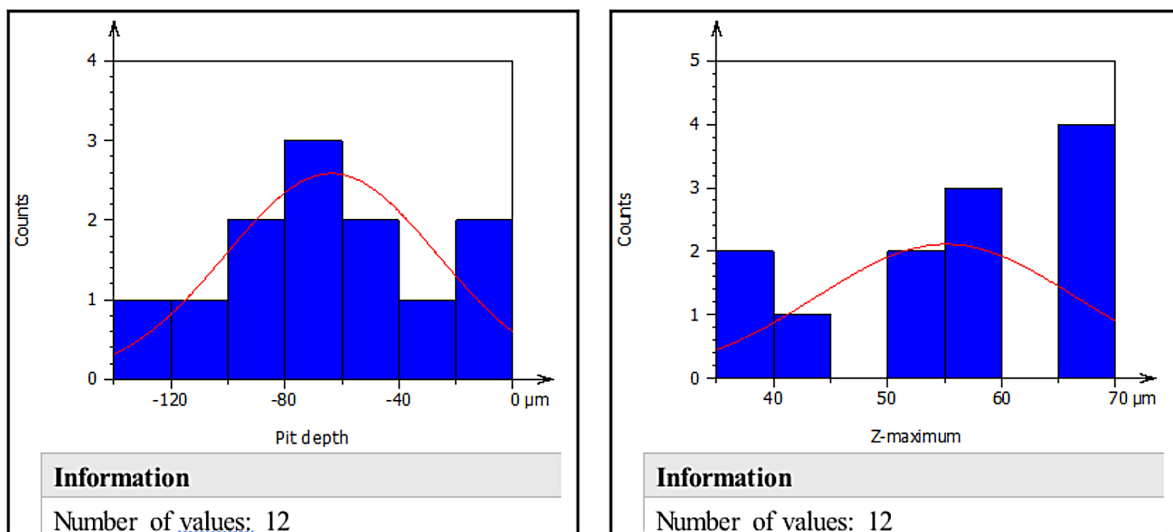
Fig. 14. Result of image processing (a) Pit depth, (b) Height
