Effect of fatigue behaviour on fracture in the 4th gear of a pick-up truck

P. Janmanee, R. Saodaen, C. Thanadngarn, T. Kumnorkaew,
K. Jamkamon, K. Utjimajiratthitikarn *

Purpose: This paper aims to investigate the effect of fatigue behaviour on fracture in the 4th gear (helical gear) of a pick-up truck.

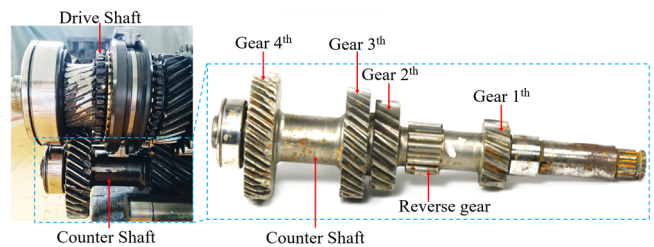
operation of the vehicle may have severe effects on safety, including life and assets. More damage to the gearbox commonly occurred on gear 4th, as shown in Figure 1. Therefore, this study aims to investigate the damage to a helical gear within the gearbox. The pick-up truck has a power of 144 HP. The results of this study will elucidate both the damage mechanism and its underlying causes. The data obtained from this analysis will contribute to vehicle maintenance strategies, with the research outcomes offering a foundation for recommendations and enhancements to improve vehicle reliability.

Fig. 1. Locations of cracks on the 4th gear in the countershaft

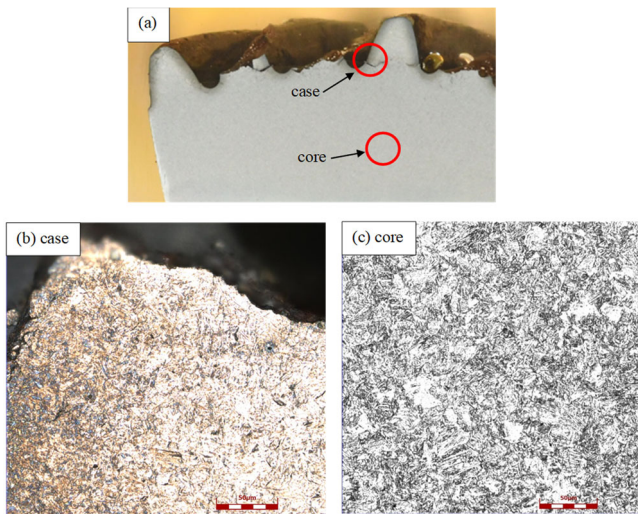
According to metallographic views, optical micrographs of the helical gear presented in Fig. 5 reveal characteristics of cracks over the cross-sectional gear surface and microstructure obtained at specific locations. The locations were pointed out at a case and core of the corresponding surface, as shown in Figure 5(a). It was found that the gear was broken explicitly with the propagation of cracks within the root of a gear tooth. The crack propagation was found from one side to another. In Figures 5(b) and (c), it is obvious that microstructures of the case and core surfaces implied the influence of microstructure on fatigue crack, especially on the gear tooth (case). The microstructure of the case, at the outer periphery region, could be tempered martensite. It may consist of tiny martensite with uniformly dispersed cementite particles embedded within the ferrite matrix. Tempered martensite formed due to stress relaxation caused by heat treatment. Even though this martensite feature was hard and brittle, it was somewhat softened compared to the feature processed by quenching. This subsequently led to improving ductility and toughness of the gear tooth. The microstructure could be upper bainite for the central region (core). The upper bainite is generally stronger but softened than pearlite; therefore, it exhibits a desirable combination of strength and ductility. The structure revealed fine bainitic laths that were more like pearlite, termed 'feathery' bainite, where a shear mechanism at the austenite grain boundaries nucleated it. These microstructures implied that the gear was heat-treated by carburising, quenching, and tempering. The specific heat treatment is a common practice for SCM 420 steel [22].

Fig. 5. Optical micrograph of the helical gear showing (a) characteristics of cracks over the crosssectional gear surface, (b) 500x magnified case area presented tempered martensite microstructure, (c) 500x magnified core area presented upper bainite microstructure

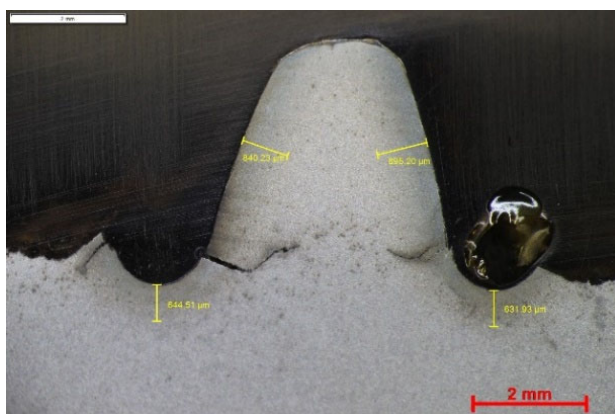
A low magnification micrograph of a failed gear tooth displayed in Figure 6 indicates a different hardened surface finish on the failed gear tooth. The thickness of the hardened layer was approximately 868 μm . The result of excessive tooth loads resulted in root stresses, which were higher than the endurance limit of the material. When gears were loaded and subjected to adequate repeated stress cycles, the gear tooth failed. Stress risers occasionally exacerbate this condition, subjecting the gear to elevated root stress levels beyond typical predictions. These risers encompass elements such as notches in the root fillet, inclusions, minor heat-treatment cracks, and residual stresses [23].

Fig. 6. Different hardened surface layers of the failed gear tooth at 1x magnification

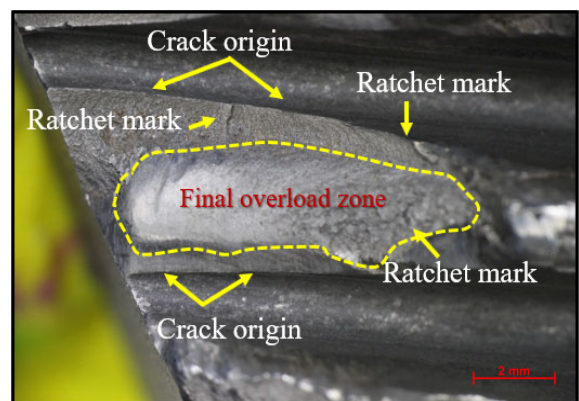
The failed helical gear is presented in Figure 7. The evaluated area consists of crack origin, ratchet mark, and final overload zone. From a morphological aspect, it can be concluded that the failure was initiated at the crack origin and then propagated into the centre. The propagation of crack origin caused the formation of ratchet marks. The ratchet marks presented on the fracture surface indicate that the fracture had multiple origins. The ratchet mark could be due to high stress exerted on the workpiece or the area of high-stress concentration. Eventually, the crack reached the point where the remaining material was overstressed, forming the final overload zone [24].

Fig. 7. The cracking characteristics of the failed helical gear

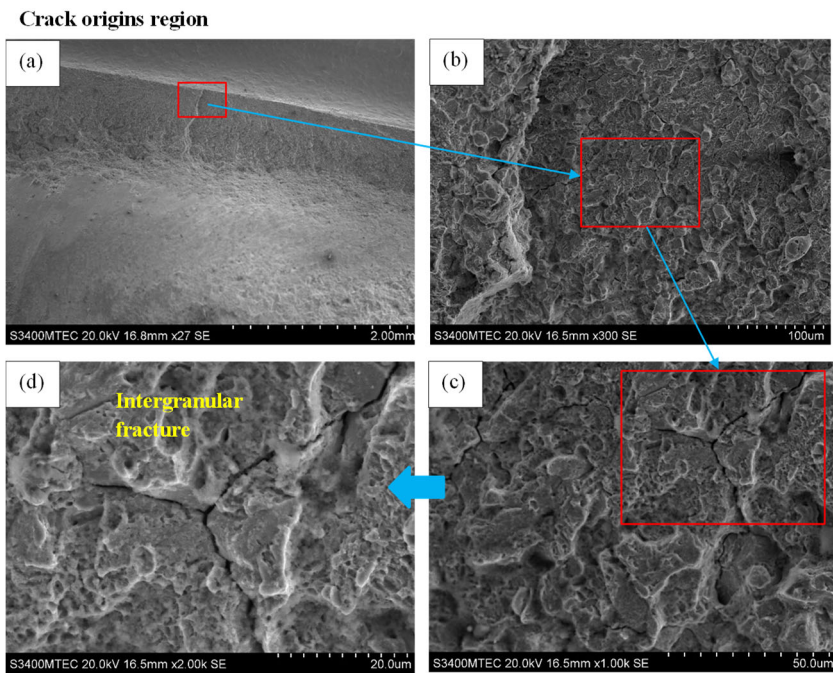
The location of a ratchet mark on the failed gear is presented in Fig. 8 (a). It is indicated that the ratchet mark propagated perpendicularly from the tip edge or crack initiation zone to the instant fracture zone. Several small cracks formed near the ratchet marks were found at higher magnifications, as shown in Fig. 8 (b). In Fig. 8 (c) and (d), the intergranular fracture was presented along a triple junction of grain boundaries. This feature may result from a brittleness of grain structure, leading to increased mechanical properties of the hardened material [25].

Fig. 8. SEM fractographs showing (a) The failed gear outer surface region fracture at 30x magnification, (b) the formation of small cracks near ratchet marks at 300x magnification, (c-d) characteristic of intergranular fracture along a triple junction of grain boundaries at 1.00 kx and 2.00 kx magnifications, respectively

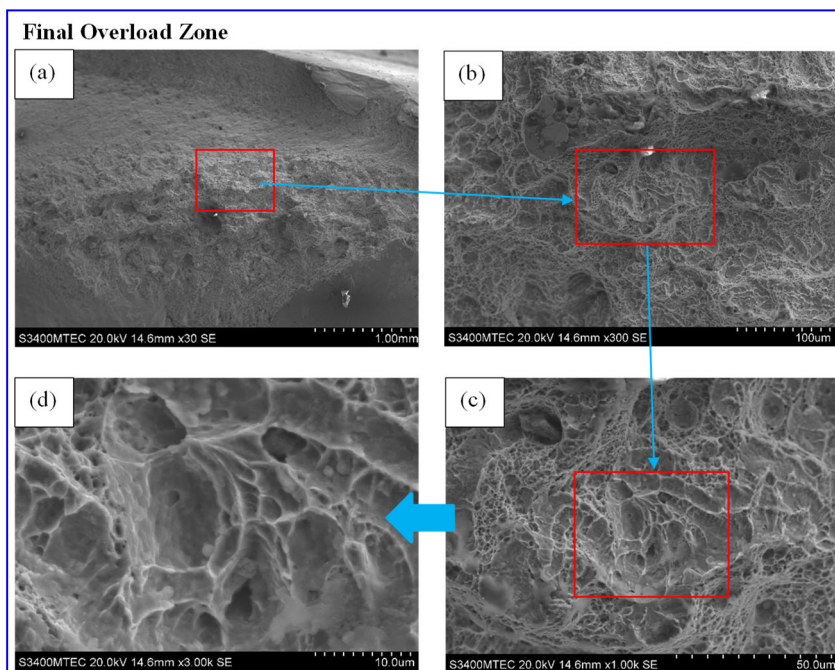
A fractograph shown in Figure 9(a) reveals a fracture tip in the area of the instant fracture zone. It is noteworthy that the ductile fracture was found in the vicinity of the front tip (Fig. 9(b)). This area has high magnification (Fig. 9(c-d)), ductile dimples were formed. The formation of dimples is characteristic of ductile fracture resulting from uniaxial tensile failure. Each dimple developed from micro-voids and subsequently propagated to fracture. Noticeably, the dimples were distorted and formed on 45 angles of the shear lip. A group of dimple distortions assembled into a parabolic C-shape. This specific shape may indicate shear failure, a fracture mode of ductile failure arising from shear load [26].

Fig. 9. SEM fractography showing (a) a fracture tip in the area of the instant fracture zone at 30x magnification, (b) characteristic of ductile fracture in the vicinity of the fracture font tip at 300x magnification, (c-d) formations of dimples into a parabolic C-shape at 1.00 kx and 3.00 kx magnifications, respectively

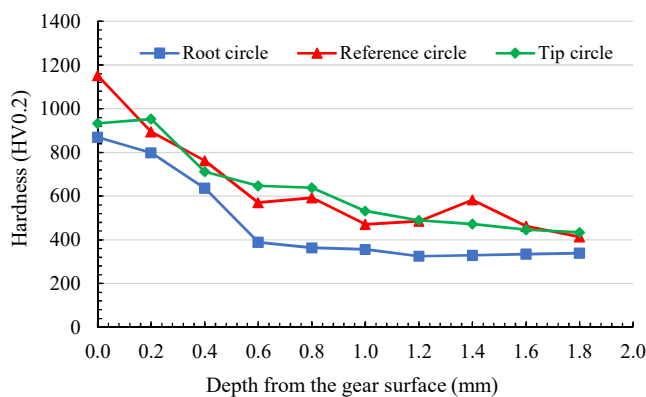
Fig. 11. Hardness distribution profiles obtained across the measured layers of the failed helical gear

Decreasing in hardness values depended on the hardening depth from the gear surface. The maximum values obtained at the tip, reference, and root circle were 933 HV, 1152.57 HV, and 870 HV, respectively. Meanwhile, the minimum values measured at the tip circle, reference circle, and root circle were 434 HV, 414 HV, and 339 HV, respectively. The maximum values of all profiles were

explicitly found at the outer surface (case), whereas the minimum values were raised at areas towards the gear centre (core). The results show that the hardness values of some areas of the gear were somewhat different depending on the hardening depth. It was because of the effect of heat treatment caused by carburising and hardening treatments. The tempering process might be a major cause of gear failure [27].

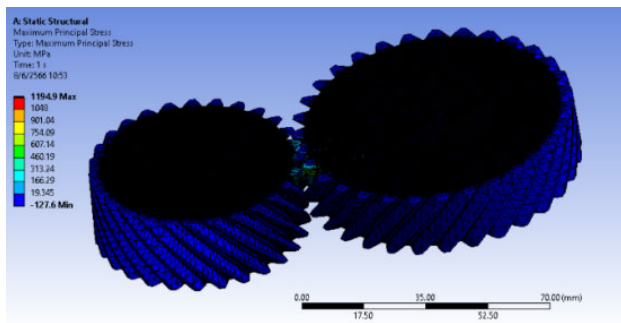
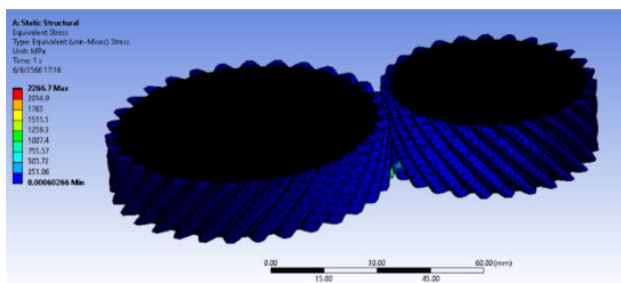
For the simulation results, stress distributions over the simulated results can be seen in Figures 12 and 13. In contrast, the deformation gradient on a simulated result can be visible in Figure 14. The maximum principal stress was 1194.9 MPa, which was close to the calculated bending stress. The bending stress values increased with increasing torque. The increased values were in close agreement with those obtained from the AGMA equation. According to Figure 13, the maximum equivalent stress was 2266.7 MPa, located near the tangential transmitted load. Such a value at the highest-stress density area was 12.48 kN. The simulated result was closely related to contact stress obtained from the calculated result. The contact stress started from the surface of a gear tooth. The bending stress was developed toward the central axis of the gear. The development of bending stress could lead to the formation of the contact stress. Hence, the final fracture occurs when the torque exceeds the contact strength of 1550 MPa [19]. The calculated contact stress due to general operation was 1.46 times higher than the allowable contact strength.

Fig. 12. Distributions of maximum principal stress on the Finite Element (FE) model

Fig. 13. Distributions of equivalent Von Mises stress on the Finite Element (FE) model

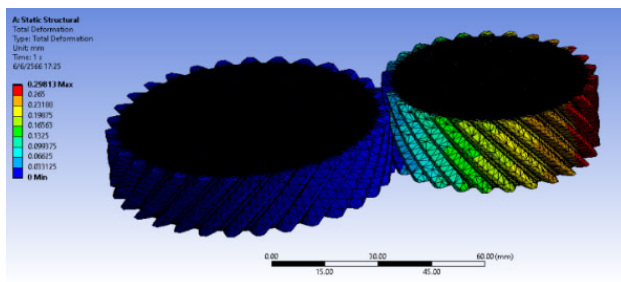
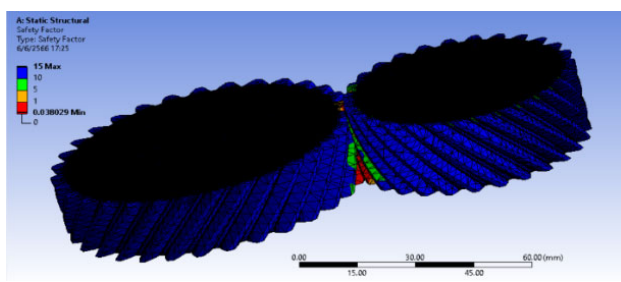
In Figure 14, the total deformation was 0.29813 mm, and Figure 15 shows the distribution of safety factors. The minimum value of 2.80 was presented on an oblique angle of the gear tooth. The calculated and FE simulation results are very similar [6,20,21,28,29].

Fig. 14. Distributions of total deformation on the Finite Element (FE) model

Fig. 15. Distributions of safety factors on the Finite Element (FE) model
