APPLICATION OF INCLINOMETER MEASUREMENTS FOR RELATIVE HORIZONTAL DISPLACEMENT INVESTIGATIONS ON LANDSLIDE GROUNDS

Ryszar Malarski, Kamil Nagórski, Marek Woźniak

Warsaw University of Technology
Faculty of Geodesy and Cartography
Department of Engineering Surveying
Warsaw, Poland

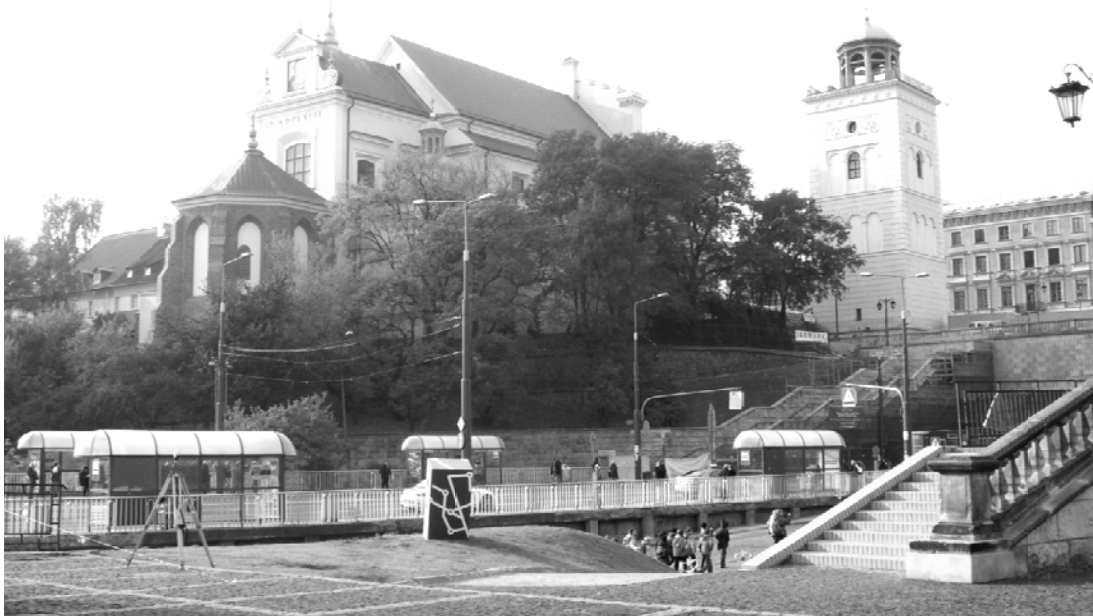
Fig. 1. A view of the church, the Gothic apse with buttresses and baroque gable dated back to 1667

Last years St Anna's Church has its difficult time again. Slits and fractures appeared on its floor, walls and vaults.

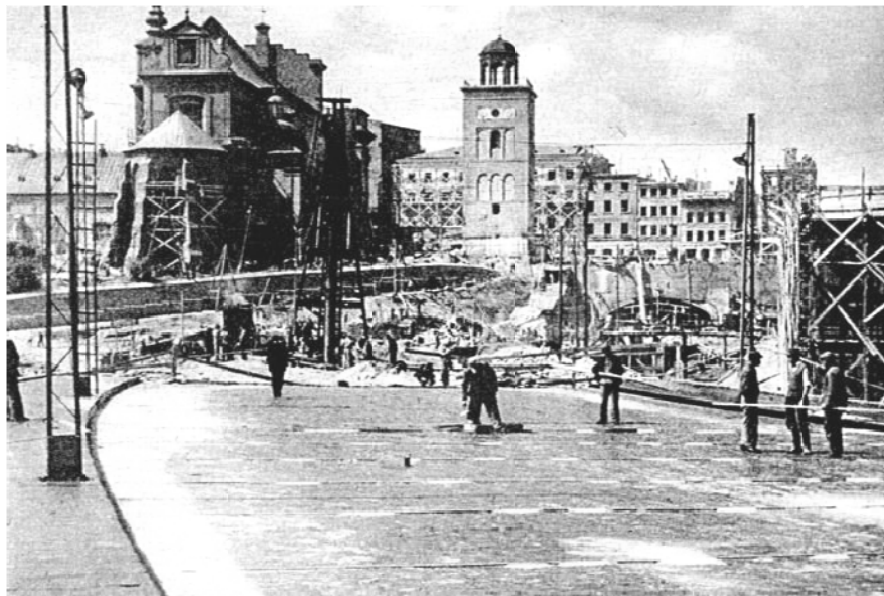
In 1949, during the construction of Warsaw's East-West Route, due to a failure to secure the slopes of a deep excavation, the walls and vaults of the church were cracked as deep as the foundation level. The apse and the north-eastern part of the church were slowly coming down. The immediate intervention of a commission of experts of various professions prevented the church from collapsing. The ground around the structure was reinforced with steel-concrete posts and electroosmosis, its foundations were embraced with reinforced concrete, and concrete retaining wall were built on excavation side.

Fig.2. View of the St. Ann's Church during the construction of Warsaw's East-West Route in 1949 (*origin PAP*)

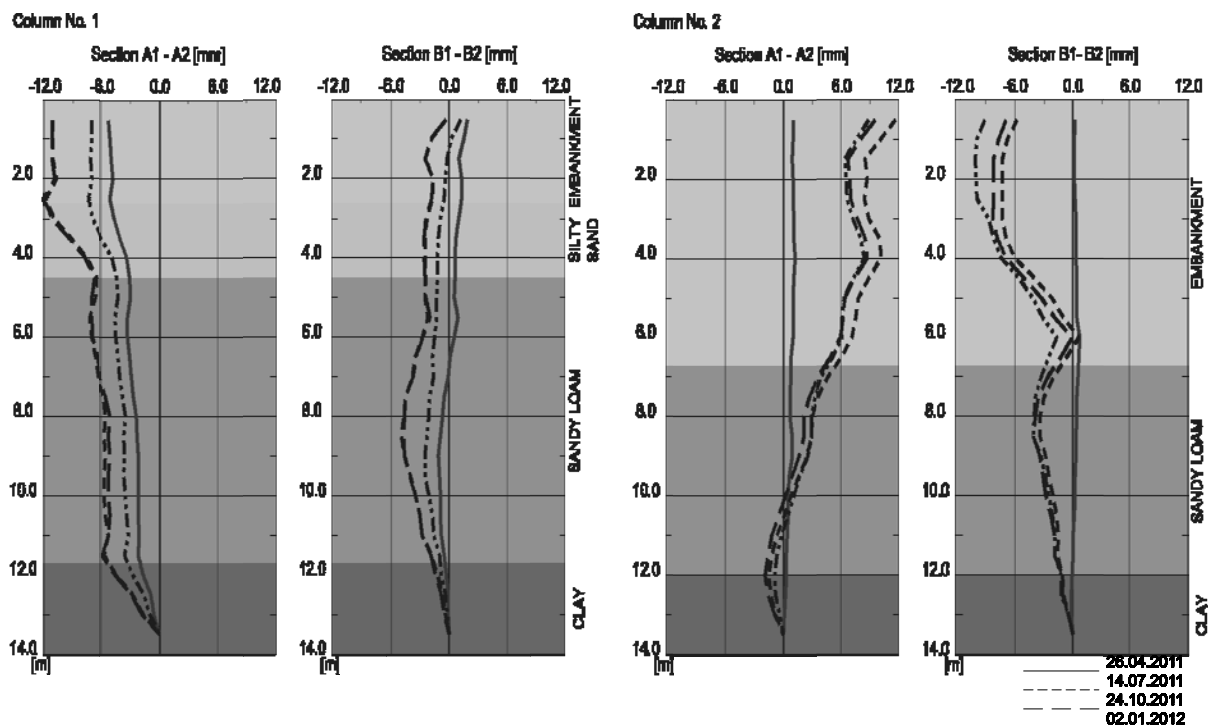
Fig. 4. The graphs of horizontal displacement in relation to hill side foot

Observations of inclinometer No.1 indicate relative horizontal ground displacements. It is well seen from diagram in Fig. 4 a displacement trend due to heavy rainfall spell, which subsides during the period from July to October.

Data collected with inclinometer No.2 indicate existence of relative ground displacement. Displacement trends towards retaining wall are distinct. In the period from October 2011 up to January 2012 reverse trend is evident. In the upper part of column sheltered by 5.5 m thick retaining and unsheltered (exposed) part at 3m height could be explained by thermal expansion. One has to notice that ground consists mainly of sand and brick rubble in this area. Noticeably, there is change of displacement trend from the base of column at the depth of 11.5 m cross section A1-A2 and for cross section B1-B2 at the depth of 9m. It is supposed that the column gets through a layer of Tertiary Period silty clay. Relative horizontal displacements referring to level depth of 11.5 m are presented in Fig 5.

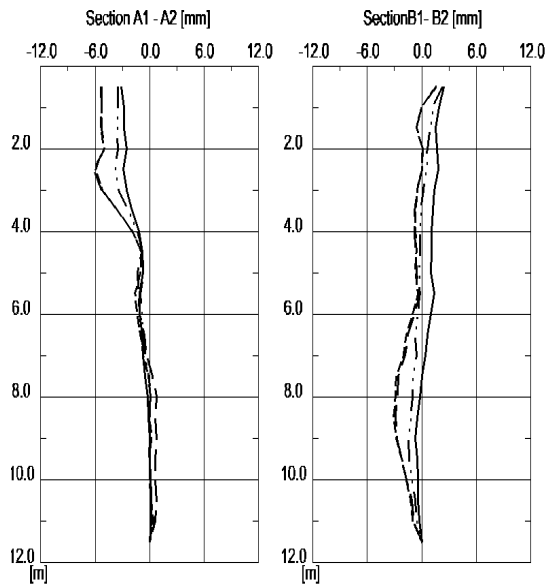
In case of positioning column No.1 at the same reference level instead of column No.2 any significant change in displacement of ground at the adjacent layers of clay and sandy loam could have been found.

Fig 5. The graph of relative horizontal displacements referring to level depth of 11.5 m in column No.1

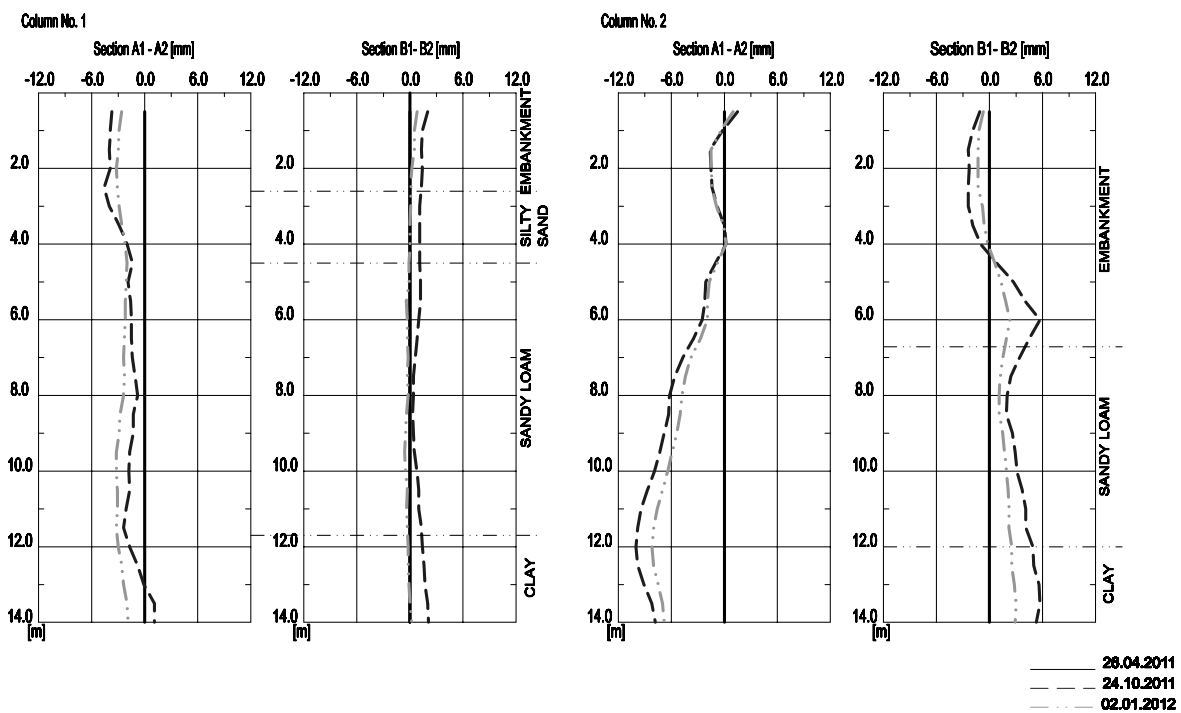
Taking comparison between relative displacements [Fig 4] and absolute displacements [Fig 6] one can easily notice that detected changes take place in a clay layer spread over several meters under ground surface.

Fig. 6. The graphs of absolute horizontal displacements in column No.1 and No.2

Inclinometer observations should be extended and supplemented by absolute horizontal displacement measurements of inclinometer head to asses thoroughly ground position changes.
