## **SOBIESKI PALACE IN LUBLIN AFTER THE ASSESSMENT OF THE EXISTING CONDITION. RESTORATION AND MODERNIZATION PROJECT**

**Keywords:** Sobieski Palace in Lublin, the Technical University of Lublin,  
place identity, modernisation of a historic building

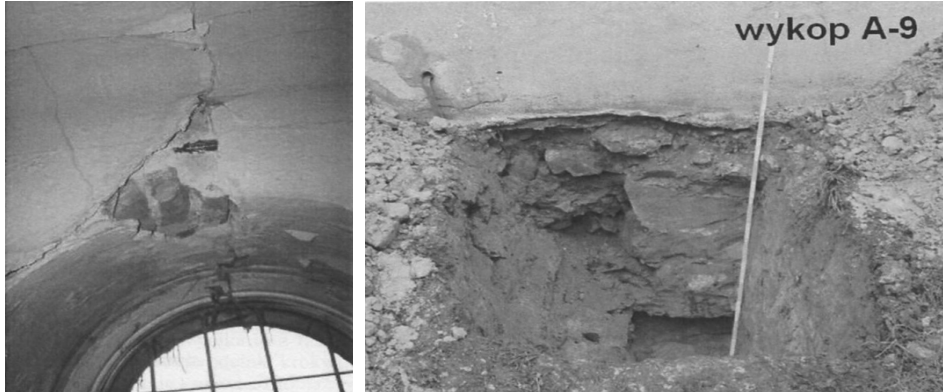
The foundations are made of full ceramic bricks on lime mortar (tower) and limestone (wings). They are in an unsatisfactory condition due to moisture, corrosion of the ceramic and limestone materials, the lack of isolation and shallow foundation (in extreme cases, above the frozen soil zone). They require a complex analysis, and then concrete foundation needs to be performed of the widths adjusted to the designed loads after the reconstruction.

There are numerous reasons for the cracks and subsidence of the walls and foundation. The historic background may be considered as one of them (a heterogeneous structure, the lack of expansion joints). Also, various foundation levels of walls, shallow foundation, as well as uneven loading of the subsoil contributed to the mentioned damages.

Fig. 3. Lintel with a visible crack exposing the reinforcing steel, 5<sup>th</sup> floor (tower) [4].

Fig. 4. Dig A-9 from the courtyard. Visible stone wall corroded surface, with losses of stone and corroded mortar, no insulation [4].
