## **STRUCTURE STUDIES OF POROUS OXIDE LAYERS FORMED ON 13CrMo4-5 STEELS LONG-TERM OPERATED IN THE POWER INDUSTRY**

*Monika Gwoździk*

The paper contains results of studies on the formation of oxide layers on 13CrMo4-5 steel long-term operated at an elevated temperature. The material studied comprised specimens of 13CrMo4-5 steel operated at the temperature of 455°C during 130,000 hours (steel 1) and 540°C during 120,000 hours (steel 2). The oxide layer was studied on a surface and a cross-section at the outer surface of the tube wall. The paper contains results of studies of porosity in the oxide layer. The oxide layer formed on the studied steel 1 is ~146 μm thick, while on the steel 2 ~248 μm. It has been found that steel 2 has higher porosity.

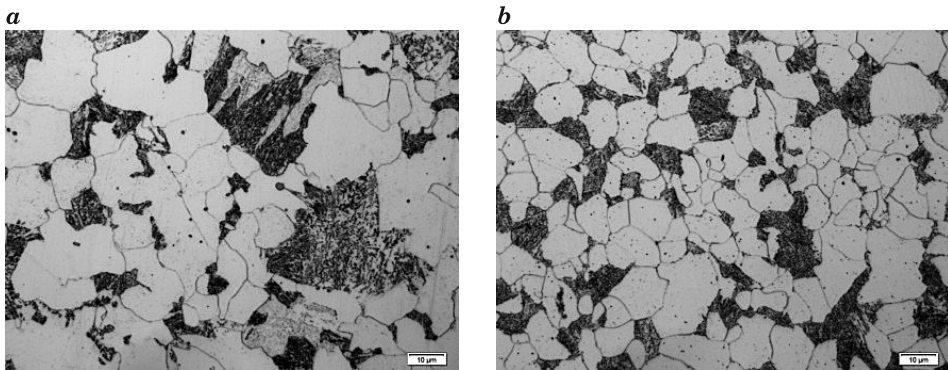
Steels 1 and 2 have the same structure, which is ferrite, perlite and bainite (Fig. 2). For steel 1 it was observed that the size of the grain is diversified and the elements of the structure are unequally placed. In addition, in this steel there are sporadic sulphide precipitates which occur both inside and on the grain boundaries (Fig. 2a). The structure of steel 2 is characterized by a large amount of carbide precipitates both inside and on the grain boundaries. The carbides which occur on the grain boundaries create so-called “chains” (Fig. 2b).

Fig. 2. Microstructure of 13CrMo4-5 steel, LM, 1000x: *a* – steel 1, *b* – steel 2

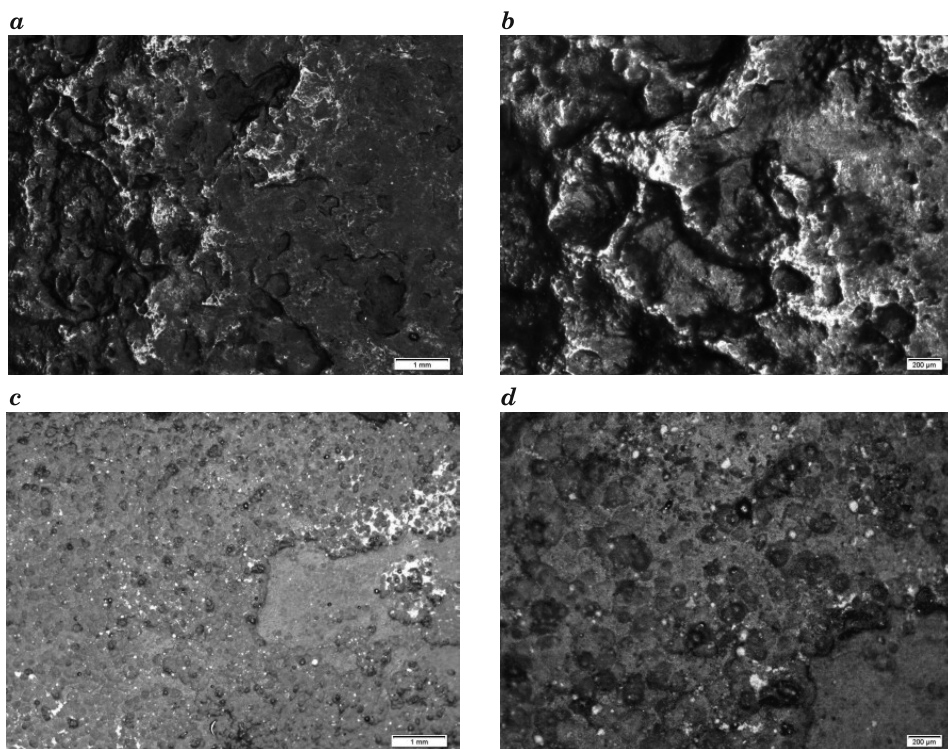
The macroscopic observation of the examined surfaces (Fig. 3) showed that in both cases the significant development level of the surfaces and the outer layer damages occur.

Fig. 3. Oxides formed on 13CrMo4-5 steel, outer surface, LM: *a* – steel 1, 15x, *b* – steel 1, 45x, *c* – steel 2, 15x, *d* – steel 2, 45x

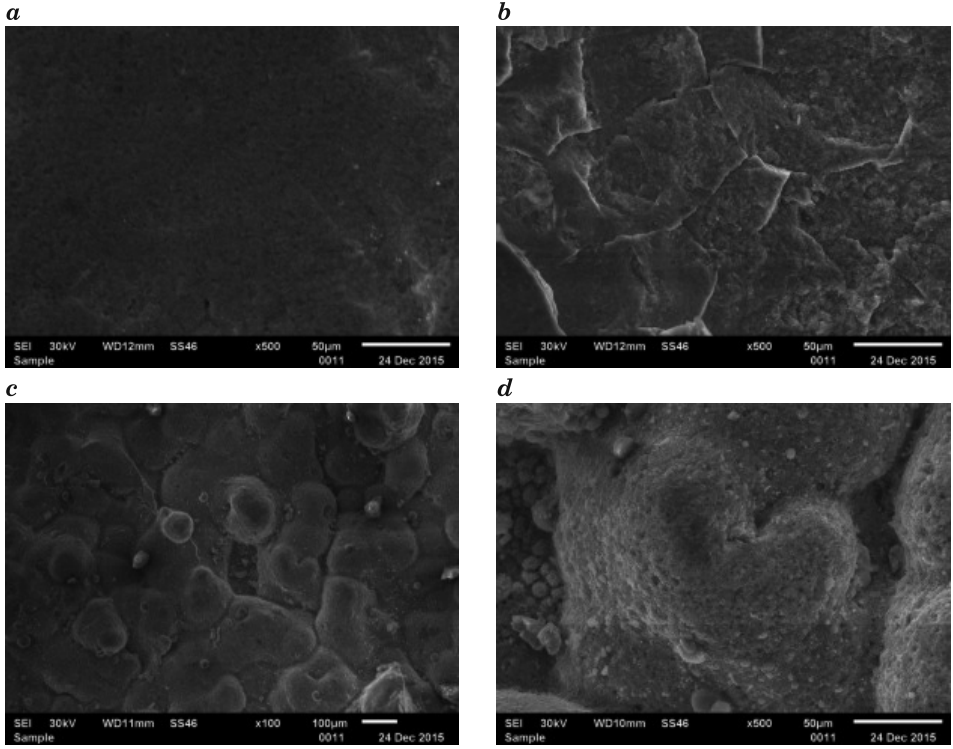
Observations of the oxide layer surface by means of scanning electron microscopy have shown that in the case of steel 1 there are oxide areas without damage, presented in Fig. 4a. In turn, Fig. 4b presents a damaged oxide layer from the same steel. Damaged areas of the layer, which are crystalline in nature, are visible. Figs. 4c and d present the oxide surface formed on steel 2. A significant surface development may be observed on this steel. Also deposits exist, apart from the oxide layer, confirmed by the EDS analysis (Fig. 5).

Fig. 4. Oxides formed on 13CrMo4-5 steel, outer surface, SEM: *a, b* – steel 1, 500x, *c* – steel 2, 100x, *d* – steel 2, 500x

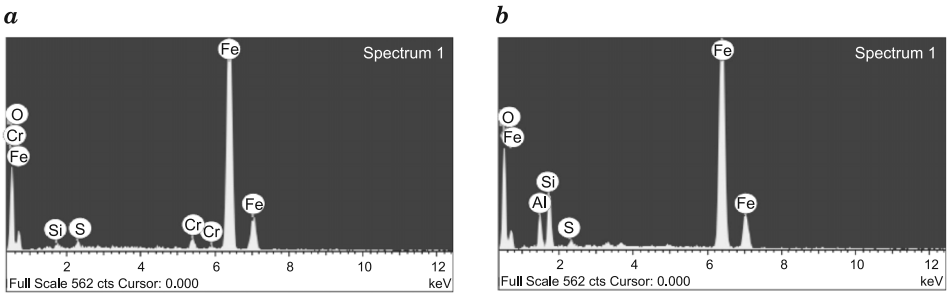
Performed XRD measurements (Fig. 6) have shown that in both cases (steel 1 and 2) the oxide layer is built of hematite ( $\text{Fe}_2\text{O}_3$ ) and magnetite ( $\text{Fe}_3\text{O}_4$ ). Moreover, the EDS analysis in both cases have shown the existence of Si and additionally – for steel 2 – of Al. These elements form such compounds as  $\text{SiO}_2$  and  $\text{Al}_2\text{O}_3$ , which are components of hard coal ashes.

Fig. 5. SEM / EDS: *a* – steel 1, *b* – steel 2

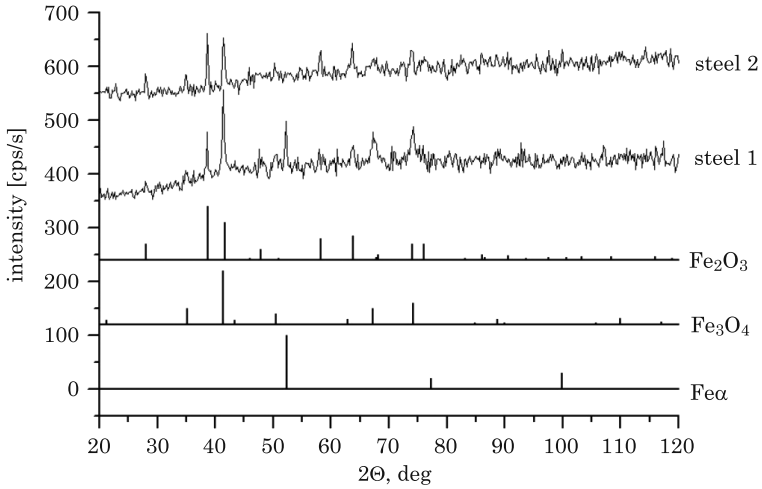
Fig. 6. X-ray diffraction patterns from the oxides layer obtained by means of XRD technique

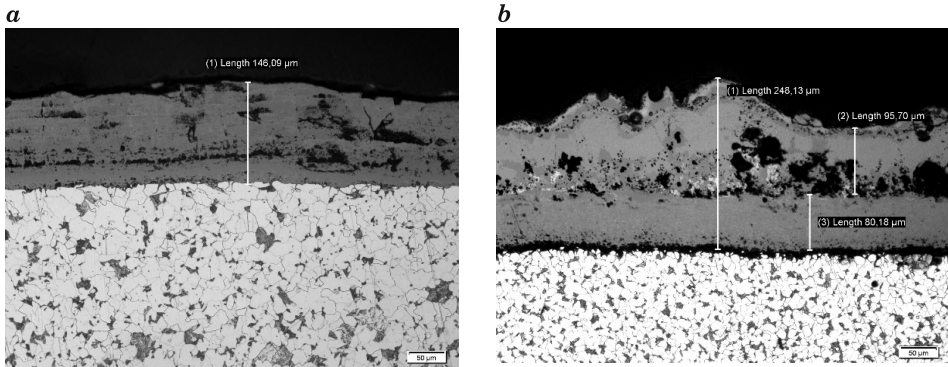
Observations of metallographic microsections made on a cross-section have shown that for steel 1 the oxide layer was  $\sim 146 \mu\text{m}$  thick (Fig. 7a), while for steel 2 it was  $100 \mu\text{m}$  thicker and was  $\sim 248 \mu\text{m}$  (Fig. 7b).

Fig. 7. The thickness of oxide layer formed on the steel examined, LM, 200x: *a* – steel 1, *b* – steel 2

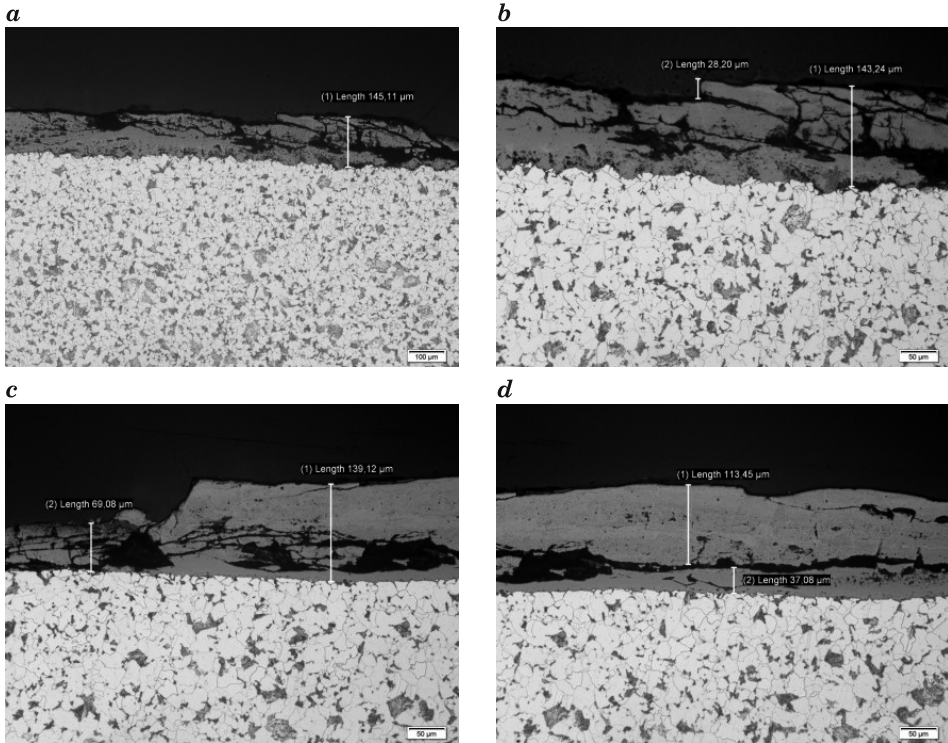
In the case of steel 1 (Fig. 8) the amount of defects in the formed layer is much smaller than for steel 2 (Fig. 9). The oxide layer formed on steel 1 shows local damage in the form of numerous cracks, which locally create a network on the entire layer cross-section (Fig. 8a, b). Large fissures originate in places and fine porosity exists locally. In turn steel 2 features a great degradation (Fig. 9). In some places the oxide layer is entirely separated from the substrate, which is shown in Fig. 9a. Also huge fissures occur, reaching the depth of  $70 \mu\text{m}$  (Fig. 9b). The oxide layer on steel 2 is mostly torn off and cracked (Fig. 9c). In addition, in steel 2 directly on the steel side there is major corrosion along grain boundaries, reaching the depth of  $15 \mu\text{m}$  (Fig. 10). Abang and others in paper (ABANG et al. 2011) showed that, under both operating conditions the surface layer was characterised by loosely attached formations of ash that were partially flaked. The outer layer of corrosion was covered with many tiny pores. Apart from the tiny pores under oxyfuel conditions, the inner layer of corrosion also had a few large pores.

Fig. 8. Defects of oxides layer existing on steel 1

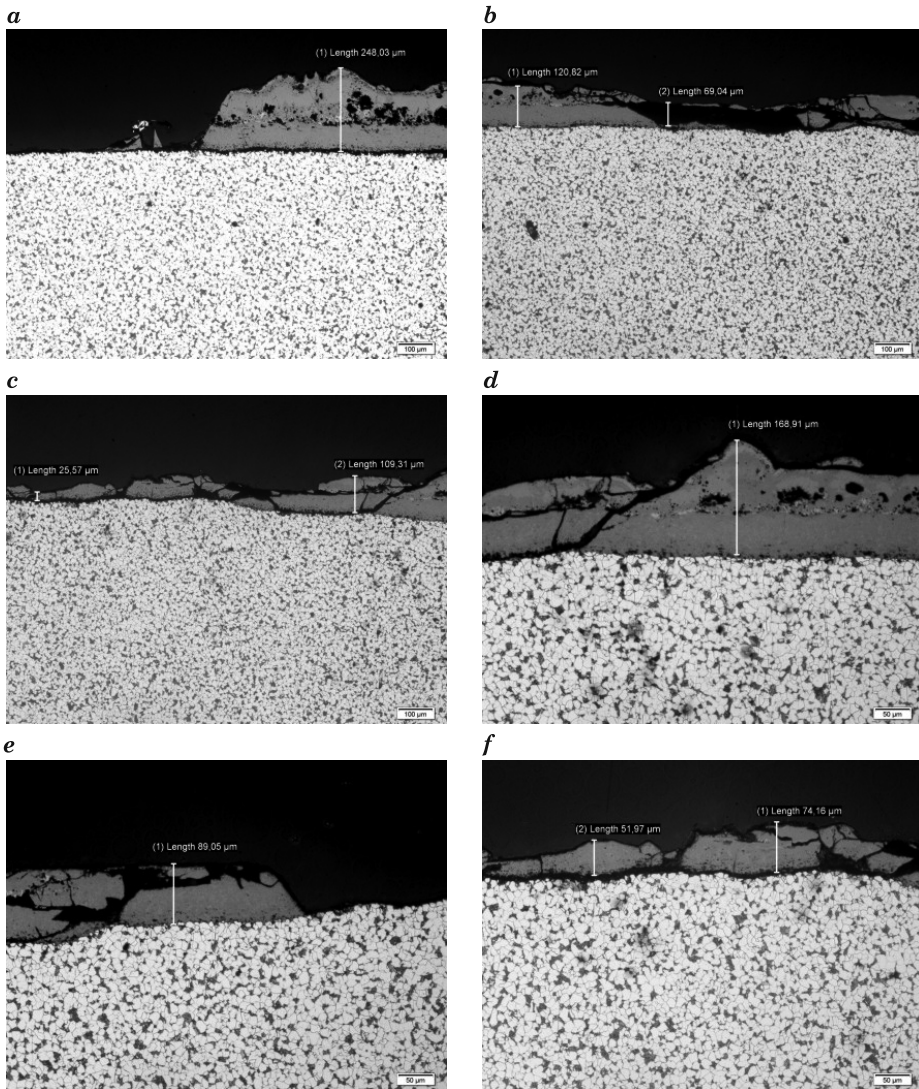
Fig. 9. Defects of oxides layer existing on steel 2

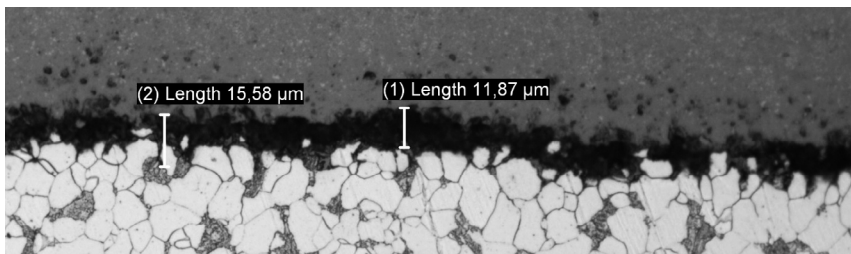
Fig. 10. Corrosion on the grain boundaries at the outside surface, 500x
