## The impact of design and executive errors affecting the damage to the floor of the concert hall

**Purpose:** The aim of the article is to demonstrate the influence of errors and performance errors that affect the damage to the concert hall floor.

**Design/methodology/approach:** When the project was launched, cracks appeared which made the floor unsuitable for further use. In order to determine the cause of the damage, the team conducted a detailed structural health analysis.

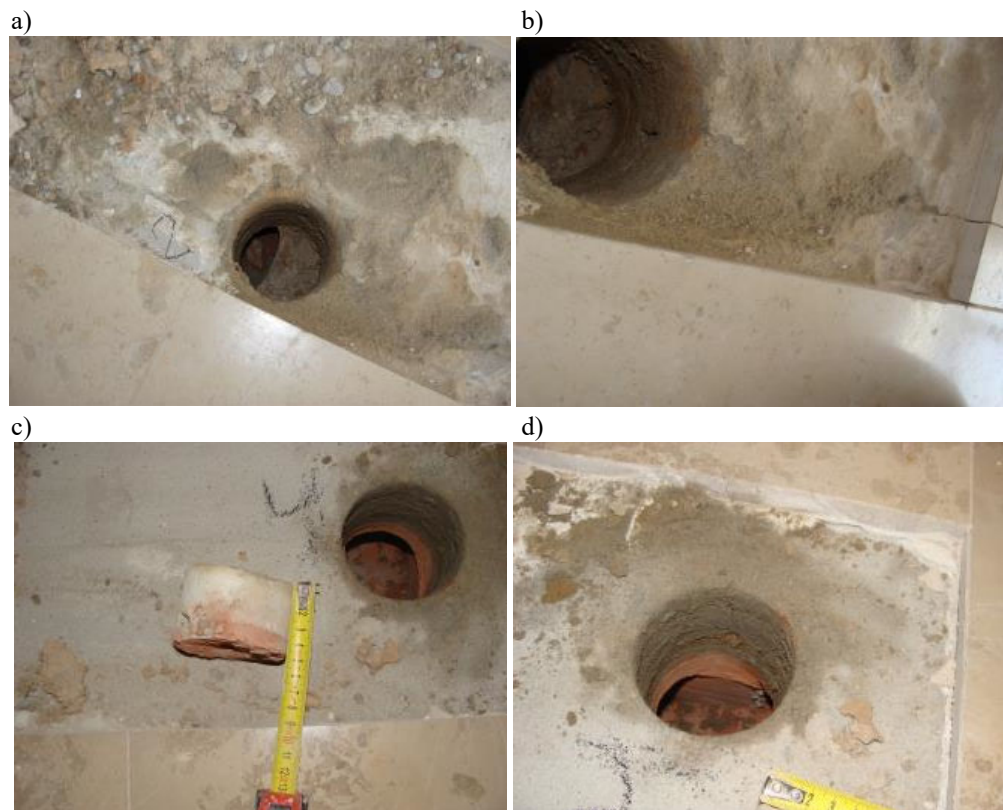
In order to verify the actual state of the layout of the floor layers engineers took five different outcrops from the top level of the floor cavity blocks (Fig. 1).

Basing on the outcrops it was established that premises of the statistical formulas attached to project documentation of a building redevelopment were incorrect. Thickness of ceiling concrete Ackerman is ~ 3 cm (see Fig. 1c) while in the project estimation [8] and technical expertise preceding the renovation [9] it was assumed to be 9 cm. It significantly increased arm of span bending and thereby overstated lifting capacity of the floor (load-bearing capacity of this floor). Internal forces arm for span bending that was used in project calculations is 23.0 cm and the actual one calculated for the analysed outcrops is – 18.5cm which means reduction of this arm the by over 24%.

Additionally, floor layers done by construction team aren't consistent with project documentation. Project specification [8] calls for 7 cm stabilized sand with a characteristic load 1.33 kN/m<sup>2</sup> when in reality there's an average of 6.5 cm of concrete screed and average of 1.0 cm of glue mass which is the characteristic load 1.74 kN/m<sup>2</sup>.

- cement and lime plaster – 1.5 cm,
- Ackerman ceiling – 21 cm,
- screed (gentry) – 4 cm
- fibreboards and vapor barrier – 1.0 cm,
- concrete screed – 6.5 cm,
- adhesive mortar – 1.0 cm,
- stone floor – 2.0 cm.

Fig. 1. Examples of outcrops from floor layers: a, b) no 2, c, d) no 4

- cracks on the stone-slabs of the floor are consisted with cracks of the layers of adhesive and base surface – execution fault (finishing works),
- layout of the floor layers is inconsistent with project documentation which overloaded the supporting

structure of the Ackerman ceiling, including payload (of the crowd of people) that was taken into account – execution and design faults

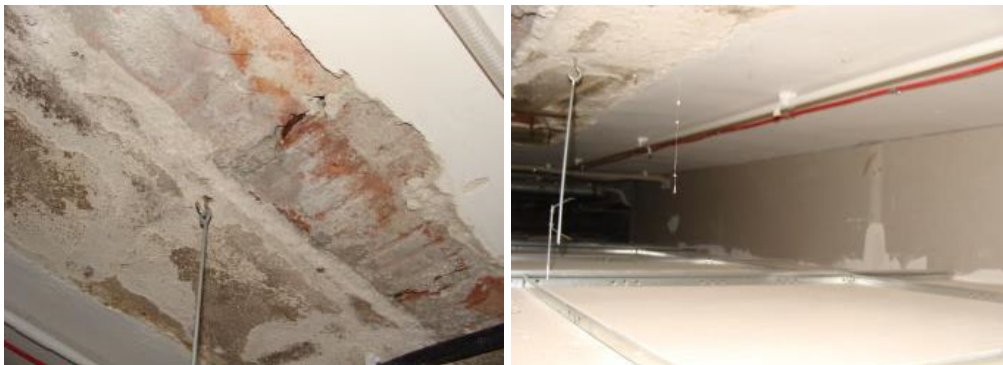
Fig. 2. View at the construction of Ackerman ceiling from the bottom

Engineers assessed the technical condition of inter-story ceiling during the site inspection, looking at it from the bottom of the construction – Figure 2.

Looking at the bottom of the construction engineers didn't notice any signs of damage on the supporting structure – suspended ceiling and electrical installation are attached to the it. Ferromagnetic device was used to measure the thickness of jacket on reinforcing bars (cover of reinforcing bars) which is 2.0 cm and the diameter of reinforcing bars of ceiling ribs was 10 mm.

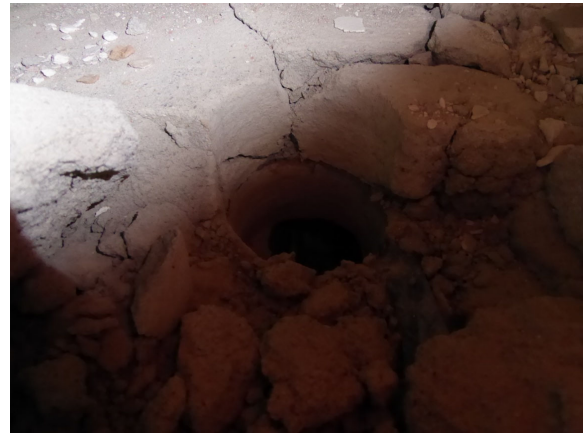
The process of reparation work carried on the floor was being monitored to make sure it was executed according to the project recommendations. Assumptions that were made during the expert evaluation of discrepancies of the actual

layout of the floor compared to project documentation were confirmed as seen on the Figure 3 demolition area below.

Fig. 3. View on floor layers during scheduled demolition work

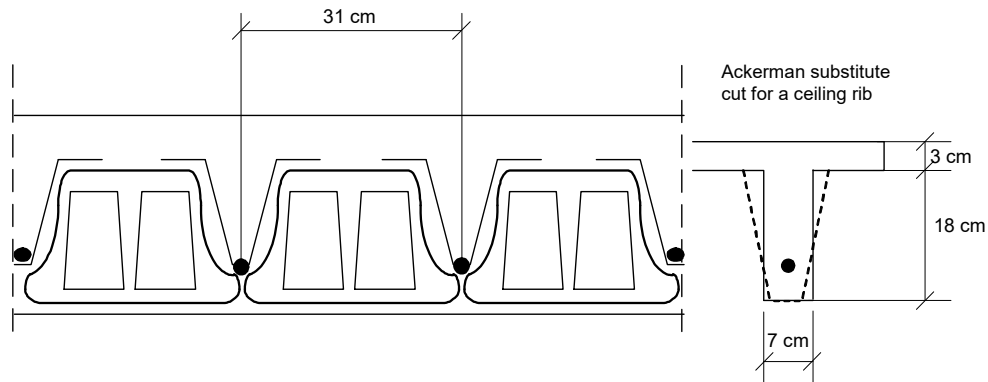
Engineers performed new calculations for load capacity of the Ackerman ceiling and agreed on geometrical representation of the floor intersection as in Figure 4.

Fig. 4. Adoption of the equivalent intersection of the Ackerman ceiling rib

hence the reserve of load capacity for service loads was:  $0.34 \text{ kNm}$  per floor rib. The value of the design utility loads was  $1.22 \text{ kN/m}^2$  – the design assumed  $3.90 \text{ kN/m}^2$ .

All four solutions for the new layout of floor layers on Ackerman ceiling involved replacement of the stone-slabs floor. Engineers recommended the third solution from the list which offered possibly the greatest load relief for the ceiling structure biggest relief of the surface bedrock construction. Based on the control computations and on the grounds of the technical evaluation that was carried out, it was recommended to put the concert hall out of use until the reconstructive work was completed. Adding designed imposed loads (payload) to possible weight of a crowd attending a concert and a dead weight of the existing floor construction could create a risk of construction disaster. Engineers advised to carry a continuous technical supervision while the floor was being renovated. Its results confirmed engineers' conclusions from the expert opinion that was shared when the project team investigated the discrepancies between the actual state of the construction layers and the project documentations and t thickness of the concrete overlay.
