## Analysis of damage to medium and low voltage cable lines in tram traction stations – maintenance experience

Andrzej Adamkiewicz<sup>1</sup>, Mariusz Haraburda<sup>2</sup>

<sup>1</sup> Maritime University of Szczecin, Faculty of Mechanical Engineering  
Diagnostics and Machine Repairs Department  
70-205 Szczecin, ul. Podgórna 51/53, e-mail: a.adamkiewicz@am.szczecin.pl

<sup>2</sup> Trams Szczecin Ltd.  
ul. Klonowica 5, 71-241 Szczecin, e-mail: marhar@ts.szczecin.pl

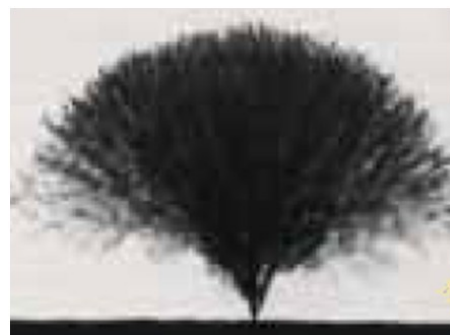
- degradation in micro cracks and gas inclusions of the insulation;
- degradation throughout treeing – see the example shown in figure 6;
- degradation of insulation surface;
- degradation due to discharges in oil [10, 11, 12].

Fig. 6. View of water treeing in polyethylene insulation of a cable [8]

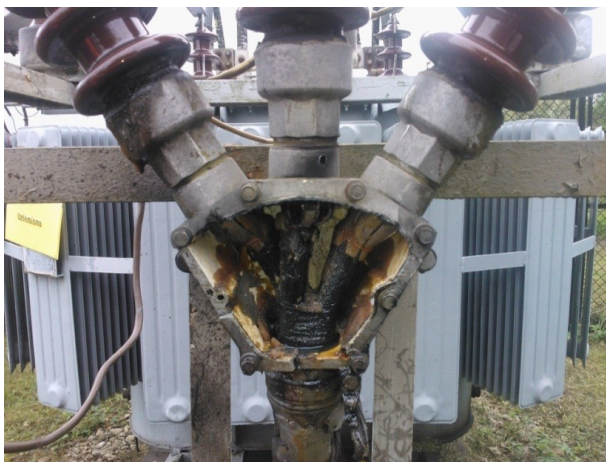
In the majority of cases, aging processes are responsible for the causes of damage in cable heads. In particular, in the case of external heads the main causes of damage are: high humidity and high temperature; in summer months daily amplitudes of temperature and switching overvoltage. Then damage usually entails their total destruction as a result of an explosion whose consequences can be seen in the figure 7 (visible place of breakdown in the column of L2 phase, the explosion led to severing a lid under the columns). Insulation faults cause phase – to – phase and earth faults. Much less frequent are the failures of head fittings e.g. bridge faults [13].

Fig. 7. View of a damaged cable head

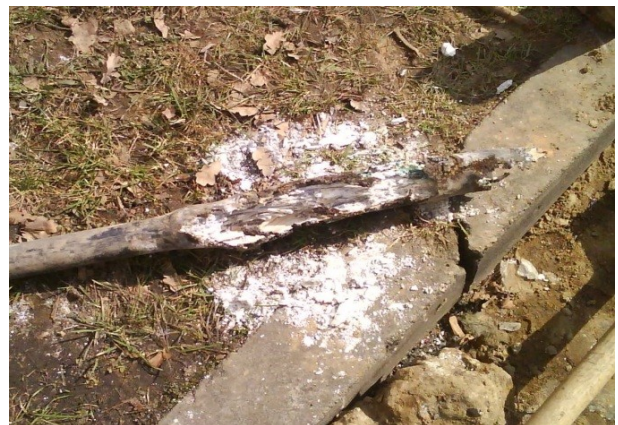
The result of damage of cable core insulation, which not always – due to the kind of power supply (rectified voltage) – leads to the line switching off, is in most cases a slow process of aluminum oxidation which is induced by water and aggressive soil components, especially chlorides, entering the core [14]. The consequences of oxidation of an aluminum cable core are shown in figure 10.

Fig. 10. A view of the consequences of the oxidation process

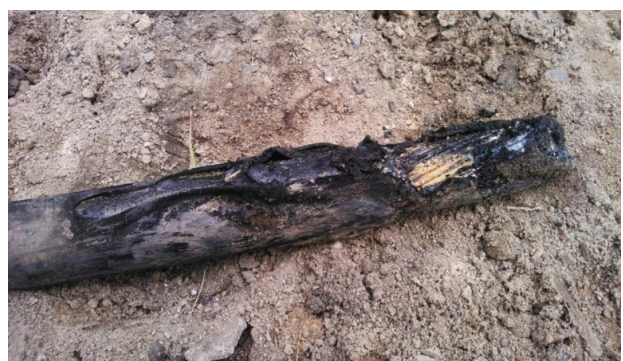
Another important cause of damage to traction cable lines of low voltage is their overheating due to high intensity of the flowing currents. An example of cable damaged in that way is shown in figure 11.

Fig. 11. A view of a damaged traction cable core
