# Risk Assessment While Maneuvering a Loaded Bulk Carrier in Close Proximity to a Vessel Performing Underwater Work

G. Rutkowski & A. Bożek

*Gdynia Maritime University, Gdynia, Poland*

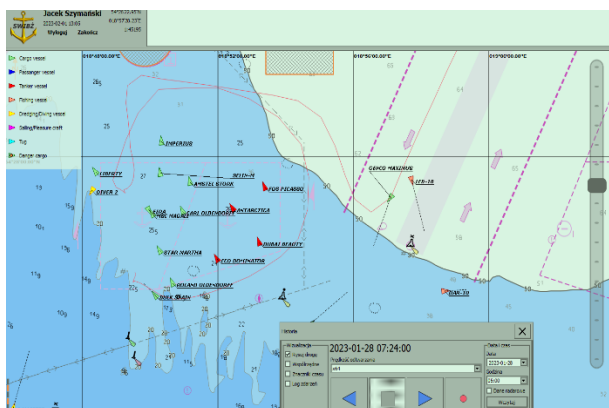
Figures 1 to 4 show the data obtained from the system SWIZB (Navigation Safety Information Exchange System) of VTS Gulf of Gdansk. The analysis of those data shows that SHIP 1 approached the DIVER 2 diving boat at a distance closer than the minimum required (see Fig. 2), generating a high risk for divers performing underwater operations. It is important to remember, that these distances are measured from the point where the antenna is attached on SHIP 1 and DIVER 2. Taking into account the length, width and draft of SHIP 1 (LOA=288 m; B=45 m, T=15 m) and also the size of DIVER 2 diving boat (LOA=15 m, B=4 m), it can be noticed that the real distance the vessels passed each other was even less than 3 cables (on Fig. 2 it is 0,24 Nm which gives only about 450 meters minus ship's real contour).

Figure 1. SHIP 1 dangerous activity observed at Gdansk Anchorage No. 4. Source: VTS Gdansk [5].

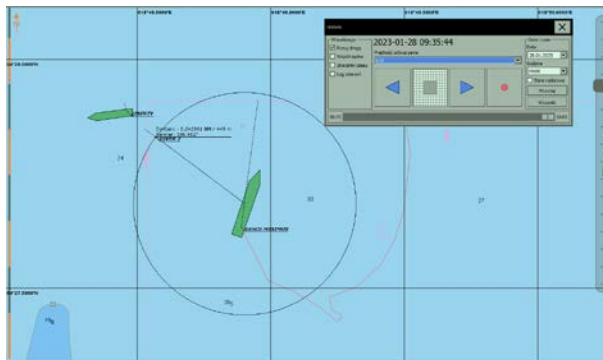
Figure 2. Distance between SHIP 1 and DIVER 2 diving boat = 0,24 NM = 449 m. Source: VTS Gdansk [5].

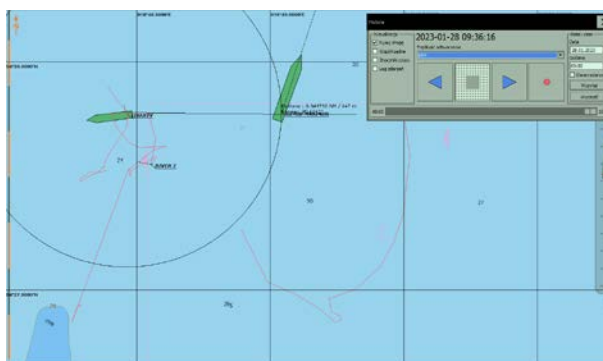
Figure 3. Distance between SHIP 1 and SHIP 3 = 0,35 NM = 647 m. Source: VTS Gdansk [5].

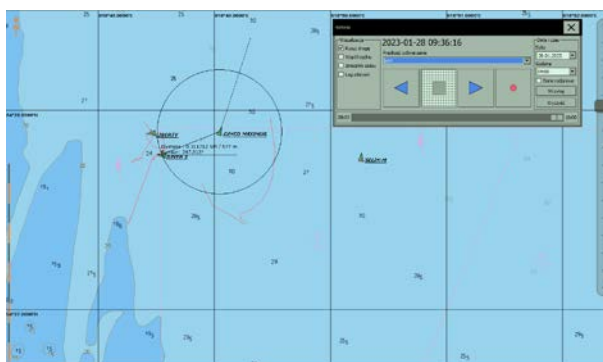
Figure 4. Distance between SHIP 1 and SHIP 3 = 0,31 NM = 577 m. Source: VTS Gdansk [5].
