## **Study of the Outflow Conditions of the Weir Skoki on the Paklica River**

## Abstract

The paper presents an assessment analysis of the flow capacity of the barrage on the Paklica river. The analysed barrage consists of a mill weir and bottom outlets, and is supplied with water from Bukowiecki Lake. The reasons for addressing this subject matter were: from the need to determine the technical condition as well as the ecological condition of the lower position. The environmental status of the area below the system was considered as equally important. Field research included photographic documentation of the technical condition of the weir, taking into account the state below and above the structure, its abutments and the threshold. Additionally, there were made velocity

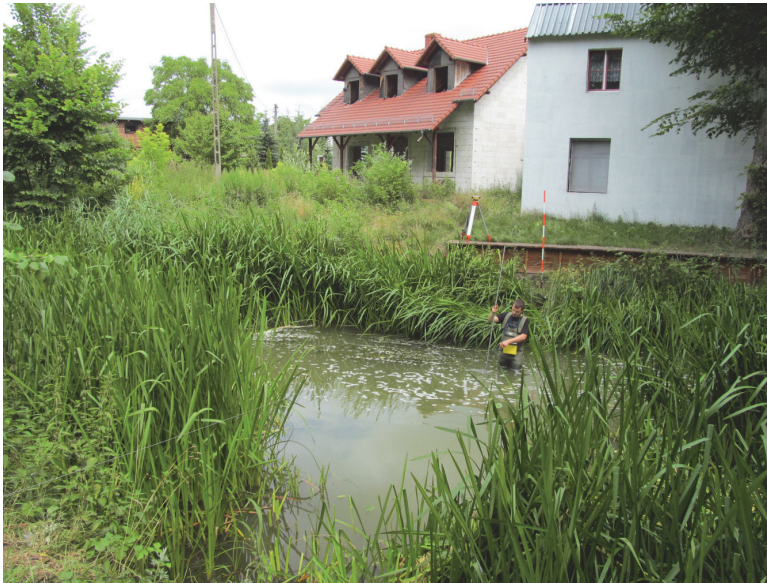
**Fig. 8.** Measurement of water flow velocities on the Paklica River

The average water velocity (approx. 0.1 m/s) was also measured in cross-section 5 (Fig. 7), although the velocities for individual depths varied significantly by up to 0.03 m/s. Variability in velocity values with a simultaneous increase in depth was caused by the location of the cross-section including the connection of the main channel to the inflow channel and the resultant local water accumulation as a direct effect of a large clump of grassy vegetation (Fig. 8).

A significant effect of grassy vegetation on velocity values was observed in analyzed cross section (Fig. 8), located in the area with intensive biological development represented by reed on both sides of the cross-section. Riparian vegetation additionally affected the narrowing of the cross-section, particularly at the level of water table. The bottom zone had the velocity values higher by half than the average. (Local vegetation has the shape of cylindrical elements, through which water flows without much resistance).

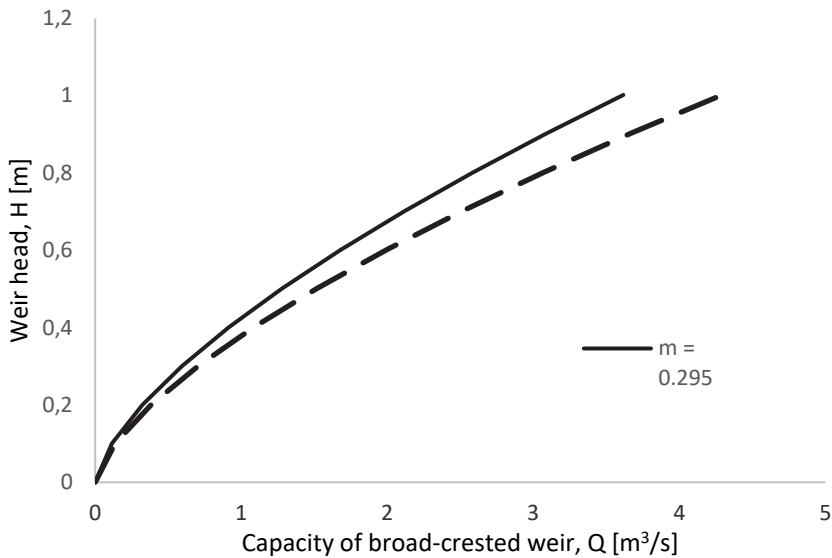
Fig. 10. Capacity of broad-crested part of the Skoki weir

In order to properly assess the weir's capacity, it was assumed that the length of the crest is 2.76 m, and the values for water height above the crest fall within 5 cm to 100 cm. Calculations of the flow capacity of a broad-crested rectangular weir at the barren drop of the barrage were made taking into account two values of the flow rate coefficient:  $m = 0.292$  (current state, damaged concrete surfaces of the overflow) and  $m = 0.365$  (after modernization). The results are calculated in the Fig. 10.

The expenditure of a broad-crested rectangular weir at the idle drop of a water step at NPP = 58.40 m above sea level ( $H = 0.8$  m) is  $2.57 \text{ m}^3/\text{s}$  and together with other overflow devices it allows safe passage of large waters. The modernization of this broad-crested rectangular weir (rounding the inlet edge, smoothing the broad-crested rectangular weir) would increase its capacity by approx. 19%. It would also be necessary to equip the overflow with a modern steel movable closure, e.g. a flat gate valve (Novak et al. 2001).

Modernization of the broad-crested rectangular weir located on the Paklica River by rounding the inlet edge and smoothing the broad-crested rectangular weir would increase its capacity by approx. 19%. Equipping the broad-crested rectangular weir with a modern steel movable closure would allow more accurate flow control on the barrage.
