ANALYSIS OF DAMAGE OF THE COOLING AGGREGATE IN VEHICLE WITH COLD STORAGE CHAMBER

Marek Woźniak, Damian Batory, Krzysztof Siczek

Lodz University of Technology
Department of Vehicles and Fundamentals of Machine Design
Stefanowskiego Street 1/15, 90-924 Lodz, Poland
tel.: +48 42 6312253, +48 42 6312243, +48 42 6312250, fax: +48 42 6312252
e-mail: marek.wozniak@p.lodz.pl, damian.batory@p.lodz.pl, ks670907@p.lodz.pl

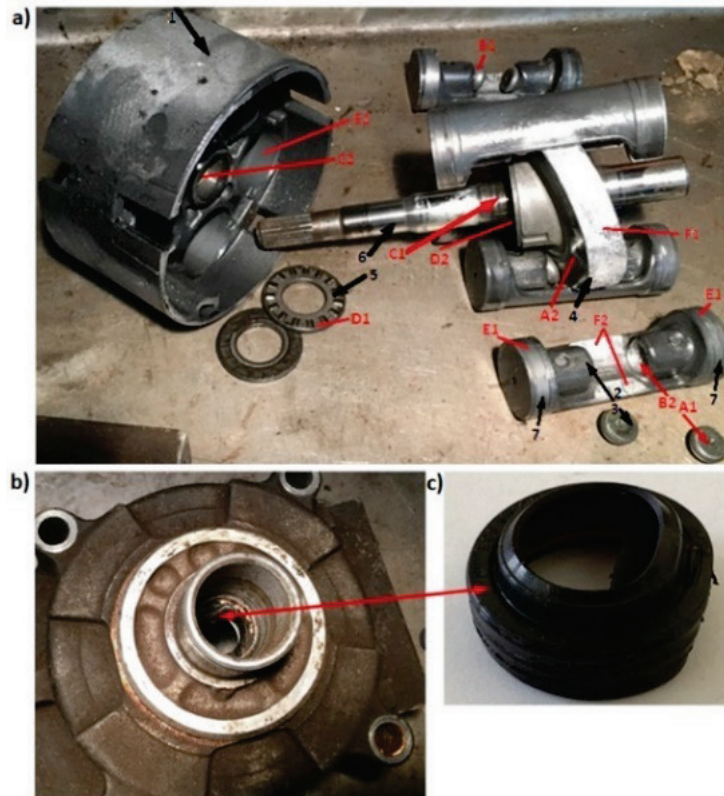
Fig. 2. a) Components of the axial compressor of cooling aggregate, b) compressor housing part, c) damaged seal ring, 1 – head component, 2 – piston, 3 – tappet, 4 - the spatial disc cam, 5 - needle roller bearing, 6 –rotating shaft, needle roller bearing, 7-lubricating rings

Pistons could make small radial and circumferential motions and swings within a clearance between surface E1 and E2 and between surfaces F1 and F2. Such pistons were driven through tappets (3) made of steel, mating through their spherical surfaces B1 with spherical seats B2 made in small pistons. Through their front surfaces A1, placed opposite to the spherical surfaces B1, the spatial disc cam (4) drove, small pistons (surface A2) made of aluminium alloy. The cam was mounted on the rotating steel shaft (6) via splined connection. The shaft (surface C1) was bearing in two head parts via two journal bearings (surfaces C2). The shaft could also make small radial motions and swings within a clearance in the journal bearings. The spatial disc cam (surface DO) was beared relative to the head parts using two axial needle roller bearings (5) (surface D1). It allowed small motions of the shaft within an axial clearance. As mentioned, the damage of radial sealing ring (Fig. 2b, c) was observed, which could initiate consequences that are more important.

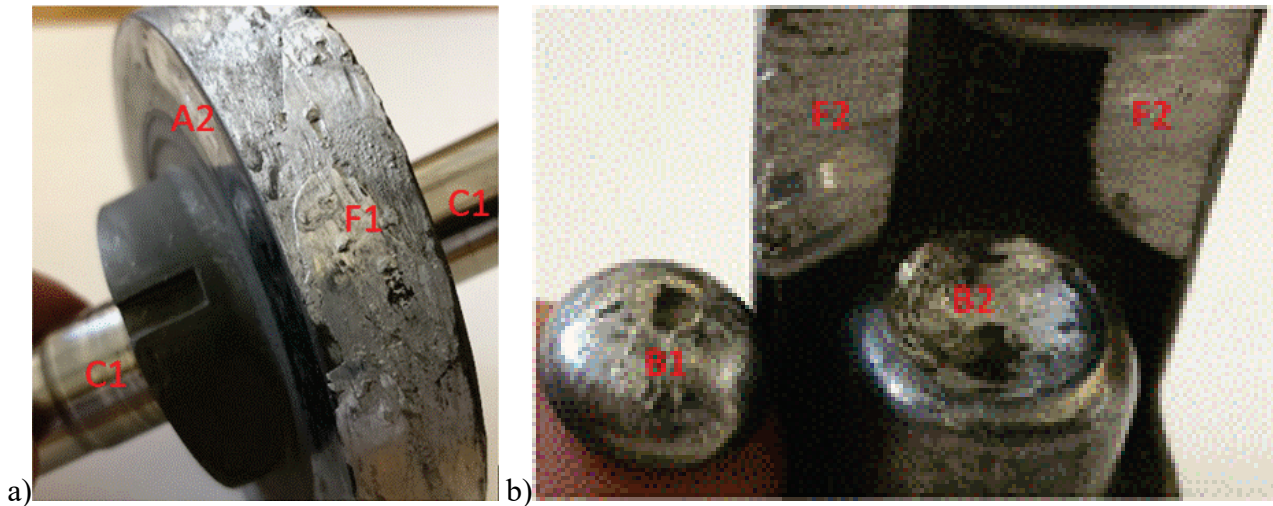
The measured values of clearances in journal bearing were lower than 0.05 mm. In addition, the registered values of clearance between pistons and cylinders were in the range between 0.02 - 0.06 mm. The existence of such clearance values could not explain possible collisions between the cylindrical surface F1 of the spatial disc cam (Fig. 3a) and surfaces of pistons F2 (Fig. 3b). Nevertheless, such conditions resulted in visible wear of the cooperating surfaces. Probably, displacements of the head parts occurred – due to vibrations and loosening of screws. This

together with noticed increase of clearances in journal bearing and between the pistons and cylinders allowed contacts between piston surfaces and cylindrical surface of the spatial disc cam. These contacts can become more dangerous when pistons are locked in the cylinders. This can result from the occurrence of foreign bodies, e.g. hard dusts, debris, recorded during the visual inspection of the interior of the disassembled compressor. The situation may be even worse, if dilution or lack of oil occurs. Dilution can result from a temporarily too high amounts of refrigerant in the refrigerant-oil mixture arising during disturbances of the refrigeration cycle performed by the aggregate with worn components. The registered damage of radial sealing rings in the compressor head could cause leakage of oil and refrigerant.

Fig. 3. The damaged surfaces of: a) the spatial disc cam and its shaft, b) the piston and the tappet

The failure was noticed in the form of wear of the disc cam (Fig. 3a), front and spherical surfaces of tappets (Fig. 4) and the plastic deformation of the spherical surfaces B2 of seats (Fig. 3b). Then, due to the deformation and displacements of the rotating shaft, collisions and wear of the side surface of the disc cam occurred during contacts with small pistons surfaces. Moreover, noticeable wear of the side surfaces of pistons, their lubricating rings (Fig. 4a) and the cylinders in fixed head was registered. On the surface of tappets are visible traces of the material transfer. In order to analyse the character of wear the surface of tappet was analysed with use of SEM.

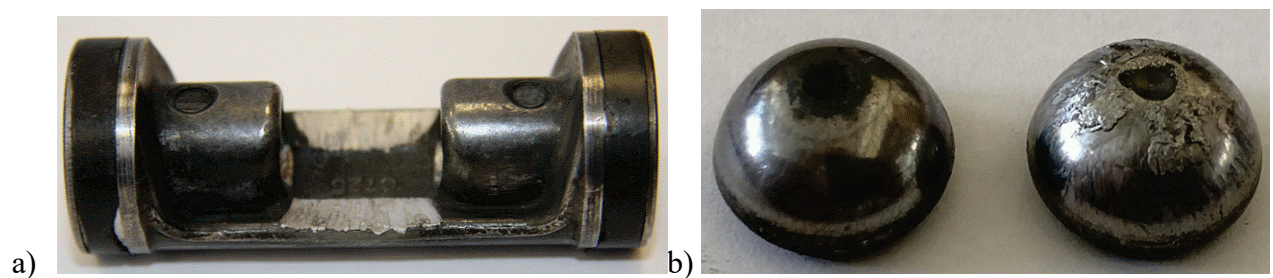
Fig. 4. a) Surface damaging for the piston and lubricating rings, b) Different rate of surface damaging for the tappets

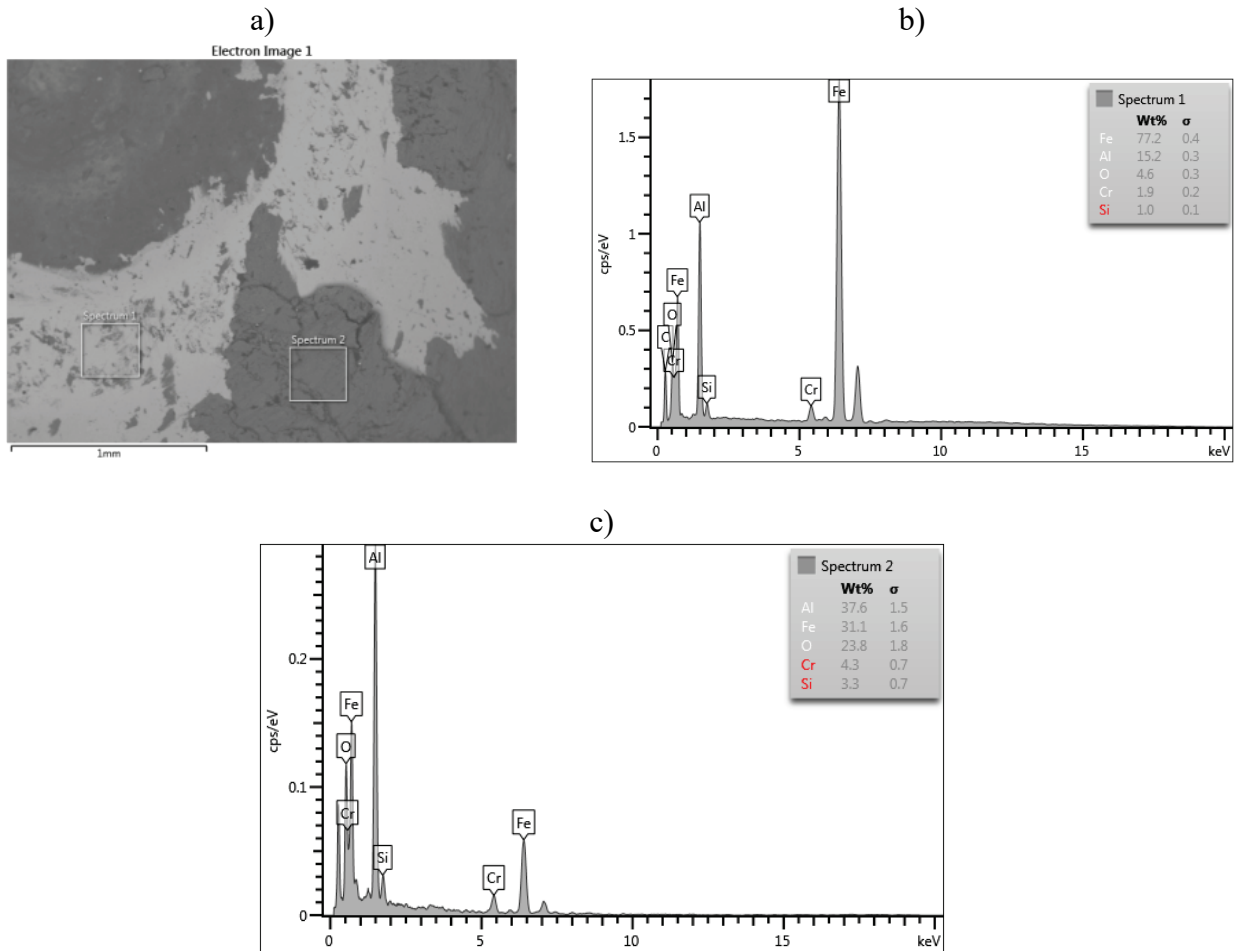
Results of SEM analysis of the tappet surface are presented in Fig. 5. The backscattered electrons image shows a strong phase contrast on surface of the tappet. Moreover, a build-up layer with visible cracks is visible. This indicates strong material transfer between the tappet and cooperating seat in the piston. Different materials of the piston (aluminium alloy) and the tappet (steel) indicate wear of the seat in the piston and transfer of the seat material on the surface of the tappet. The EDS spectra collected from the surface without the build-up layer shows noticeable amounts of iron, whereas the chemical composition of the build-up layer indicates large amounts of aluminium, which proves the material transfer between the seat and the tappet.

Fig. 5. Results of SEM analysis of tappet surface: a) SEM image, b) EDS spectra of the surface without the build-up layer, c) EDS spectra of the build-up layer
