Wojciech Kocot*

An Analysis of the Causes of Damage to Reinforced Concrete Road Viaduct Located in the Mining Area**

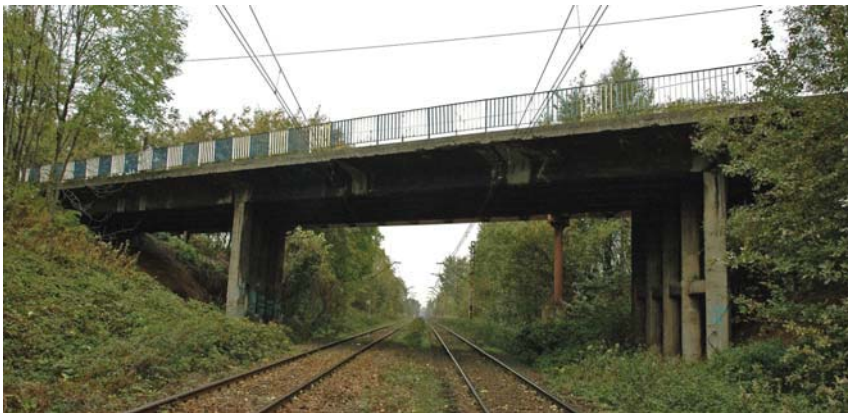
Fig. 1. South side view of the viaduct

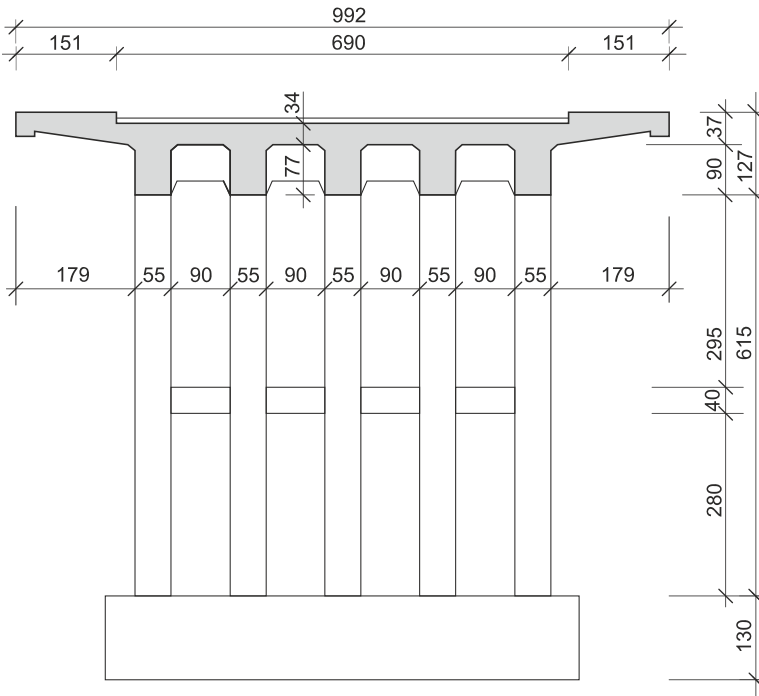
Fig. 3. Viaduct span cross-section and view of the pier

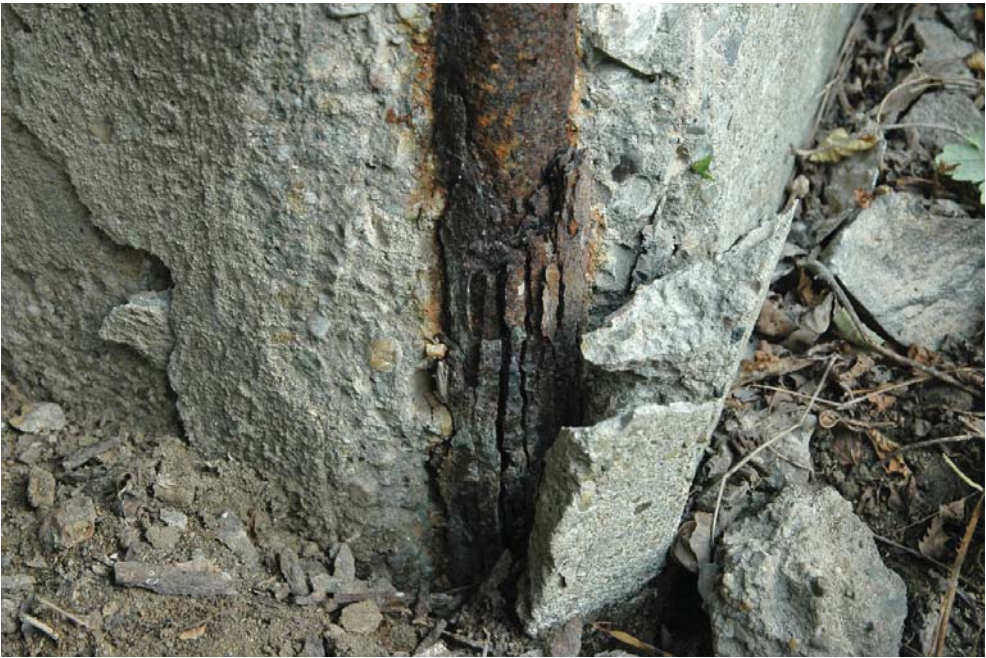
Fig. 4. South pillar of the eastern pier – visible losses of concrete coating and advanced reinforcement corrosion

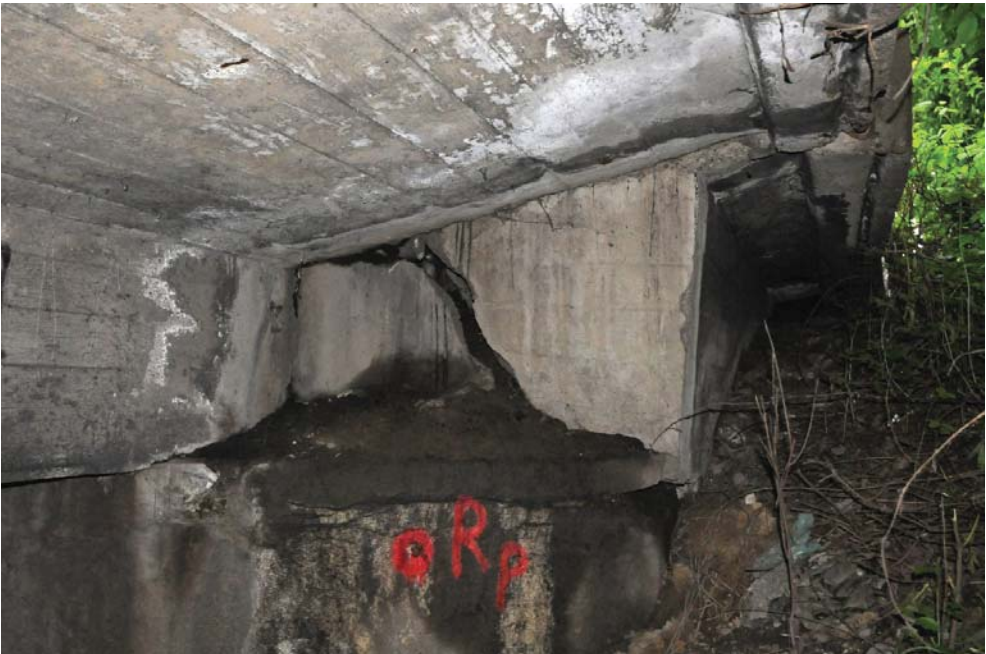
Fig. 5. Western abutment, north side – visible crack of the back wall and dislocation of broken off parts towards the outside

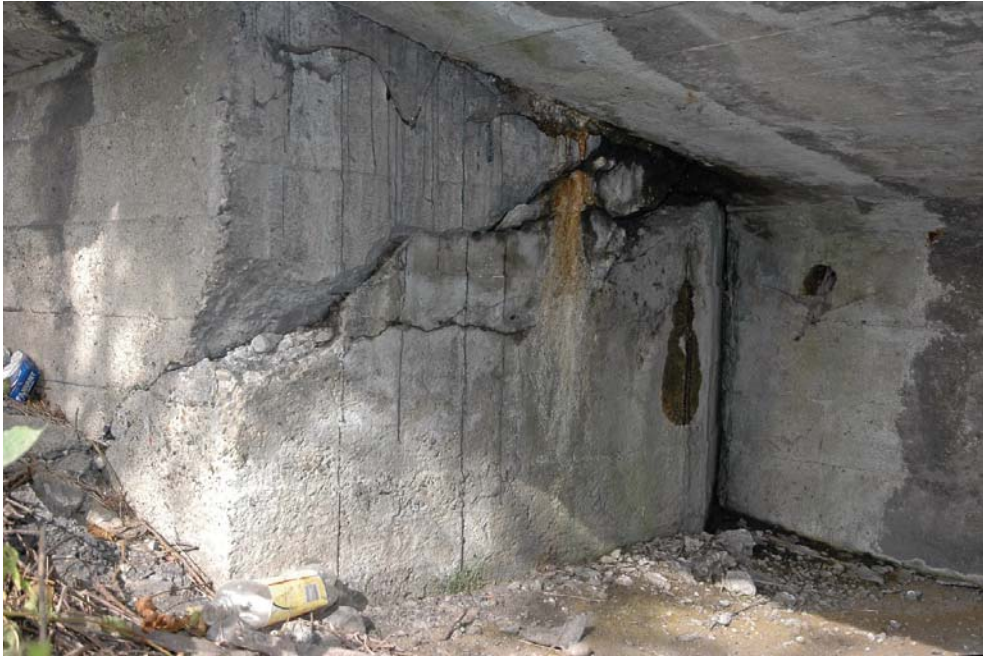
Fig. 6. Western abutment, south side – visible crack of the back wall and chipping of concrete

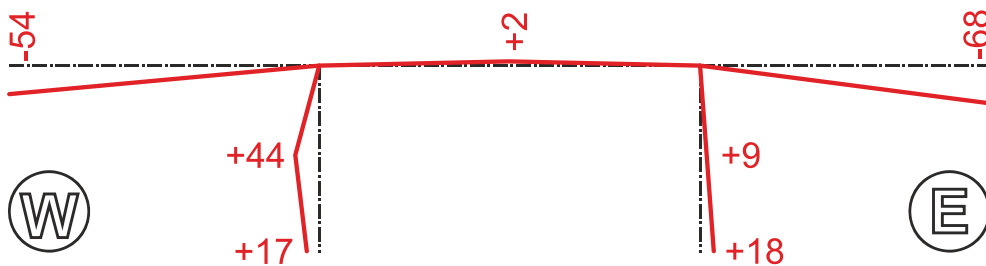
Rys. 8. Deviations from the theoretical axis of the viaduct elements on the south side [mm]
