Analysis of Navigational Casualties within European Waters and Case Study

A. Kerbrat

Gdynia Maritime University, Gdynia, Poland

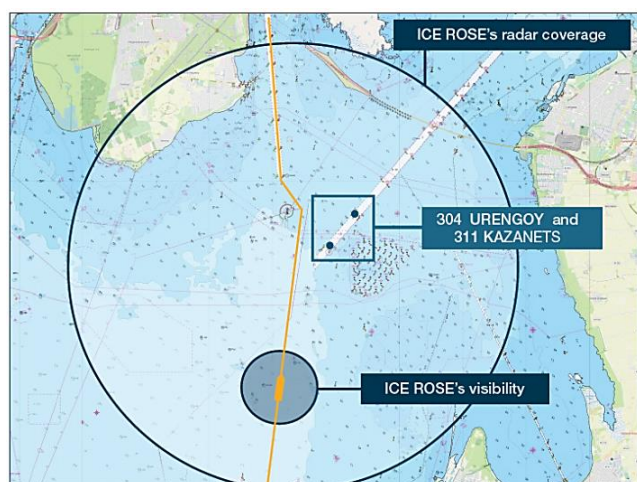
Figure 4 . Approximate radar coverage and visibility on Ice Rose at around 0935.
Source: DMAIB accident report [4].

Ice Rose's X-band radar was set to 6 Nm with 1 Nm range rings, 3 minutes relative trails and 60 minutes relative vectors, north up, no any target is acquired for tracking, auto-acquisition off. In the report it is stated that radar was set to master's preferences but third officer was the one mainly observing it's screen. Both of the Warships were visible on the screen (fig. 5) but located between buoys of eastern channel and blurred by the trails so their detection is difficult for unexperienced person. The master and third officer were mostly relying on visual cues to detect danger of collision and randomly checking targets by selecting them and analysing their CPA and TCPA values. EMSA is pointing out two main disadvantages of that radar configuration. Firstly possibility of delayed detection of moving

target and acquisition of it. Secondly not enough time for ARPA to show accurate data of acquired target. It is clearly stated that at 0935 neither master nor third officer were aware of warships presence in the area. First observations of them was made few minutes later when third officer reset trails to true and first of the echoes was clearly distinguished from the buoys. Second echo was not recognized properly until only minutes before collision.

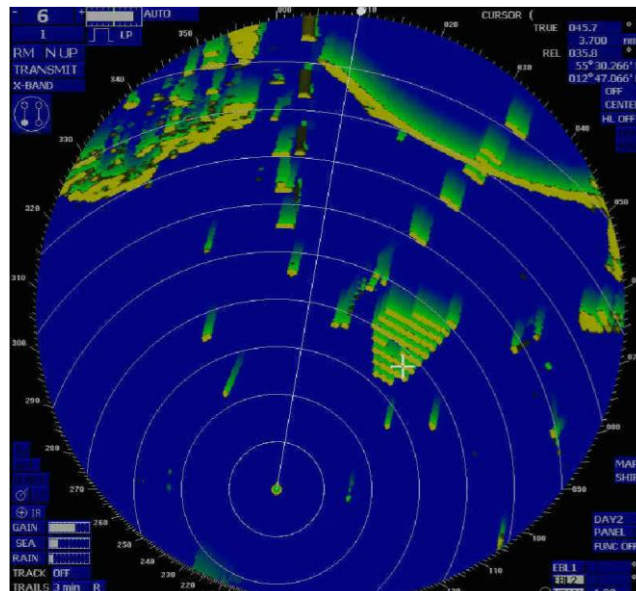
Figure 7. Ice Rose's radar image at 0935.
Source: DMAIB accident report [4].

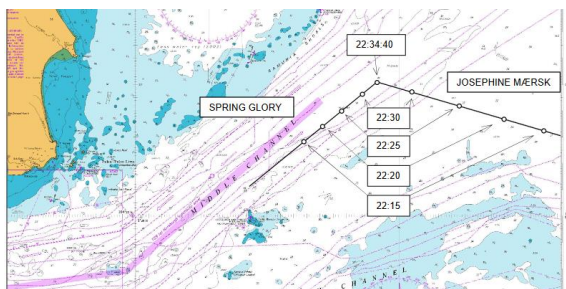
A bulk carrier SPRING GLORY was en route from Singapore (Singapore), where she loaded iron ore, towards Qingdao (China). Container vessel JOSEPHINE MAERSK was on her way from Port Chalmers (New Zealand) to Tanjung Pelepas (Malaysia) with load of general cargo in containers. Ships collided with each other about 7 nm NE of Horsburgh Lighthouse in eastern approaches to Strait of Singapore around 22.34 local time. Meteorological conditions were good with SE wind of 8 knots, southerly seas of 2 meters and visibility of 10 nm.

Figure 8. Site of the incident and the ships positions prior to the collision.
Source: DMAIB accident report [4].

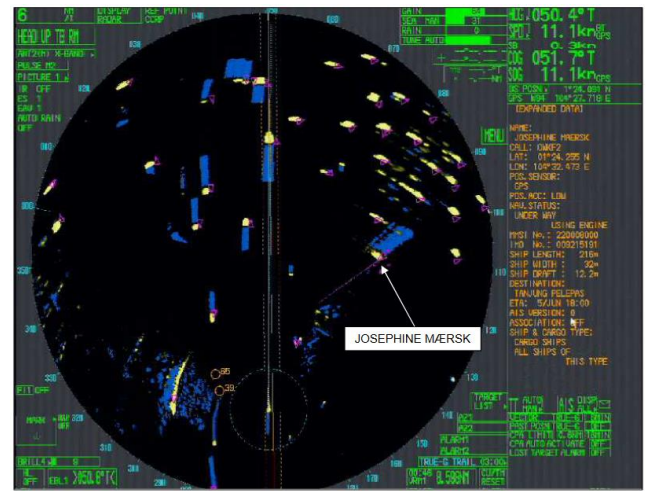
The SPRING GLORY'S radar was set to 6 nm range head up, off centre and relative motion, ARPA was not in use, but 3 minutes long true trails were used. Radar had AIS overlay. About 17 minutes before collision radar range was changed to 12 miles for short moment. Then JOSEPHINE MAERSK could have been observed, from that moment until collision JOSEPHINE MAERSK remained visible on the radar, also when it was set back to 6 nm. About 8 minutes before collision JOSEPHINE MAERSK was selected as a target and identified with expanded data on the AIS (fig. 9). Even when CPA was indicated as 0.03 nm SPRING GLORY maintained course and speed. 4 minutes before collision duty officer of SPRING GLORY tried to establish communication with JOSEPHINE MAERSK. That was successful at first but later communication on channel 15 failed. A minute before collision and after few missed trials to communicate over the radio SPRING GLORY was put to hard turn to port.

Figure 9. Radar screen on SPRING GLORY about 10 minutes before collision.
Source: DMAIB accident report [...].

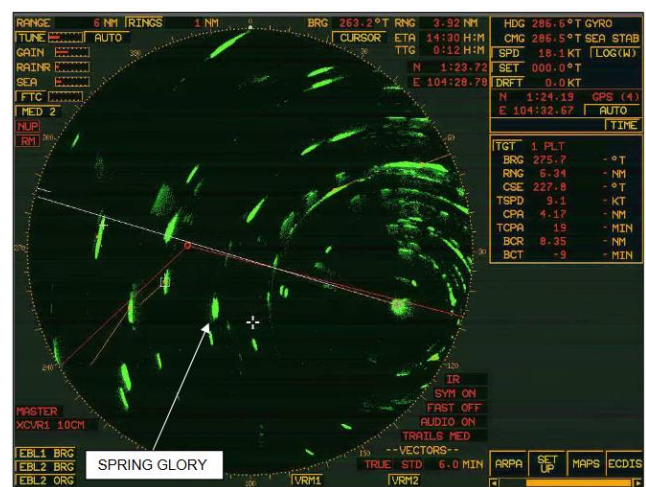
On JOSEPHINE MAERSK 3rd officer took watch at 20.00. He had an able seaman for a lookout duty on the bridge. The main focus of the OOW was on passing the anchored vessels and three ships he had detected on his starboard bow, that were entering TSS. He planned to follow them and overtake later when westward bound. The officer did not detect any vessels approaching from port side (only anchored vessels), nor did lookout. Duty officer was concentrated on starboard side traffic and port turn that he had to do to enter TSS. SPRING GLORY became visible on the radar at a distance of approx. 11 nm and was visible on the radar until collision. About 10 minutes before collision SPRING GLORY was visible on the radar screen at a distance of approx. 5 nm and it could be identified on AIS (fig. 10).

Figure 10. Radar screen on JOSEPHINE MAERSK about 10 minutes before collision.
Source: DMAIB accident report [...].

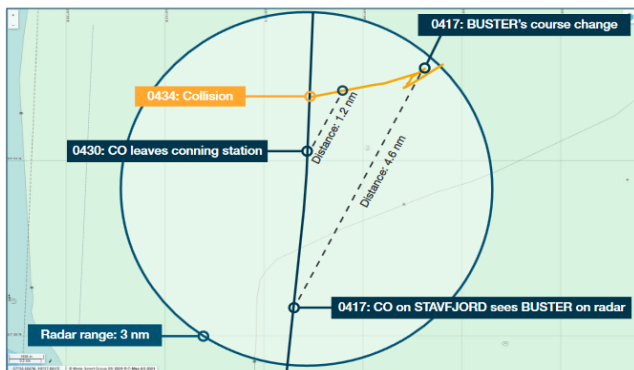
Both vessels were equipped with AIS and radars. BUSTER's skipper determined that there was no vessel on his route that he would need to give way and after setting autopilot went to manage fished langoustines. On STAVFJORD chief officer took watch at 0400. AB from lookout duty was released as the sun was rising. Chief plotted BUSTER on the radar about 15 minutes after taking watch. Vector indicated that target will pass astern at a safe distance. He could see fishing boat approximately 15-20 degrees on starboard bow at about 1,2 nm distance (figure 11). He decided to signal his presence with ALDIS lamp pointed at BUSTER. After that officer left the lookout position to go to toilet. While in the toilet he heard a loud noise and realized the ship had collided with something – fishing boat BUSTER.

Figure 11. Distance and bearing at 0417 and 0430. Source: DMAIB accident report [6]

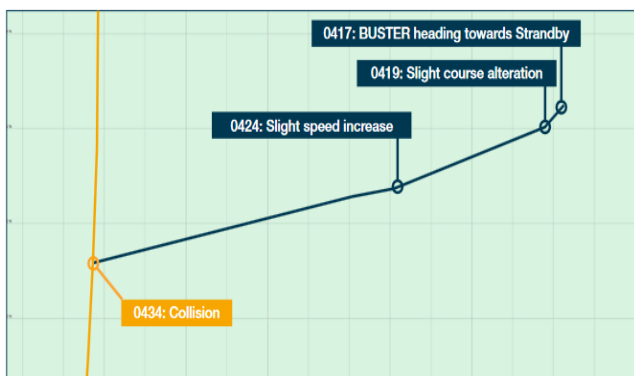
Figure 12. BUSTER's sailed route prior to collision. Source: DMAIB accident report [6].

No data from VDR was retrieved as STAVFJORD suffered VDR malfunction resulting in no data being recorded since April 2021. In the course of investigation it was found that chief officer did not look or verify BUSTER's radar echo and CPA for about 17 minutes prior to collision and that the conning station was unattended for about 4 minutes prior to the collision. No alarm were set on STAVFJORD radar to inform chief about dangerous change of CPA of acquired targets. BUSTER's skipper was adjusting his course and speed before proceeding to work on deck (fig. 12), he trusted that ships on his

port side will give him way according to COLREG rules. Because of BUSTERS construction skipper had no chance to see traffic on the port side of the vessel. He also could not see signals given with ALDIS lamp from STAVFJORD.

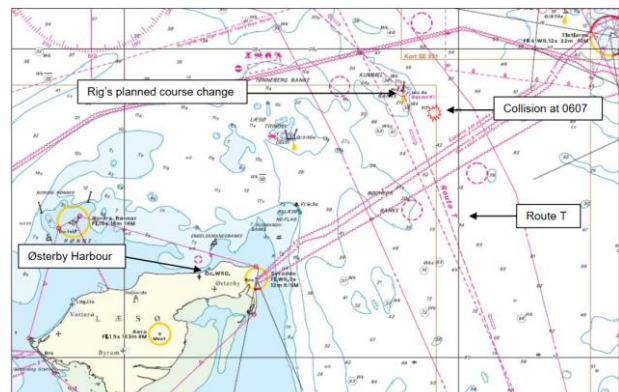
At the time of accident RIG was underway along Route T, visibility was good, force 3 winds and a slight sea. Rig radar was set on 3 nm range, 0,5 distance rings, trails, north up and relative motion. Image on the radar was clear. Officer of the watch was familiar with traffic patterns in the area of accident as he sailed these waters before. Overview of the accident position is shown in figure 13.

Figure 13. Overview of area of collision. Source: DMAIB accident report [5].

“Approximately 10 minutes before the planned course change at buoy no. 3 by Kummel Banke, the officer of the watch suddenly saw a small fishing vessel approaching on a crossing course at close quarters on the starboard side. He then went to the center of the bridge, disengaged the auto steering and put the rudder to full starboard. As the ship was in the starboard turn, RIG's port side collided with INGER MARIE's port side at 0607 LT.

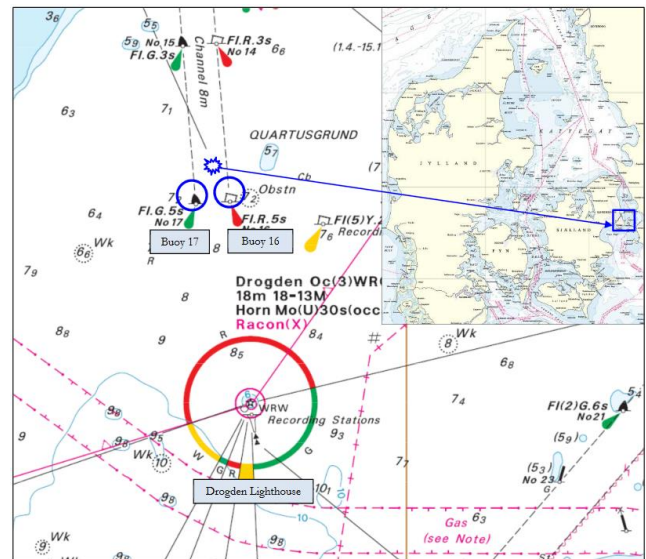
Collision happened at 13.19 UTC close to buoys 16 & 17 marking southern entrance/exit to Drogden Channel (fig. 14). Kraslava was proceeding south with "In The Sound" pilot on board. The arrangements to disembark pilot were in progress and pilot boat was alongside Kraslava adjusting speed to take pilot on board. Atlantic Lady was approaching buoy 16 after passing Drogden Lighthouse on her port side. Buoy 16 was a marker to turn to starboard to align with direction of the Channel. Though visibility was restricted only Kraslava was giving appropriate sound signals prescribed by Rule 35 of COLREG for vessel restricted in her draught, as that was AIS status advised by the pilot. Pilot also was keeping Kraslava closer to the center of the Channel to avoid shallow waters located just aside of it. Going out of dredged channel may have cause the risk of grounding the vessel. Atlantic Lady also had a status of constrained by her draught but was not giving any fog signals. She was planning to pass buoy no. 16 and then initiate turn to starboard to go along eastern part of the

Channel. Master of Atlantic Lady, on the grounds of his experience, presumed that Kraslava would hold a position on the westerly side of a channel and allow Atlantic Lady to turn into easterly side of it.

Figure 14. Scene of collision. Southern part of The Sound, Denmark.
Source: DMAIB accident report [6].
