Janusz Bialik, Wojciech Ferens, Pascal Troncin
GE Energy Switzerland in Baden, GE Power Sp Z o.o. in Wroclaw, GE France in Belfort

NAPRAWA NA OBIEKCIE POŁĄCZENIA MIĘDZYBIEGUNOWEGO WIRNIKÓW TURBOGENERATORÓW

TURBOGENERATOR FIELD POLE-TO-POLE CONNECTOR IN-SITU REPAIR

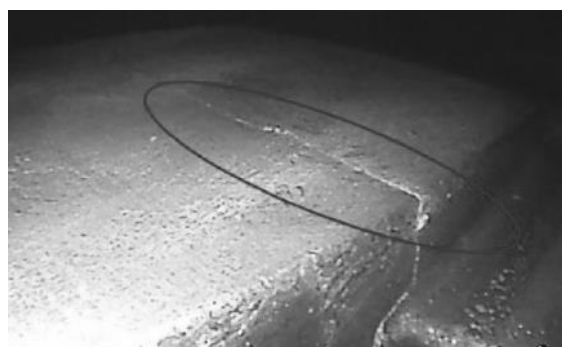
Over the last years, indications have been found on some pole to pole connections of air and hydrogen cooled turbogenerator rotors, both 50Hz and 60Hz. The indications are originating from one of the corners on the T-shaped rotor jumper (Figure 1, Figure 2). Those indications could lead to unit shut down and field windings issues and/ or retaining rings issues together with copper contamination of turbogenerator components. The root cause analysis indicates that low cycle fatigue during start/ stop cycles is the primary root cause mechanism [2].

Fig. 2. Exemplary finding in the pole to pole connection during planned inspections

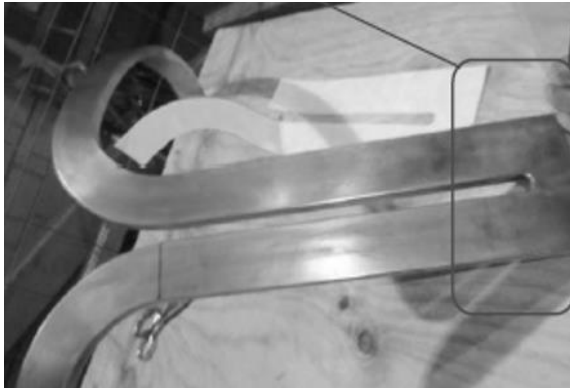
Fig. 3. Upgrade solution (classic repair)

The first attempt to repair the affected component required a rotor removal together with the retaining ring on the NDE site [2]. This repair could be done on site or in OEM workshops. It considered unbrazing of the original connections and brazing a new one in place of original one (Figure 3). After assembly no balancing is necessary. This is the so-called classic repair approach.

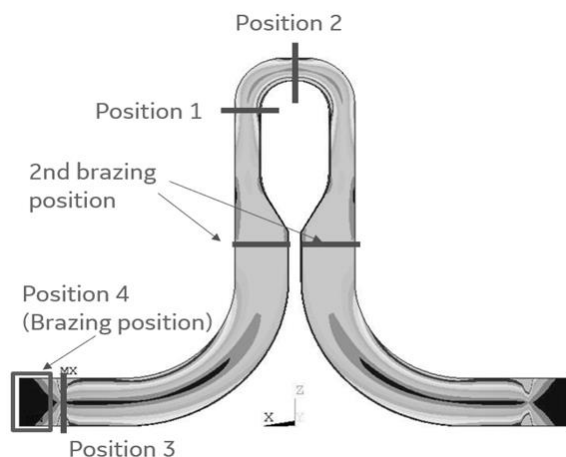
The stresses in the connection, as well as in the brazing areas were evaluated. Stress distribution in the new connection is presented in Figure 5.

Based on results, engineering could conclude that all requirements (stresses, static loads, cycling mode) even in the most critical areas fulfill engineering qualifications.

Fig. 5. Stress overview within new connector

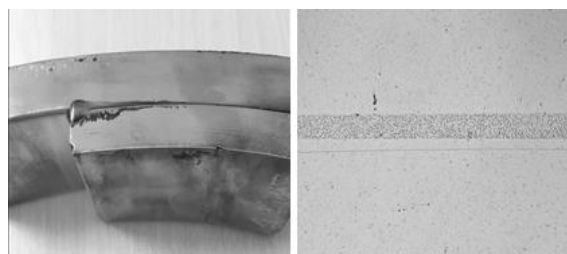
All the described steps, once well-established, became a part of a standard rotor repair procedure. Based on this, several trials have been performed. All braze components have been removed from the mockup and tested in the laboratory. Visual, Ultra Sonic, Microscopic investigation have been done on all braze joins. All braze areas fulfilled engineering acceptance criteria (Figure 9).

Fig. 9. Visual and Microscopic picture of new braze joints

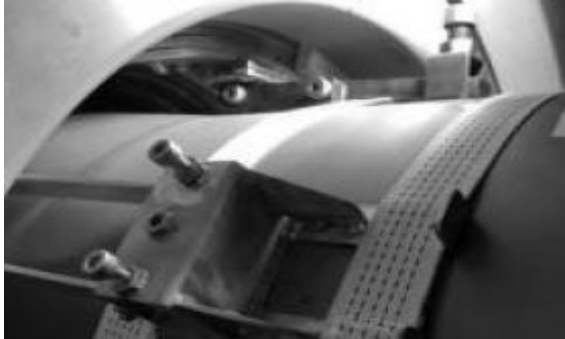
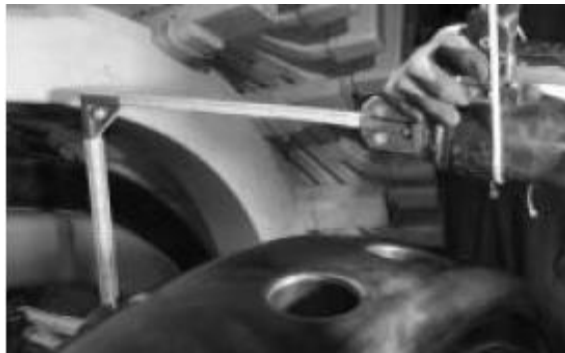
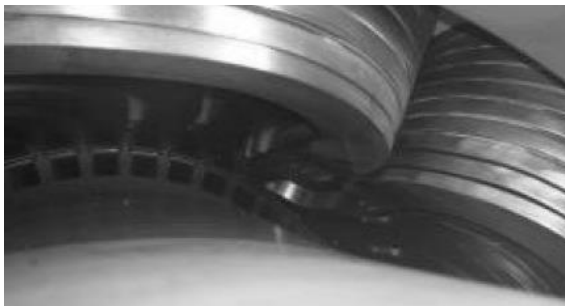
Finally, the OEM was awarded by a customer an order to perform the first on site implementation of the repair method on a large hydrogen cooled turbogenerator. On the unit, an indication had been detected on one of original pole-to-pole connections one-year prior repair.

Fig 10. On site implementation (from top): New connector in position, Inductor in place, Final repair effect

The most challenging activity on site was to guarantee enough access to the rotor winding. This was achieved by developing a dedicated scaffolding which was installed inside the machine. It provided operators sufficient space, reduced risks, and improve safety during the repair execution. This first implementation was

The unit was returned to service within less than one week and with full success.
