Analysis of the causes of damage to the wires of the steel belt of car tires

DOMINIKA GRYGIER

Wroclaw University of Science and Technology, Department of Materials Science, Strength and Welding
Technology, ul. Smoluchowskiego 25 50-372 Wroclaw, Poland

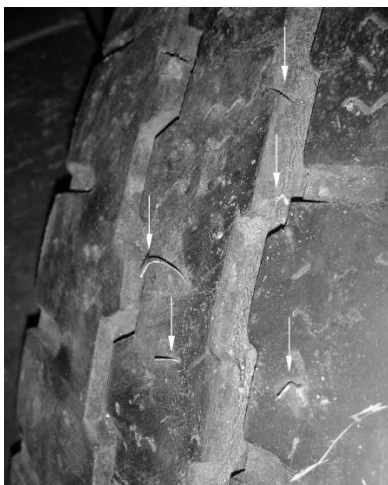
Fig. 1. Defective tire No. 1. Visible fragments of wires from the damaged belting, which pierced the tread of the tire.

The initial macroscopic tests have shown that most probably damaging of the tires happened as a result of multiple hitting of the face of the investigated tires against an obstacle or as a result of driving on bumps at high speed. However, in order to understand the mechanism of fracture of the investigated tires belting material, for further tests the ends of defective wires that pierced through the layer of rubber were cut off and subjected to detailed macroscopic analysis.

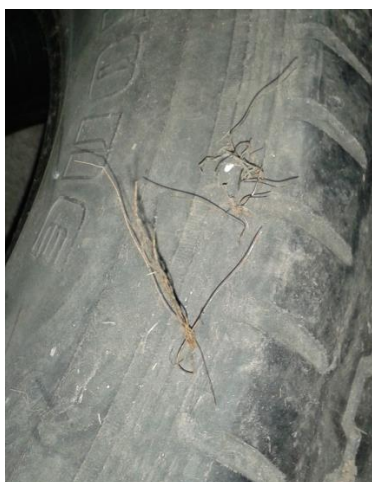
Fig. 2. Defective tire No. 2. Visible fragments of wires from the damaged belting, which pierced the side wall of the tire.

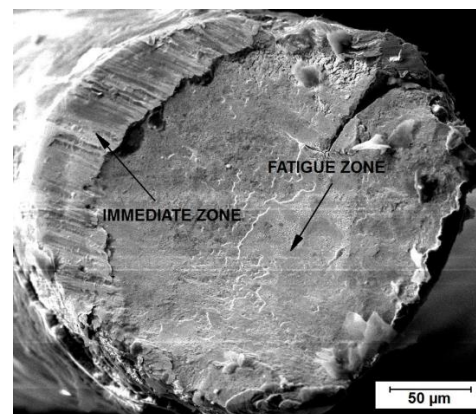
Fig. 3. Microscopic image of fatigue fracture of the cracked wire coming from tire No. 1, shown in Fig. 1. Visible smooth fatigue zone and the immediate zone.

The fractographic tests of the wires performed with the use of scanning electron microscope have shown presence of surfaces indicating for fatigue

character of the damage (Fig. 3). The fatigue part of the fracture was smooth with characteristic fatigue stripes arranged almost parallel to the direction of the fracture development (Fig. 5). The fracture focus was localised at external edge of the wire, that is in the area of the highest concentration of the complex operational stresses. At external circumference of the wire fractures the immediate zone of plastic character and extensive surface topography was visible (Fig. 4).

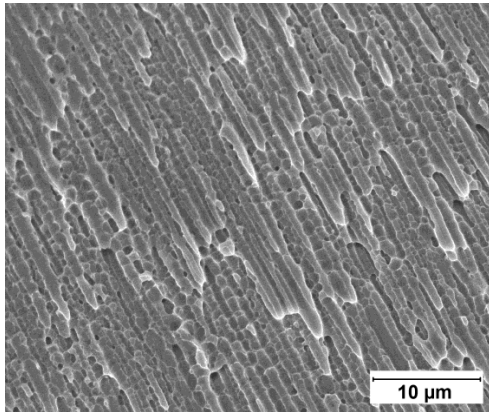
Fig. 4. Microscopic image of immediate zone of the fatigue fracture of the cracked wire coming from tire No. 1, shown in Fig. 3. Visible fracture of the plastic character and extensive surface topography. SEM.

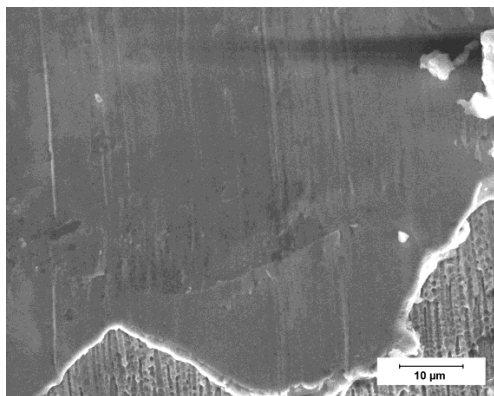
Fig. 5. Microscopic image of fatigue zone of the fatigue fracture of the cracked wire coming from tire No. 1, shown in Fig. 3. SEM.

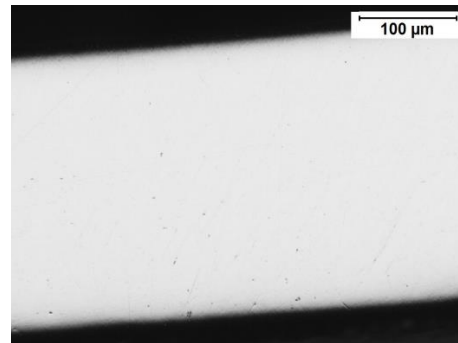
The microscopic observations of the investigated wire material in the non-etched state have shown presence of small quantity of non-metallic inclusions, mainly in the form of oxides. The impurities were distributed punctually and appeared in quantity equal to the standard 1, according to PN-64/H-04510 standard (Fig. 6), which according to the literature data [6,7] is within the permissible content of non-metallic inclusions and by that it eliminates that

factor as responsible for damage to the material microstructure.

Fig. 6. Material of the steel wire specimen coming from the defective tire No. 1. Visible non-metallic inclusions in the form of punctually distributed oxides in quantity equal to standard No. 1, according to the PN-64/H-04510 standard. Non-etched state. LM

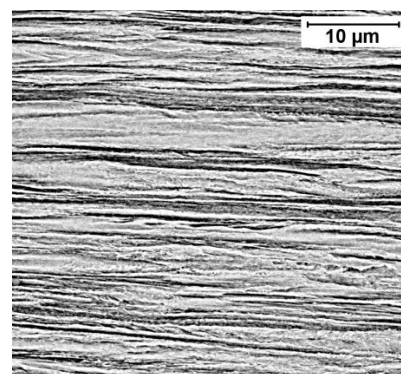
The microscopic tests performed at transverse sections of the investigated wires have shown, that all the parts investigated in compliance with recommendations of the PN-EN 10323:2005 standard (U), were made of unalloyed pearlitic steel. The microscopic analysis of the specimens at longitudinal sections have revealed the presence of material crushing texture of the 80-90% order, being the result of applied cold plastic working (Fig. 7).

Fig. 7. Microstructure of the wire specimen com-

ing from defective tire No. 1. Visible texture of material crushing, being the result of the applied cold plastic work. SEM

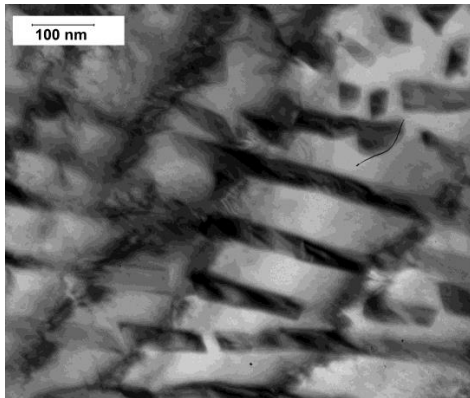
Fig. 8. Microstructure of the wire specimen from the defective tire No. 1. Visible transverse cracks of cementite lamellae created as a result of the tire operation. TEM

The initial microscopic tests have not shown significant differences in microstructure of the investigated specimens, but further observations with the use of transmission electron microscopy, have highlighted the clear impact of operation on microstructure of the investigated material. The microscopic analysis of the investigated wires material have shown presence of transverse cracks of singular cementite lamellae (Fig. 8 and 9). The observed cracks most probably were created as a result of the impact of complex stress state during the tire operation, and in combination with improper use of the tires they led to damage of the belting wires.

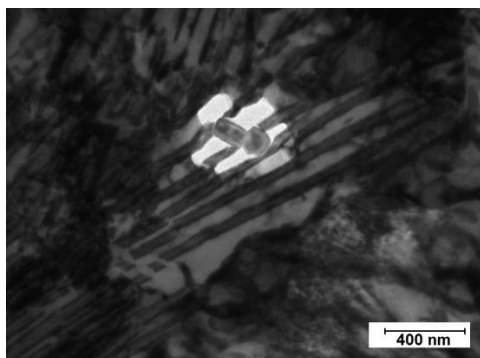
Fig. 9. Microstructure of the wire specimen from the defective tire No. 2. Visible transverse cracks of cementite lamellae created as a result of the tire operation. TEM
