TOMASZ ROKITA

Breakdown of hoisting machine in mining shaft hoist installed in southern section of R-II shaft of KGHM Polska Miedź S.A. O/ZG Rudna

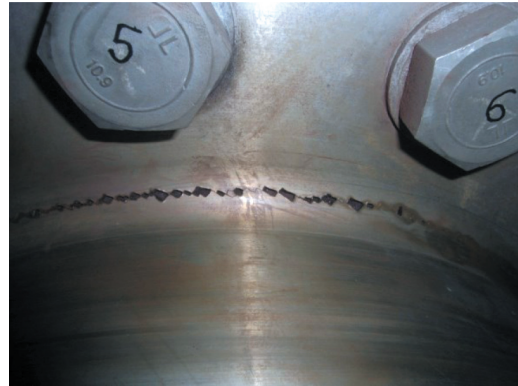
On April 17, 2011, the operators of the hoist noticed damage in the shaft of the hoisting machine in the southern section in the area of the passage of the shaft in the flange used to connect with the hoist drum on the eastern side.

A crack as well as chips of the material in some places were visible along about half of the circumference of the shaft. The nature of the damage indicated fatigue crack (Figs. 2 and 3).

Fig. 2. Cracks in circumference with crushing [1]

The decision was made to repair the cracked shaft by welding in accordance with the technology developed by the Institute of Welding in Gliwice and agreed with by ZG Rudna [4]. Due to the vast loss of the material of the flange, the preparation of a weld groove was necessary; that is, the execution of the appropriate undercuts (geometry) of the connected elements (Fig. 5). After the appropriate preparation of the edges of the weld groove, penetration tests were conducted (to detect any cracks).

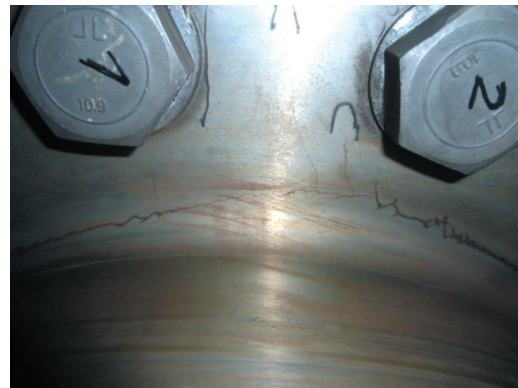
Fig. 3. Cracks on circumference and radial cracks [1]

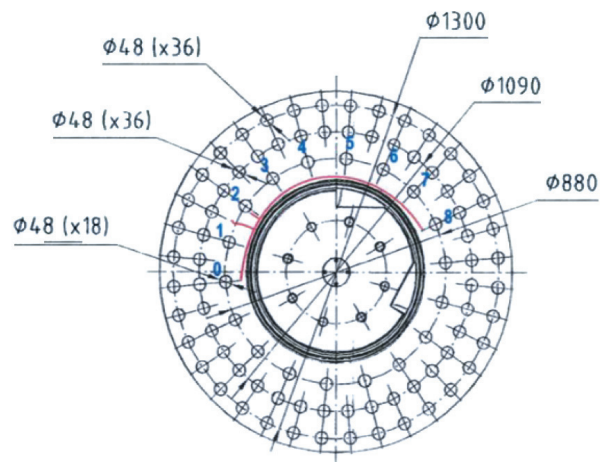
Fig. 4. Side disc of hoist drum of hoisting machine in southern section (eastern side) with cracks marked (red) [2]

- a crack on the circumference ~ 1000 mm long in the axial direction (in parallel to the axle of the shaft) through the material,
- a crack with some crushing of the material ~ 460 mm long in the axial direction through the material,
- two radial cracks (perpendicular to the axle of the shaft) from the circumference ~ 100 mm long and ~ 60 mm between the Bolts 1 and 2.

The found damages did not allow for the further operational use of the hoisting machine. The consequence of the above inspections was the decision of the Director of the Mining Office to the Power and Mechanical Equipment Test Inspections to stop the operation of the mining plant in the part related to the mining shaft hoist installed in the southern section of the R-II shaft O/ZG Rudna [3].

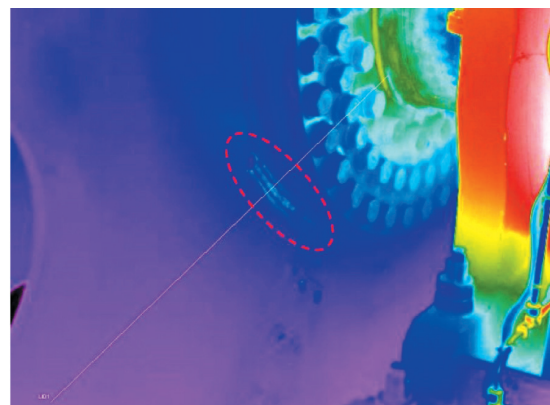
Fig. 10. Thermogram of part of drive shaft and of disk of drive wheel from southeastern side ("rain" pallet) [10]

The thermovision measurements showed a lack of significant temperature differences of the analyzed driving structure (the shaft – the hoist drum). No major

Both extensometric and thermovision inspections showed the lack of a clear increase in the concentration of local stresses (the notch effect) in the examined area of the shaft after its repair.
