## The system approach as a means of restoration activity effectiveness

**Cytowanie / Citation:** Orlenko M. The system approach as a means of restoration activity effectiveness. *Wiadomości Konserwatorskie – Journal of Heritage Conservation* 2019;57:96-105

### 3. RESTORATION OF THE “HOUSE WITH CHIMAERAS” AT 10, BANKOVA STREET

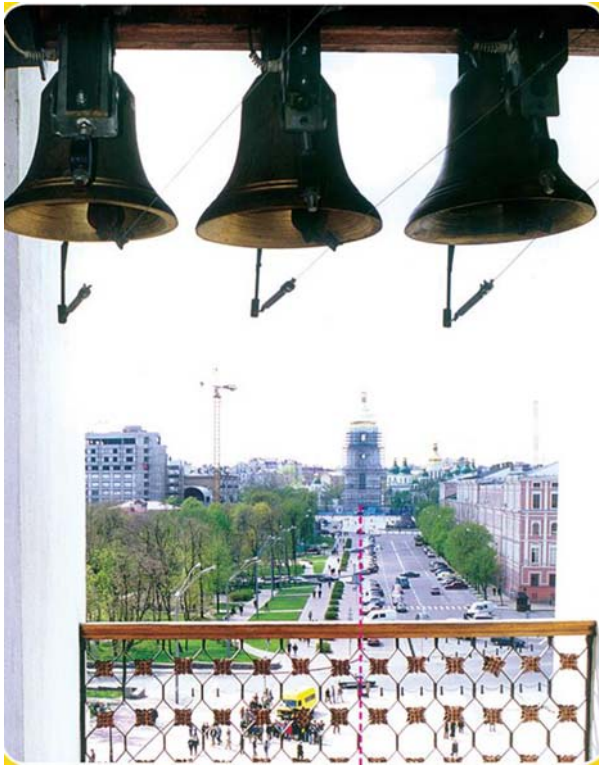
Michael’s Golden-Domed Monastery, where a number of trees, small architectural forms which obstructed the view of the visual axis, were demolished, and comprehensive landscaping was carried out, traffic was sorted, billboards and other things were removed, Fig. 1.

Fig. 1. The axis between the St. Michael's and St. Sofia bell towers – the historical axis of Kievan Rus. Recreated in 1998–1999

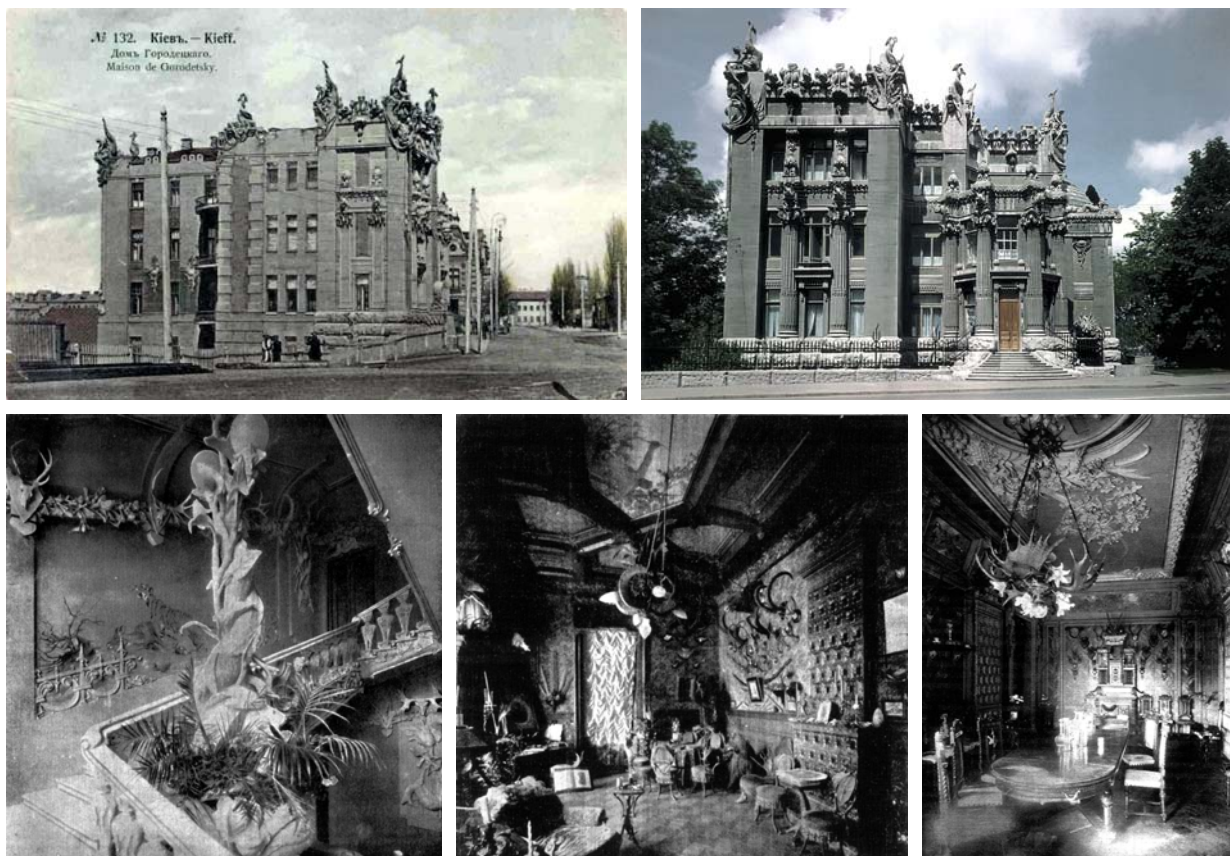
Fig. 2. Archive photos of W. Horodetski's building at Bankova, 10

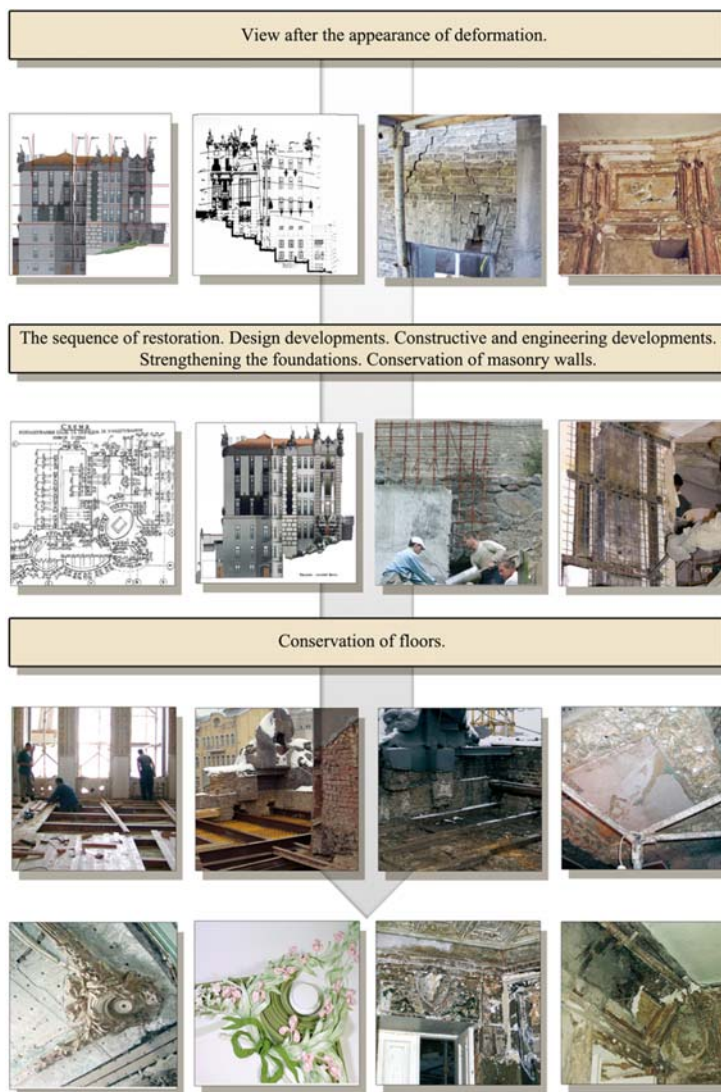
Fig. 3. The problems and restoration methods of the building of architect W. Horodecki at 10 Bankova Street in Kyiv

The reason of cracks was not eliminated, and because of the presence of a number of internal channels in the walls of the building, the injection mortar got into the channels, and its appearance in various places could not be foreseen. The inefficiency of previous restoration measures was confirmed by the fact that as of 2002, the building split into two parts and the walls were inclined from the vertical by 38 cm., Fig. 3.

The luxurious facade decor was in a state of emergency, primarily because the metal reinforcement inside the sculptures was rusted, the sculptural and stucco decoration of the walls was mainly in the cracks and in an unsatisfactory condition, including falling off of separate fragments, Fig 3–4. Previous methods of

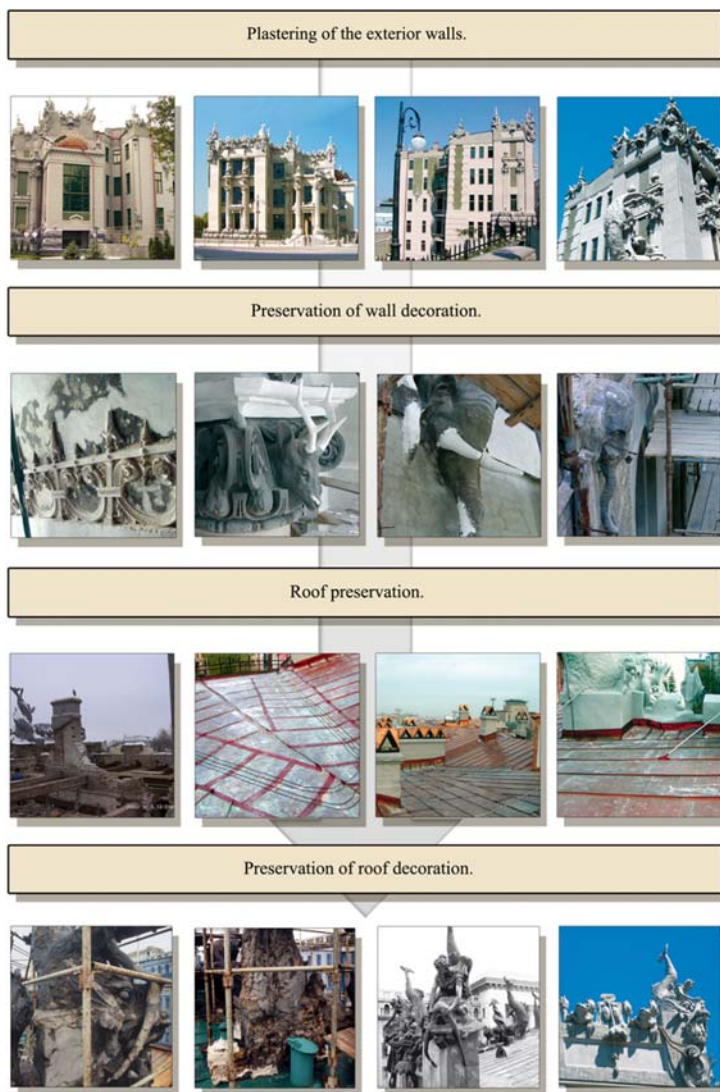
Fig. 4. The problems and restoration methods of the building of architect W. Horodecki at 10 Bankova Street in Kyiv

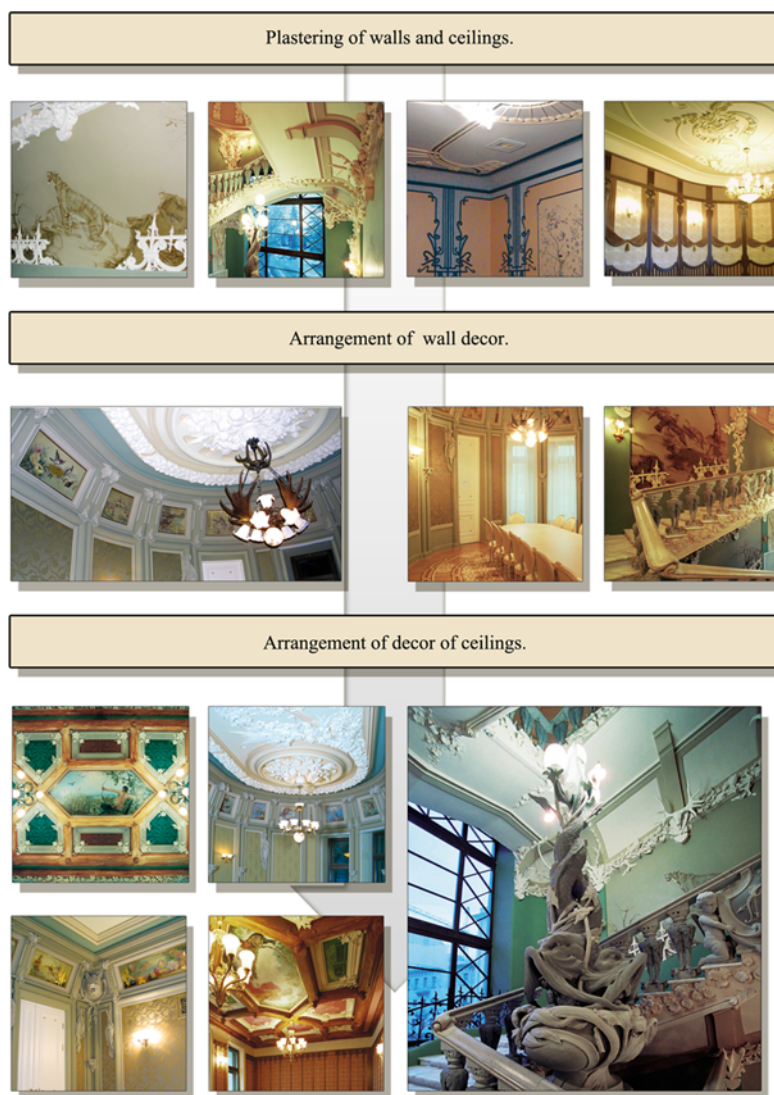
Fig. 5. Restoration methods of the building of architect W. Horodecki at 10 Bankova Street in Kyiv

jacked piles with a diameter of 132 mm to the depth of 8 to 21 m; to eliminate the split of the building into two parts, both parts were “sewed” with horizontal piles – steel reinforcing bars in the brickwork, the walls were reinforced with reinforcing bars with the use of the method of “raticolo cementato” (Italian “Cemented lattice”), the cracks were injected. These works were carried out together with constriction and strengthening with the use of steel channels of deformed and rotten beams (applying the prosthetic method) of internal ceilings, tightening and strengthening of emergency stucco moulding with copper pins (which lost about 60% of the mass in the interior). The sculptures on the roof of the “House with Chimaeras” were preserved; the corrosion-damaged reinforcement was removed and replaced with the stainless steel fittings, the interiors were restored according to archival photographs and survey materials, Fig. 5–7.

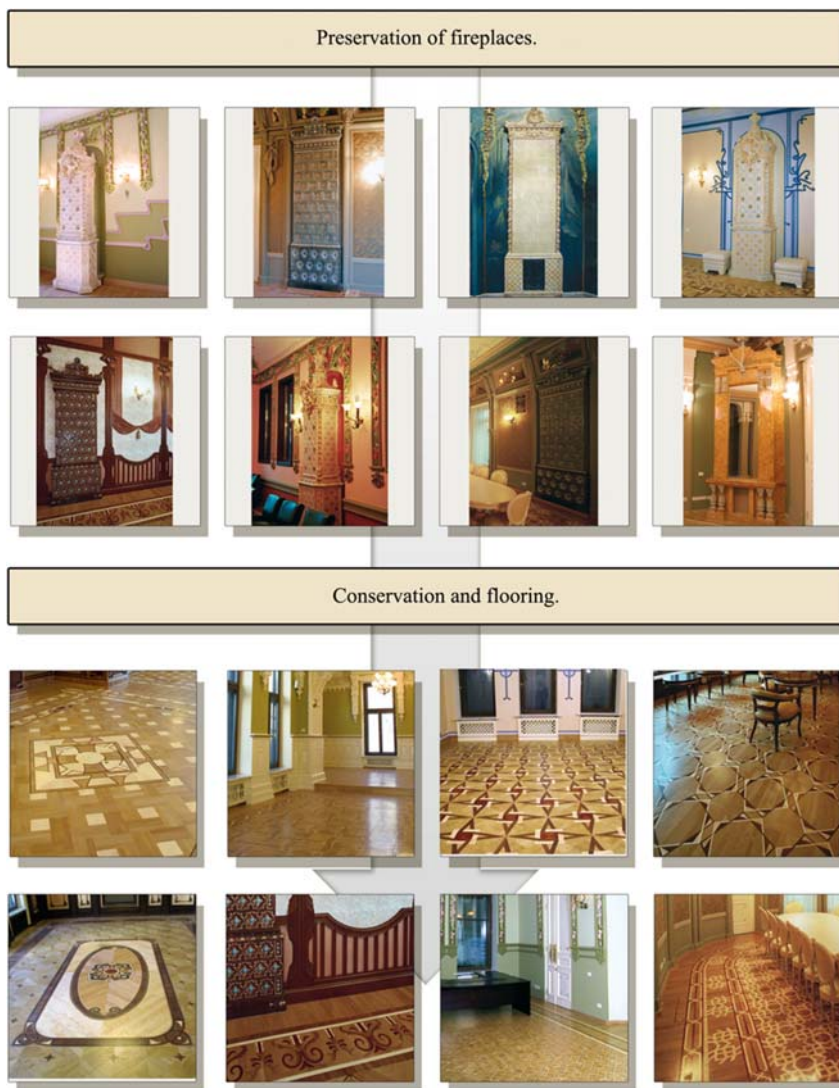
Fig. 6. Restoration methods of the building of architect W. Horodecki at 10 Bankova Street in Kyiv

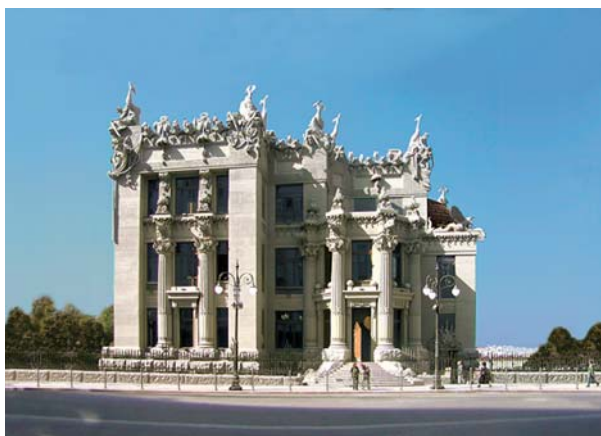
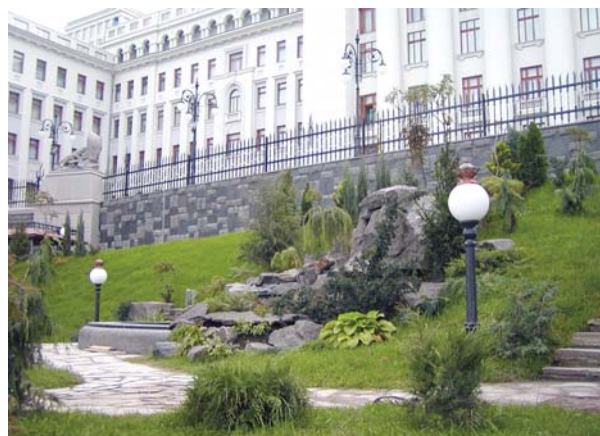
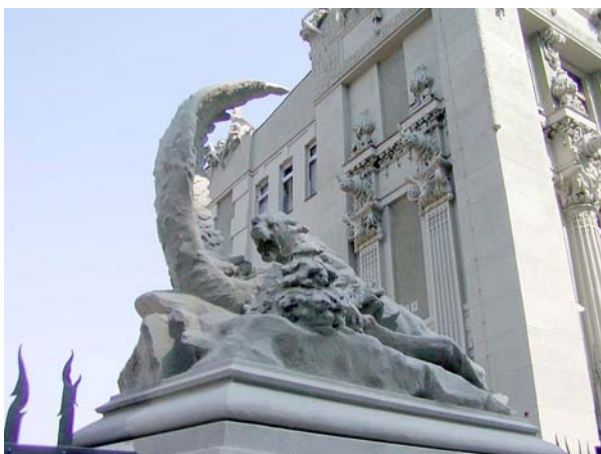
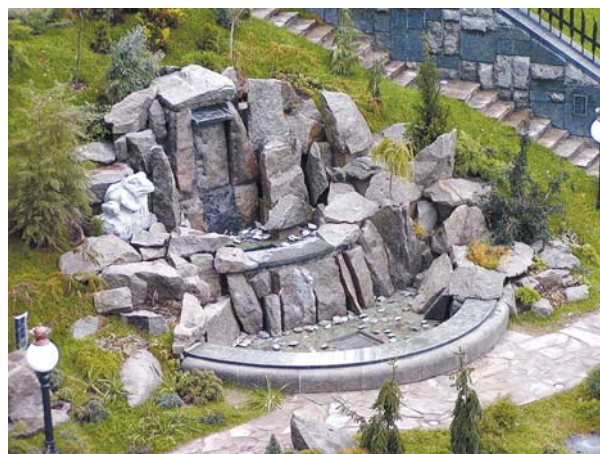
Fig. 7. W. Horodecki House at 10 Bankowa St., after the completion of the restoration work
