The repair of the coke plant „Jadwiga” coke oven battery from the 10 years of the non-failure exploitation perspective

Ludwik Kosyrzyk, Czesław Smółka, Zbigniew Sobala

Ludwik Kosyrzyk
Institute for Chemical
Processing of Coal Za-
brze, Ludwik Kosyrzyk
office@ichpw.zabrze.pl
Czesław Smółka i
Zbigniew Sobala JSW
KOKS S.A. - Coke plant
Jadwiga

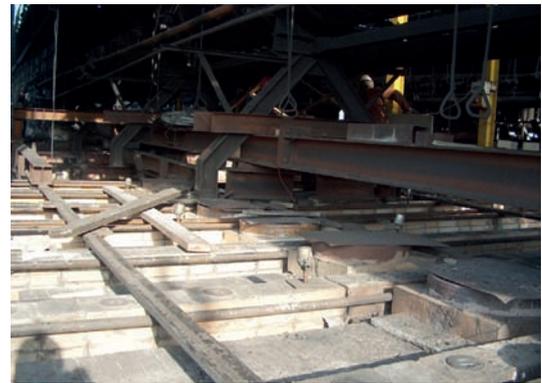
Fig.2 The view of the reinforced collecting main bearings.

Cooling down stage was performed in the same way for all repair nests. The cooling stage enclosed the heating walls, battery bottom and regenerators for the parts of brickwork designated for rebuild and the nearby walls (buffers and half buffers). The chambers designated for rebuild were permanently cut off from collecting main shortly after coke pushing and the ascension pipes were dismantled. At the same time in the buffer chamber 5 strut walls were build which made possible to service the half buffer chambers with 1,5 coking cycle. During the following cooling down days the collecting main bearings (fig.2) and the upper parts of the buckstays (fig. 3) were reinforced and repair nest was roofed and the pathway over the nest was build.

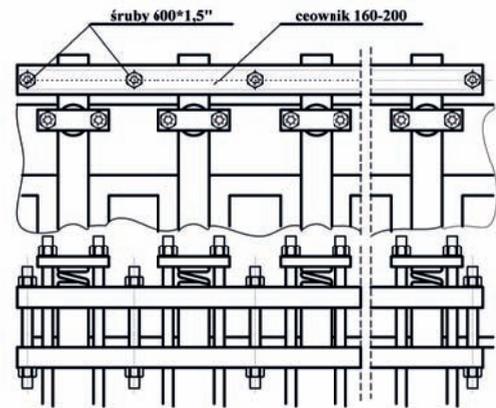
Fig.3 The draft of the reinforcement of the buckstays

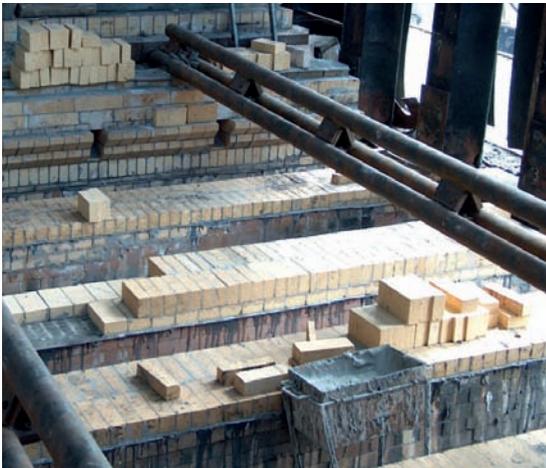
Rys. 5 Widok rozpór montowanych na poziomie trzonu

The standard tasks for demolition stage were removing of the brickwork, dismounting of the ovens fittings and buckstays springs but most important during demolition was the stepwise strutting of the free space of the repair nest on the roof and bottom level with use of the 14 heavy-walled struts Φ 120 mm. The reason was to counteract of moving the heating up or operating parts of the brickwork in direction of the repairing parts of the battery. In spite of that, during repair it was discovered that, despite of strutting, the brickwork was displacing anyway. To counteract the additional packages of the struts were mounted on the battery bottom level and on the battery roof level the additional mounted to collecting main bearings (fig. 5 and 6) struts were added. This, along with other technological activities, helped to maintain the designed chambers width.

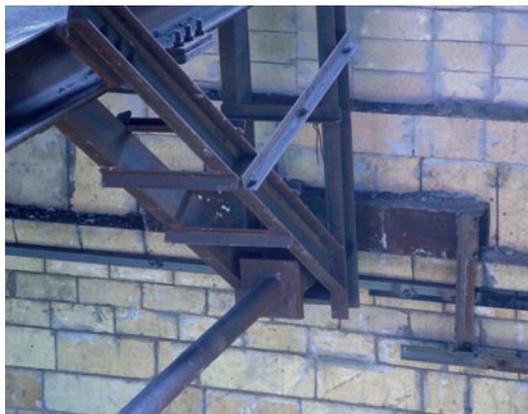
Rys. 6 Widok rozpór montowanych na poziomie sklepienia

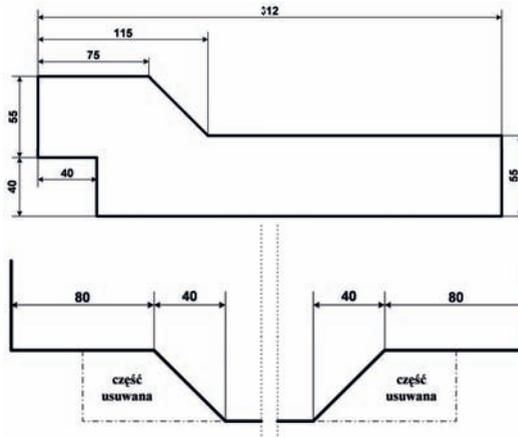
The second major issue for this rebuild was need of a change of the length of the walls, because of the old regenerators' walls base. The old parts of the brickwork, because of the crystallographic changes, elongated on the layer R39 for about 200 mm and on the layer 7R for about 150 mm. In this situation, and what is more the buckstays deflection, the rebuild with the designed length of the heating walls was out of the question. After analysis and geodetic

Fig. 7 Construction of the additional protective ceramic blocks and the method of assembly

measurements it was decided to elongate the heating walls despite of the up coming ceramic materials in original designed dimensions. The solution was to elongate the rebuild parts by 120 mm by incorporating into the wall the additional heads of the walls protective quartz-chamotte blocks (fig. 7). The spacing of the others elements of the ovens stood the same (heating flues, inspection holes, ascension pipes holes).

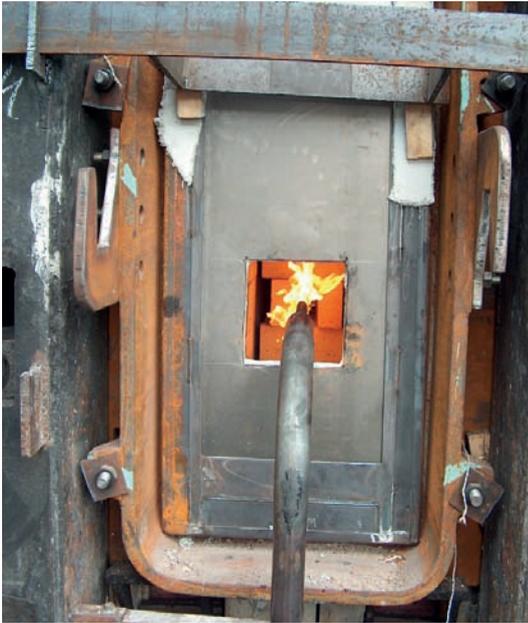
Fig. 8 View of the new solution for chamber isolation

The heating up of the rebuild parts of the brickwork was conducted in the same way as it is during the new battery start up. Firstly the heating up, up to 700 °C, was conducted through the temporary furnaces in the chambers during the one direction draft. The buffer walls for every repair nest were not heated. During this time the air-waste gas valves were disconnected from the reversion string and all valves were working on the downward stream. The innovative solution for this period was using, instead of traditional isolation walls, hanged on the frames isolation screens with a whole for the burner (fig. 8). This solution helped to improve

the commissioning works without any influence on the heating up process.
