Case Study

INDICATING VERTICAL DEVIATION OF HISTORICAL BUILDINGS USING GEODETIC METHODS - CASE STUDY OF BRICK AND WOOD TOWER IN NOWE MIASTECZKO

Maria MRÓWCZYŃSKA¹, Sławomir GIBOWSKI² University of Zielona Gora, Zielona Góra, Poland

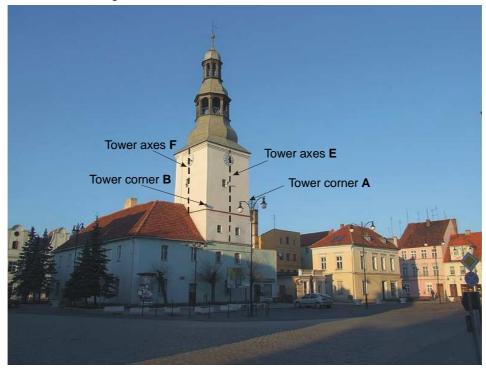
In order to determine the vertical deviation of the tower constituting a part of the Town Hall located on Rynek 2 St. in Nowe Miasteczka, two periodical measurements were taken: prior to the renovation of the tower (March 2010) and upon completing the remodeling works (September 2010). Due to the brickwooden construction of the building structure, corners A and B located on the brick section of the tower and tower axes marked as E and F were selected for measurements (Fig. 1 and 2).

Fig. 1. Tower corners and axes subjected to measurements

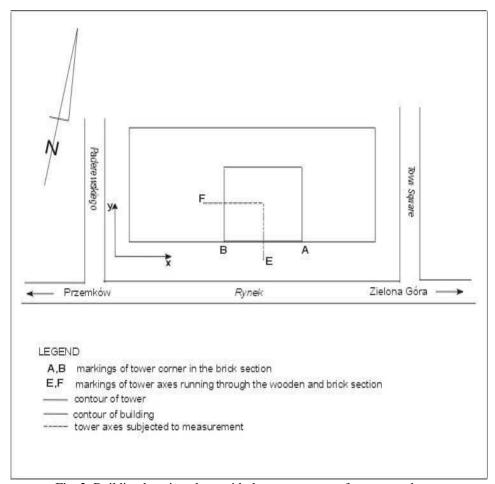
Fig. 2. Building location along with the arrangement of corners and axes

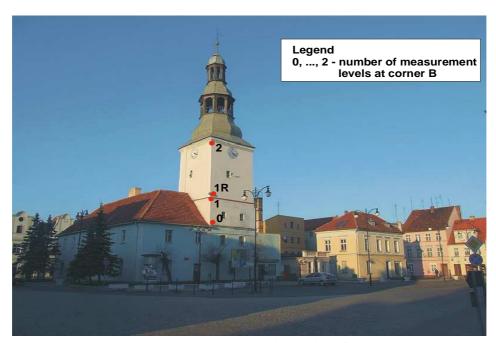
Measurement of vertical deviations by method of direct projection was carried out at 4 measurement points located at given levels of two corners (A and B) of the brick section - attention should be paid to the fact that one of the points (marked in Fig. 3 as 1R) was a reduction due to the change in the thickness of exterior walls, and at 4 measurement points located at given levels of two axes (E and F) running through the brick as well as wooden part of the tower (Fig. 4).

Fig. 3. Measurement levels on brick section of the tower

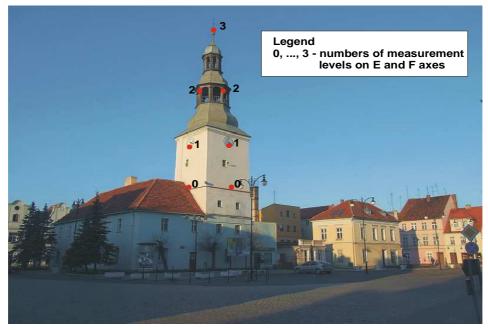
Fig. 4. Measurement levels on the axis of the wooden section of the tower

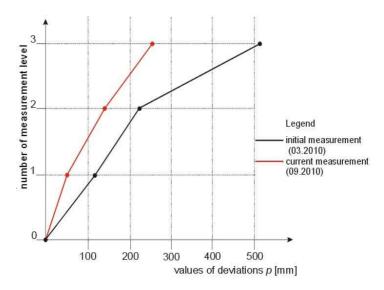
Maximum vertical deviations obtained from carrying out two periodical measurements have been presented in Table 1. Taking into consideration the measurement of vertical deviations taken for the tower axis, it was confirmed that the observed deviations are significantly larger than the deviations of the corner edges of the tower, and reach a maximum value of 511.7 mm before renovation and 265.2 after renovation at the last (4th) measurement level. Level 4 was located at a height of 34.09 m.

It ought to be pointed out that, in relation to the initial measurement carried out in March 2010, the values of deviation were reduced by -26.4 mm for corner A, -5.4 mm for corner B, and -246.5 mm for tower axes E and F. A compilation of changes in the vertical deviation at the individual levels from the initial measurement to the current one has been presented in Table 2. Deviations of the tower axis obtained at the initial measurement (prior to renovation) and the current measurement (following renovation) have also been presented graphically in Fig. 5.

Fig. 5. Deviation of tower axis in initial and current measurement
