## TECHNICAL DIAGNOSTICS OF HYDROPOWER TURBINE USING MODERN MEASUREMENT TECHNIQUES

Grzegorz ŻYWICA<sup>1</sup>, Maciej KANIECKI<sup>2</sup>

### Summary

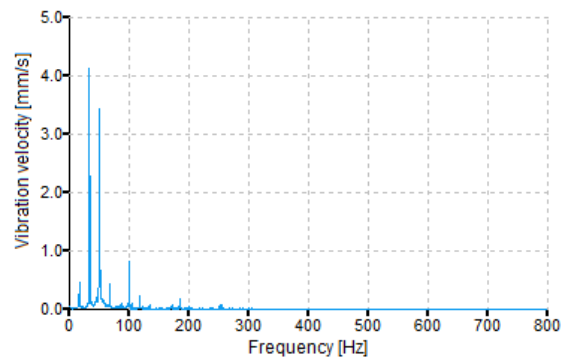
The vibration spectra for two selected measuring points, obtained during dynamic performance test are presented in Fig. 3 and 4. The dominant frequency component of 33.5 Hz is present in both signals, which is close to the frequency value corresponding to misalignment or bending of the shafts. High vibration level was also registered at 50.5 Hz. Moreover, the elevated vibration level in the vertical direction was observed at 65 Hz. Furthermore, the frequency component of 100 Hz was clearly apparent, which corresponds to the electrical excitation frequency of the generator.

Fig. 3. Frequency spectrum of the vibration velocity at node II in the direction X.

of conducted signal analysis it can be concluded that the exceeded vibration level is caused by shaft misalignment or deflection.

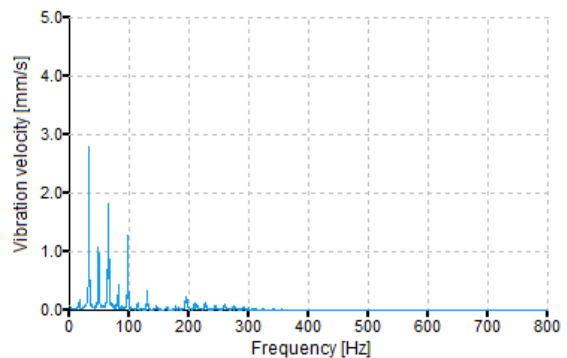
Fig. 4. Frequency spectrum of the vibration velocity at node II in the direction Y.

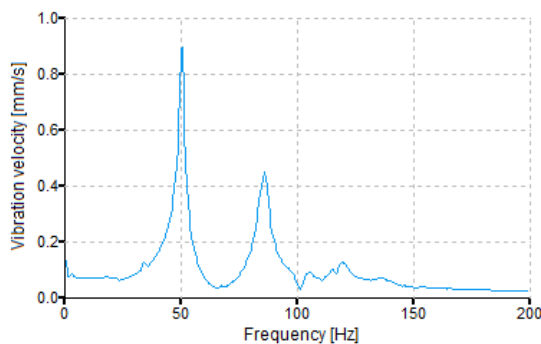
Fig. 5. Vibration spectrum after impact excitation at the node no. I (direction X).

On the basis of characteristics obtained it can be explicitly stated that the generator oscillated about its horizontal plane at the frequency of 50.5 Hz. In view of the fact that at the same frequency high vibration level was observed for two measuring nodes it has been found that these vibrations can be classified as mechanical oscillations of the entire generator. The resonance also occurred in the node I at 86 Hz, which was related to eigenvibrations of the rear part of generator (also in the horizontal plane). An attempt was also undertaken to determine other mode shapes of the hydro set but the obtained results did not allow for unequivocal identification of remaining eigenfrequencies.

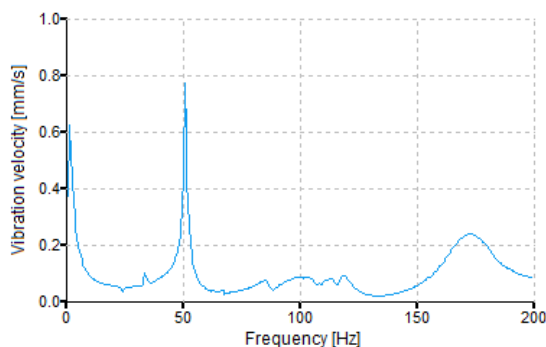
Fig. 6. Vibration spectrum after impact excitation at the node no. II (direction X).

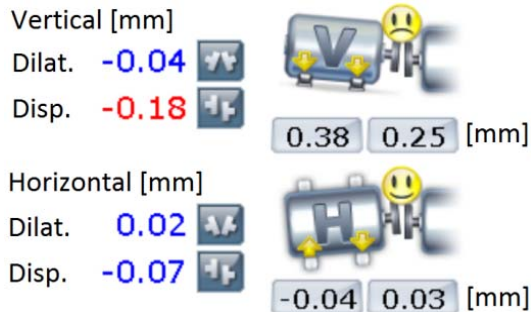
The shaft alignment check revealed the exceedance of limit values in the vertical plane. The height difference between two coupling parts was

only around 0.18 mm, meaning that a change in the heights of front and rear generator's terminals must be applied. These heights were adjusted by 0.25 mm and 0.38 mm, respectively (Fig. 8). Other values were within the recommended tolerances.

Fig. 8. Shaft alignment check results (screen from the measuring instrument).

To confirm the obtained results, the shaft alignment process was repeated several times for various angular positions of the shafts and places for fixing the measuring device. The subsequent results were very close to each other and to the results presented in Fig. 8. The generator was lowered down by removing the spacers of appropriate thickness from under its terminals.

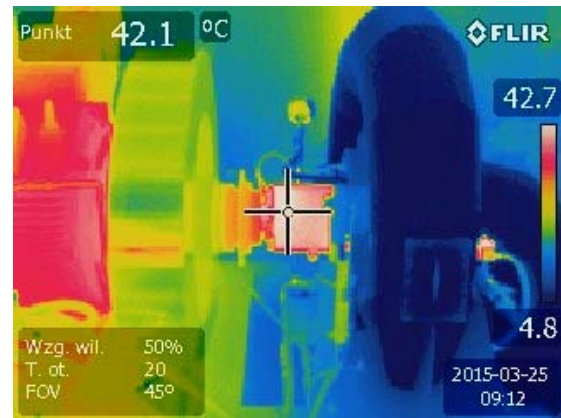
The selected results of the machine's thermographic analyses are shown in Fig. 9 - Fig. 11. In general, all temperature levels of hydro set looked good. The outer surface of the electro-generator's body reached up to 62 °C in some places and the turbine's bearing housing temperature reached a maximum of 65 °C. However, the biggest interest was aroused by the large temperature difference between the turbine and generator bodies (up to 55 °C). This can be seen in Fig. 11. In view of this information, it can be said that such a large temperature difference between bodies and bearing supports attached to the shafts should be addressed in the alignment process. Thermal expansion of steel parts, in that case, may cause the mutual displacement of the shafts in opposite directions, thus worsening operating conditions of the rotating system which leads to the occurrence of higher vibration level.

Fig. 9. Outside surface temperature of the turbine body at the point of bearing attachment.

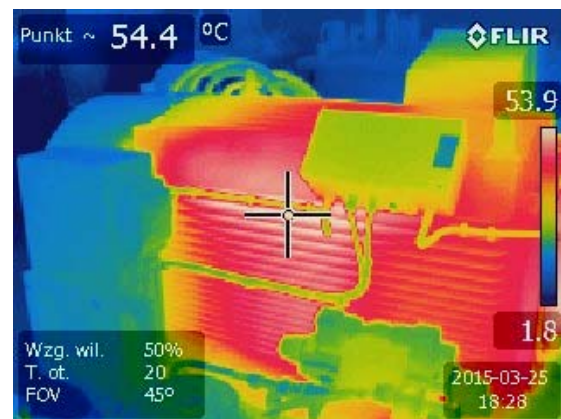
Fig. 10. The temperature distribution on the outer surface of the generator (from electrical connection side).

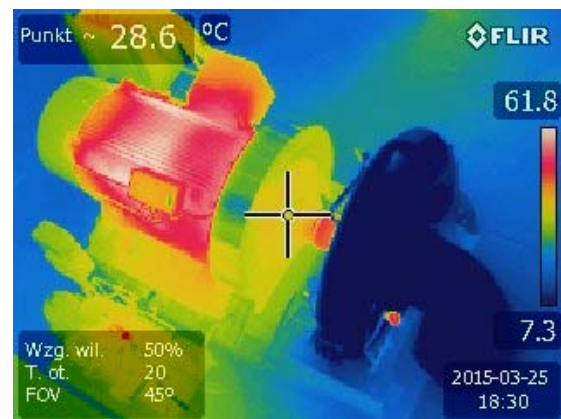
Fig. 11. Outside surface temperature of the hydro set (top view).

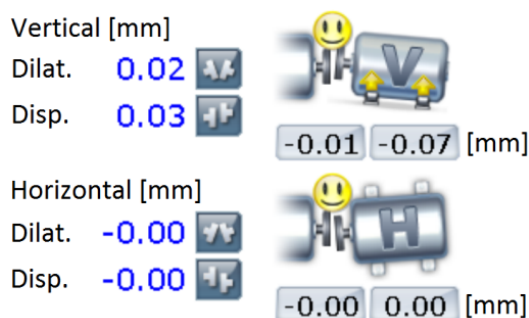
Fig. 12. The results of shaft alignment check after the adjustment of generator's position (screen of the measuring instrument).

The conducted measurements showed correct mutual positions of the shafts. The obtained deviation from ideal position in the vertical plane reached several dozen  $\mu\text{m}$ , which did not permit further correction of the position.

In the described case, the first way was used, i.e. the control measurements were carried out for the pre-heated machine. Regarding the initial position, the spacers with a total thickness of 0.4 mm were removed from under rear generator's terminals, and the spacer of the thickness of 0.2 mm from under front generator's terminals. The results of shaft alignment check obtained after the above changes are shown in Fig. 12.

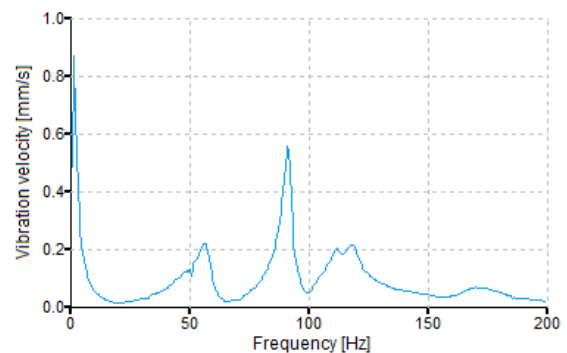
Fig. 13. Vibration spectrum after the impact excitation at node I (direction X).

At the characteristic frequency of 50.5 Hz, the elevated vibration level continued to be observed, but it was no longer seen as a resonance.

The additional elements increasing the stiffness of the generator's foundation were mounted on the steel frame to change the frequency of generator's eigenvibration. The aim was to increase the natural frequency enough to prevent overlapping it with the exciting frequency of the rotating system  $3X$ , coming from misalignment. After mounting the frame reinforcements, the registered generator's vibration spectrum (Fig. 13 and Fig. 14) showed that the eigenfrequency increased to 55.5 Hz (was higher by 5 Hz than it had been before). This avoided the problem of operation under resonance conditions. Moreover, the vibration amplitude value of this mode shape was more than three times lower, at a similar level of exciting force.

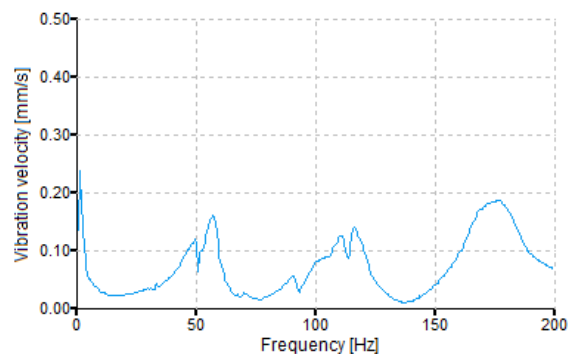
Fig. 14. Vibration spectrum after the impact excitation at node I (direction Y).

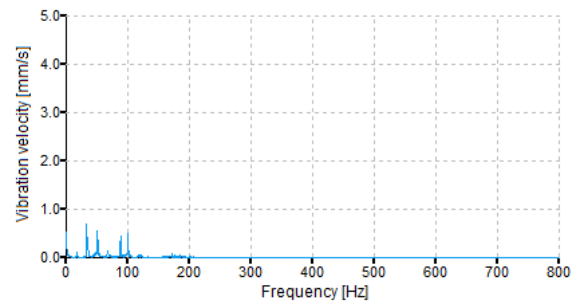
In line with a decrease in vibration level, the frequency spectra of measured signals changed (Fig. 15 and Fig. 16). Apart from a large decrease in the amplitude values of individual vibration components (compared to the results obtained during initial check, see Fig. 3 and Fig. 4), the reduction of the prevailing importance of characteristic components occurring during misalignment of the shafts could be observed. The characteristics below contain several vibration components of comparable amplitude values, which means that the overall vibration level

Fig. 15. Frequency spectrum of the vibration velocity at node II in the direction X

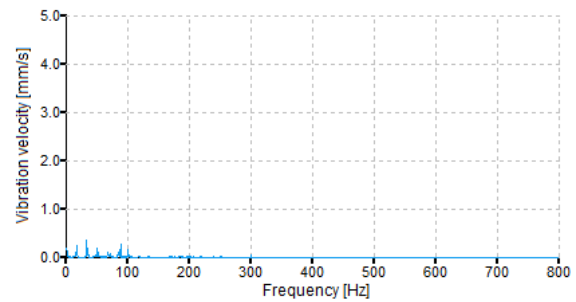
Fig. 16. Frequency spectrum of the vibration velocity at node II in the direction Y.
