## ANALYSIS OF CORROSION CAUSES OF THE CHROMIUM-NICKEL COATING APPLIED FOR PROTECTING THE ACTUATOR OF PISTON RODS

**Key words:** piston rod, chromium-nickel coating, cathode coating, anode protection, corrosion, damage in the operation.

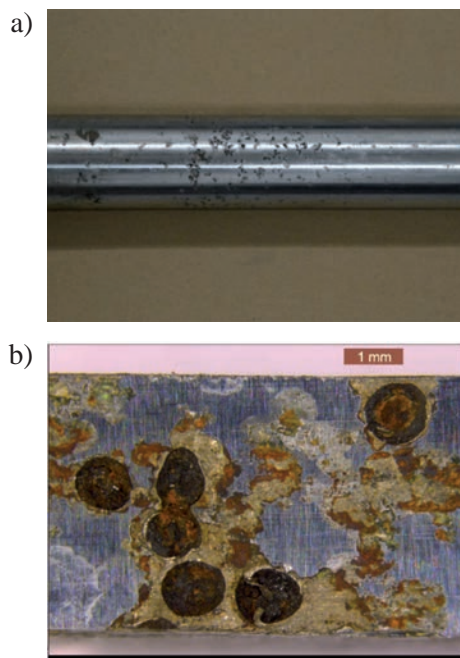
The tests were performed on an actuator rod made of the S355J2 grade steel, which had premature failure due to corrosion. The general view and the character of corrosion changes present on surface of the tested component are shown in Figure 1. It was found that the defects show the nature of pitting corrosion. Traces indicating the occurrence of mechanical damages in the chromium coating were locally observed.

**Fig. 1.** General view of the tested rod (a) and a stereoscopic image obtained from the sample collected from its surface (b). Corrosion pitting is visible and the chromium coating is peeled off locally

Due to the nature of the machine work and the environmental conditions of its operation, the effective protection against corrosion is the constructional

shielding of the piston rod fragment, which is exposed to mechanical and corrosive impact of the environment. Consideration is justified of applying superficial layers that will show higher resistance to mechanical damage and corrosion will extend the life of actuators.

Example of coatings that could be alternatives are those based on chromium manufactured with thermal spray technologies, especially high-velocity oxy-fuel (HVOF). These indicate better resistance to corrosion, especially in an environment containing ions of chlorides and proper mechanical properties [8–10].

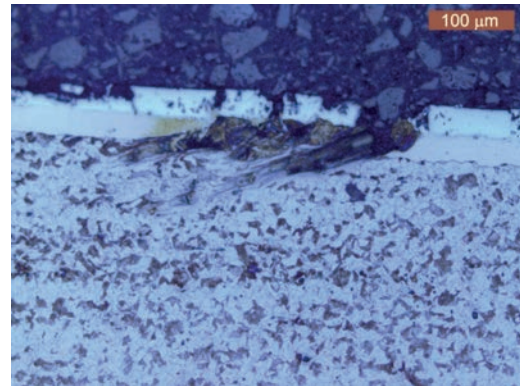
The microscopic tests using light microscopy methods were performed with the use of a Leica CTR6000 microscope at the transverse section of the sample taken from the piston rod. It was found that the microstructure of the steel substrate material was characterised with the correct ferritic-pearlitic structure. The chromium coating of about 30  $\mu\text{m}$  thickness deposited by electroplating was applied over the sublayer of nickel of the same thickness in order to increase its adhesion to the substrate. Microscopic mechanical defects of the external surface of the tested rod created as a result of the hard particles action were observed locally (Fig. 2).

**Fig. 2.** The ferritic-pearlitic microstructure of the tested piston rod in the near surface area. Visible Cr/Ni coatings mechanically damaged by the action of the hard particles. Transverse section. Etched state. Light microscopy

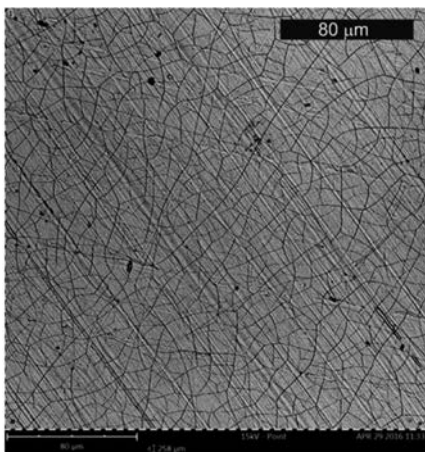
The SEM microscopic observations were performed on the external surface of the component using a Phenom ProX microscope. It was found that, in the area of macroscopic corrosion, changes shown in Figure 1 b are the local mechanical damages of the chromium coating that appeared as a result of its cracking. The characteristic feature of brittle chromium coat is its cracking leading to a network of fine cracks (Fig. 3). Similar surface damages were observed by the authors of works [2, 6, 7]. It has been proved that their density is closely related to thickness of the chromium coating and the existing residual stresses [7]. As a consequence, in locations of their occurrence, as a result of reactions with galvanic corrosion mechanisms, intensified by the presence of slots, leading to differentiation in oxygen concentration at the component surface, the sublayer corrosion took place. The chromium coatings are cathodic relative to the nickel sublayer; therefore, in the case of the appearance of its discontinuity or damage, a corrosion of the nickel sublayer at the boundary of both coatings led to the loss in adhesion and local removal of the chromium coating from substrate resulting in uncovering the nickel.

Fig. 3. General view of the cracked chromium coating. SEM

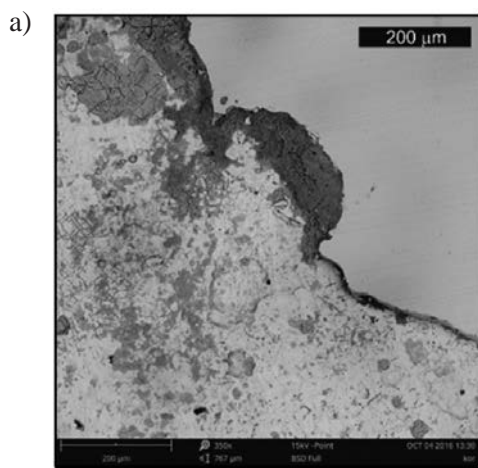
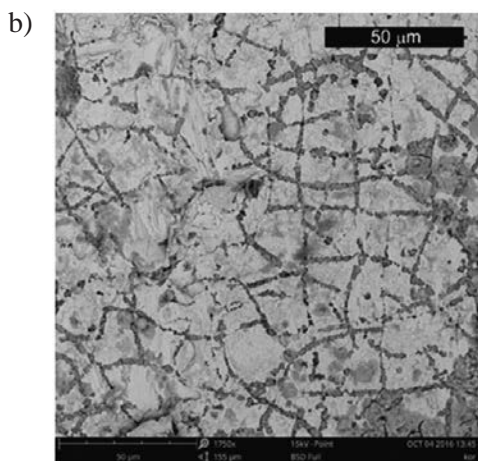
Fig. 4. The nature of chromium coating damages (a). At larger magnifications, the characteristic surface morphology is visible in locations with the chromium coating peeled off (b). SEM

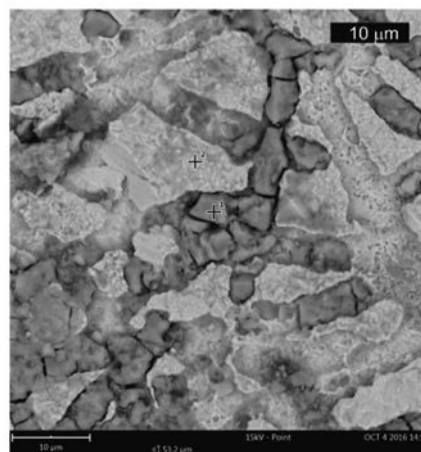
In locations of corrosion in the areas of cracking, the preserved fragments of unseparated but dissolved chromium coating were locally observed. This indicates that electrochemical processes are also taking place in the case of chromium. The residues were situated exclusively in the areas of cracking, creating the characteristic morphology (Figs. 4, 5). Spectra of the characteristic X-ray radiation enabling identification of individual structural components are presented in Figures 6 and 7. The presence of reflexes coming from calcium, sodium, and chlorine in the spectrum obtained from the residues indicates the interaction of the corrosive environment containing calcium and sodium chlorides. In presence of water and the absorption of  $\text{CO}_2$  from air, reactions (1) and (2) take place for those compounds leading to a lowering of the pH. Their

Fig. 5. The magnified fragment of the area from Figure 4. Visible residues of the oxidised chromium coating (dark areas) on the surface of the nickel coating (bright areas). Numbers 1 and 2 mark the locations of the microanalysis of the chemical composition using the EDX method. SEM

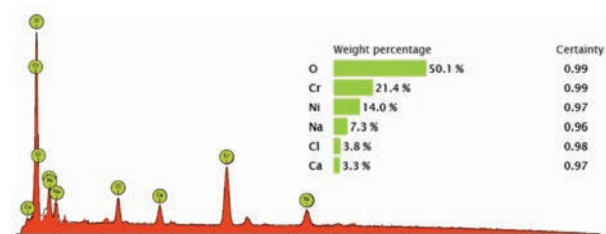
Fig. 6. The spectrum of characteristic X-ray radiation and the results obtained from microanalyses performed for location 1 shown in Figure 5. In the location of the oxidation of chromium and nickel coatings, the presence of chlorine, sodium, and calcium was observed

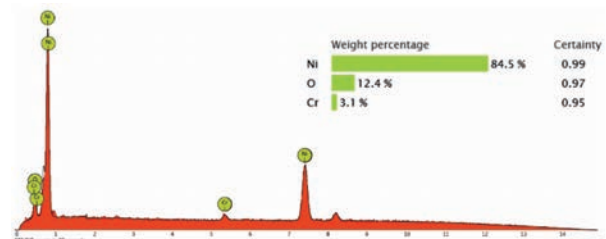
Fig. 7. The spectrum of characteristic X-ray radiation and the results obtained from microanalyses performed for location 2 shown in Figure 5, in the place of the nickel coating's appearance

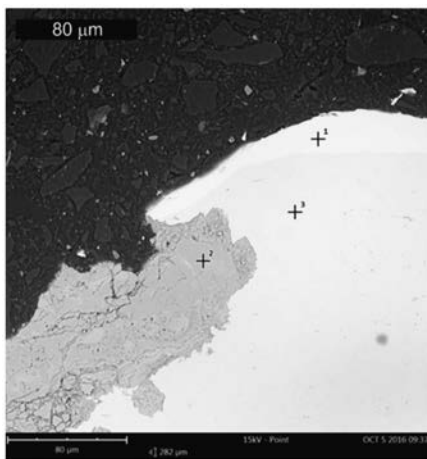
As a result of corrosion or mechanical damage of the impaired nickel coating, the steel substrate was uncovered locally. Both coatings, i.e. chromium and nickel, are cathodic in relation to steel, and losing their density leads to intensive corrosion of steel. Where the steel substrate is revealed, the corrosion pitting happened. The high intensity of the processes is observed

in this case, since the unfavourable phenomenon of large cathodic and small anodic surfaces appear here. This leads to a high density of anodic currents, and it means high rate of the local corrosion in practice. The exemplary microscopic image obtained at the transverse section running through a corrosion pit is shown in Figure 8, and the spectra obtained with the EDX method is shown in Figures 9 to 11. The carbon content in the obtained analyses is overstated due to the application of the conducting graphite resin in the preparation. In order to better illustrate the course of corrosion damages, it is schematically presented in Figure 12.

Fig. 8. Visible exposure of the nickel coating and the products of steel corrosion created as a result of its damage. Numbers 1 and 2 indicate locations of the microanalysis of chemical composition. Transverse section. SEM

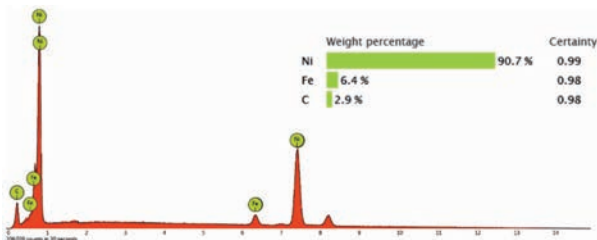
Fig. 9. The spectrum of characteristic X-ray radiation obtained from location 1, shown in Figure 8, indicating for presence of the nickel coating

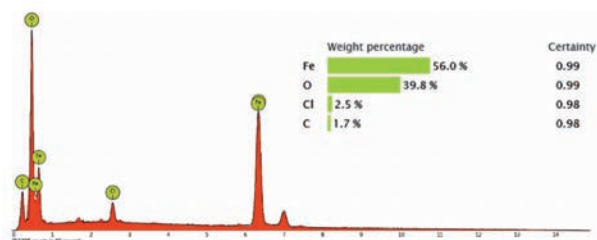
Fig. 10. The spectrum of characteristic X-ray radiation obtained from location 2, shown in Figure 8, in the area of the appearance of steel corrosion products. The presence of chlorine was observed, indicating for its participation in the corrosion process

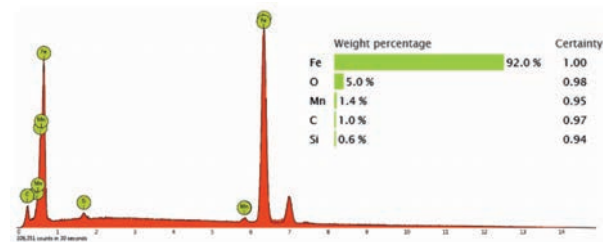
Fig. 11. The spectrum of characteristic X-ray radiation obtained from location 3, shown in Figure 8, in the area of the substrate material

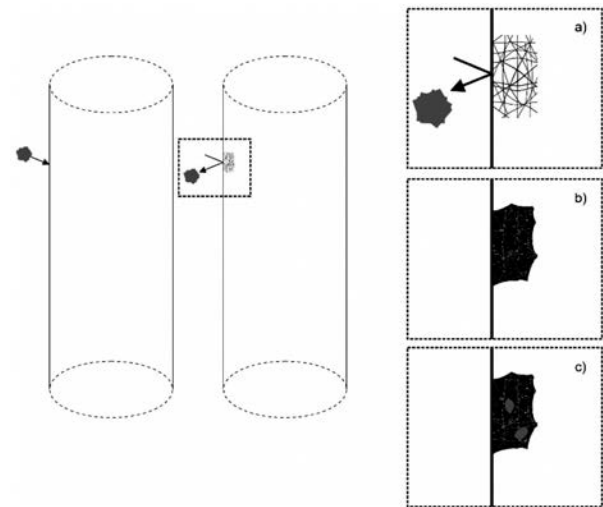
Fig. 12. Schematic diagram of creating damages to the chromium coating surface. (a) Network of fine cracks, (b) loss of the chromium adhesion, and (c) corrosion of the steel substrate
