EXPERIMENTAL CRACK PROPAGATION ANALYSIS OF THE COMPRESSOR BLADES WORKING IN HIGH CYCLE FATIGUE CONDITION

Lucjan Witek

*Rzeszów University of Technology
Rzeszów, Poland*

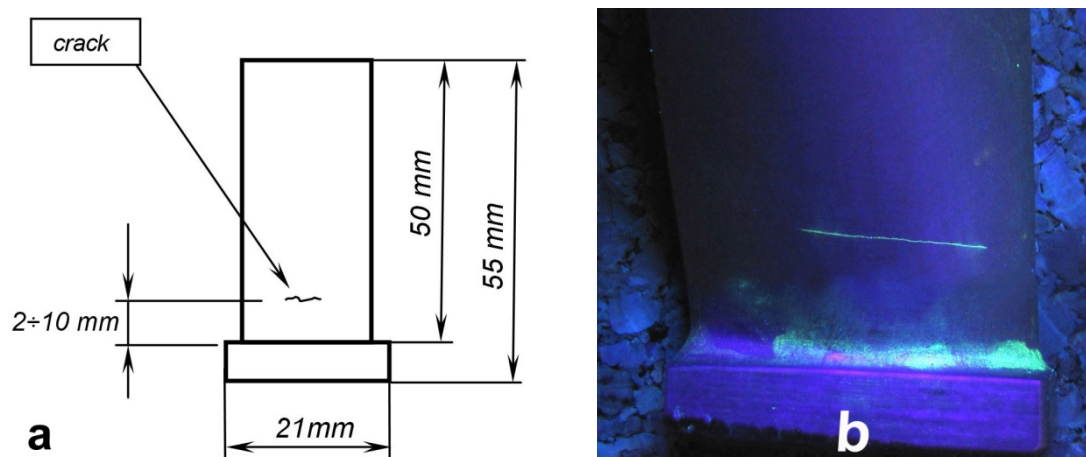
Fig. 3. Overall dimensions of the first stage blade of compressor with location of the cracks (a) and view of luminous crack in UV light (b).

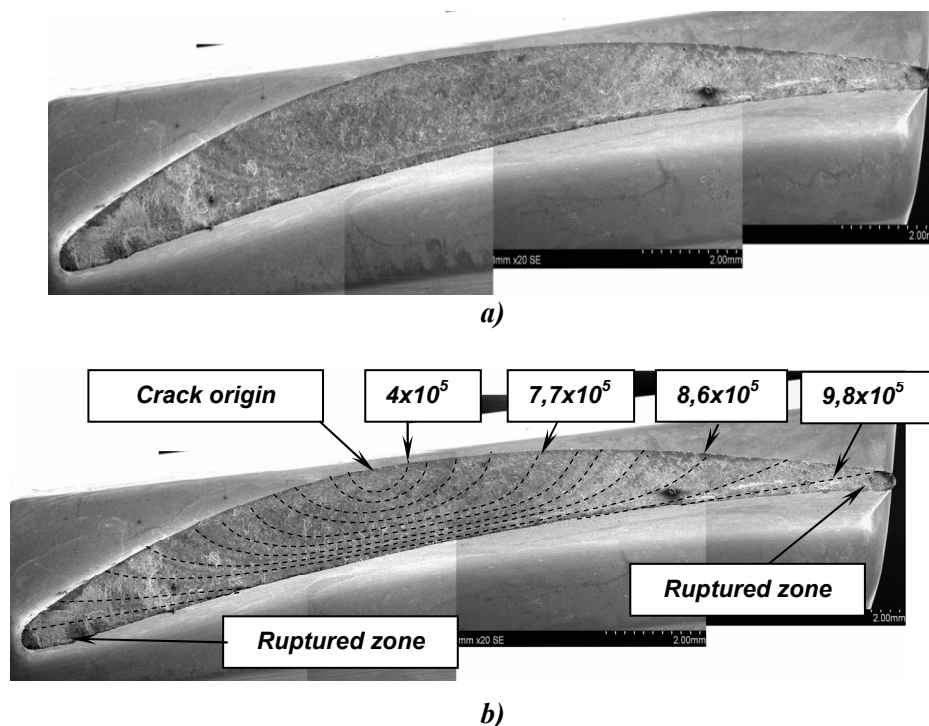
Fig. 4. View of damaged blade (a). Fracture with marked beach marks, created by different number of cycles (b), blade no. 1.

Results presented in Fig. 4÷7 and Tab. 1 are obtained from tests in which intensity of vibration was defined as 12g (for blades no. 1, 2 and 3). The fractured blade number 1 is shown in Fig. 4.

The crack was initiated on the convex surface of profile, about 6 mm above the blade locking piece. The crack origin zone was not covered by corrosion product.

The fatigue test for blade number 1 was conducted in short time and the crack was propagated in non-corrosive environment thus the beach marks presented in Fig. 4a are not well visible,

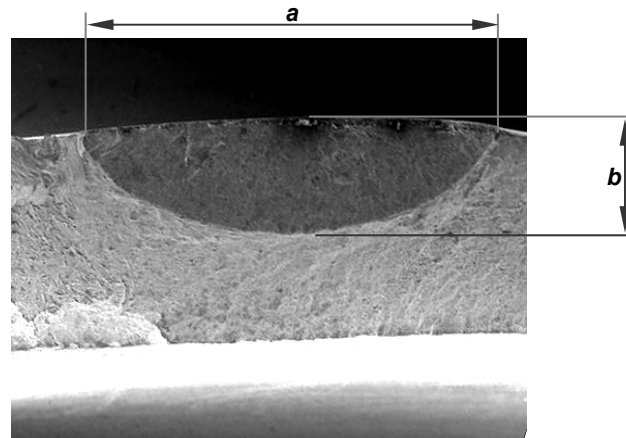
Fig. 6 is a magnified view of the fractured surface. As seen from this figure, the crack front in the early stage of fatigue intensively moves inside the structure. The depth of crack (b dimension) is about 50% of total blade thickness. The fatigue fracture area is dark grey. A fluorescent penetrant was locally heated (in result of micro-friction during vibration) hence its black color around the crack origin zone. This color is not related with corrosion products.

Fig. 6. Shape of crack front just after crack initiation (blade no. 2).

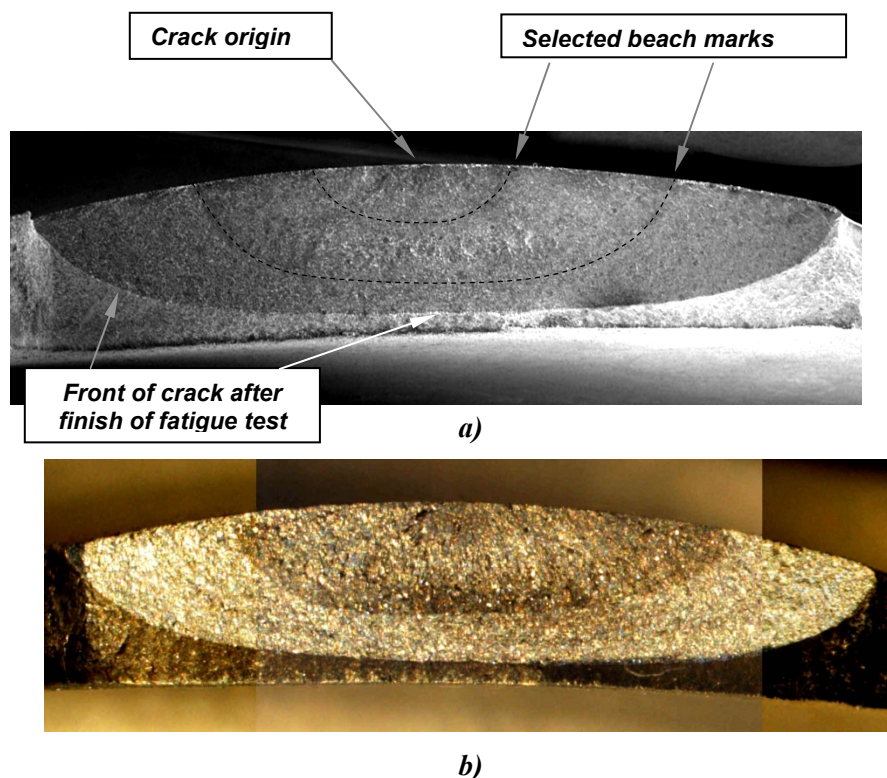
Fig. 7. Shape of crack front in advanced phase of fatigue, after about 8×10^5 number of cycles, visible with use scanning (a) and optical (b) microscope (blade no. 3)

Blade number 3 was vibrated as long as the fatigue crack length (a dimension) was about 10 mm. Next the blade was statically ruptured with use the testing machine. Shape of crack in advanced phase of growth is presented in Fig. 7. As seen from this figure, the crack in advanced

phase of growth propagated quickly in the horizontal direction. By comparison Fig 7a and 7b is visible that not scanning, but optical microscope is better for beach marks observation. Blade no. 3 was tested with about 3 month pause, hence on the fatigue fracture area are visible two different regions (dark around crack origin zone and bright).

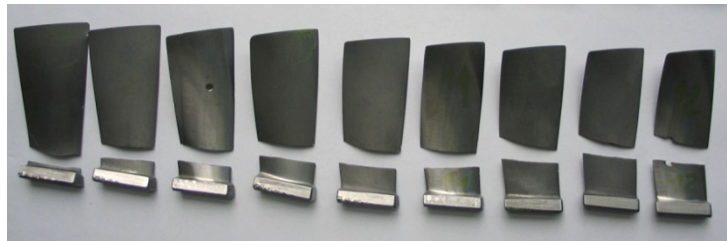
In this paper, results for only three from ten blades were in detail described. The damage schemes of remaining blades are similar to presented in Fig. 4. The cracks were initiated on the convex surface of profile, from 2 mm to 10 mm above the blade locking piece (Fig. 8). The crack origin zones were not covered by corrosion product. In one case the crack was initiated from hole, which was made for fixing of the acceleration sensor (last blade presented in Fig. 8).

Fig. 8. Ruptured blades of the 1-st stage of compressor after investigations (b).

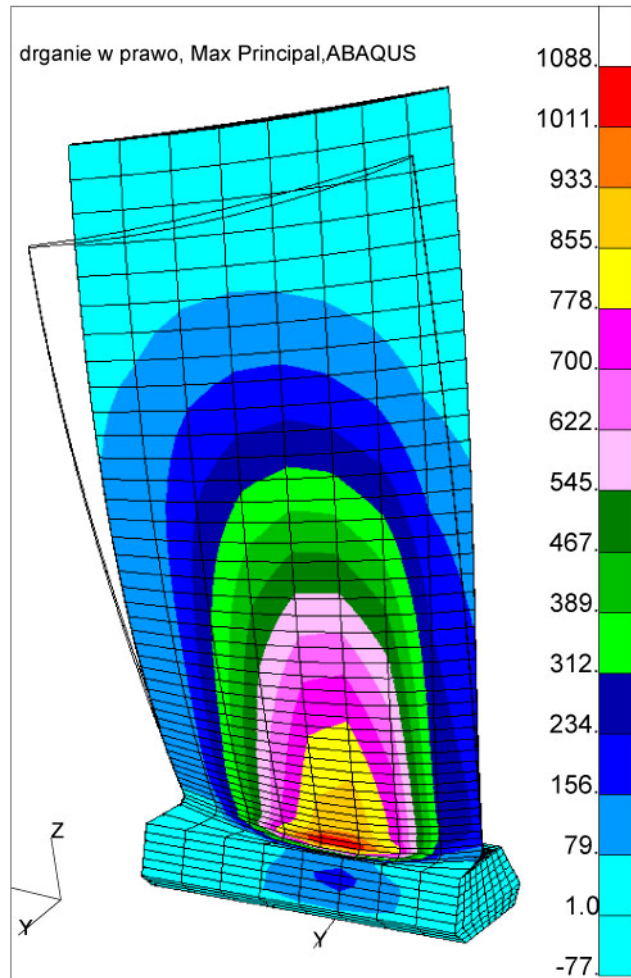
Fig. 11 shows, that the tensile stress on convex surface of blade where the cracks appeared, achieves 622-1011 MPa (for right deflection of blade). The maximum stress region (1088 MPa) is located about 1 mm above the blade locking piece, on central part of convex surface (Fig. 12a). Near the neutral axis of blade cross-section, the tensile stress decreases to 0 MPa. Between maximum stress region and the neutral axis, the high gradient of stresses is observed. During left deflection, the maximum tensile stress region (934 MPa) is located near attack edge of blade (Fig. 12b).

Fig. 11. Maximum principal stress distribution for blade during resonance (mode I, transverse vibrations, amplitude of blade tip: 2,5 mm, right deflection of blade).

The general remark can be formulated based on results of this analysis: the transverse vibrations can be very dangerous for compressor blades because of high stress occurred during blade resonance. In consequence the crack cans rapidly growth to the critical size leded to failure of engine. For these reasons, the work of engine blades in resonance condition should be avoided.

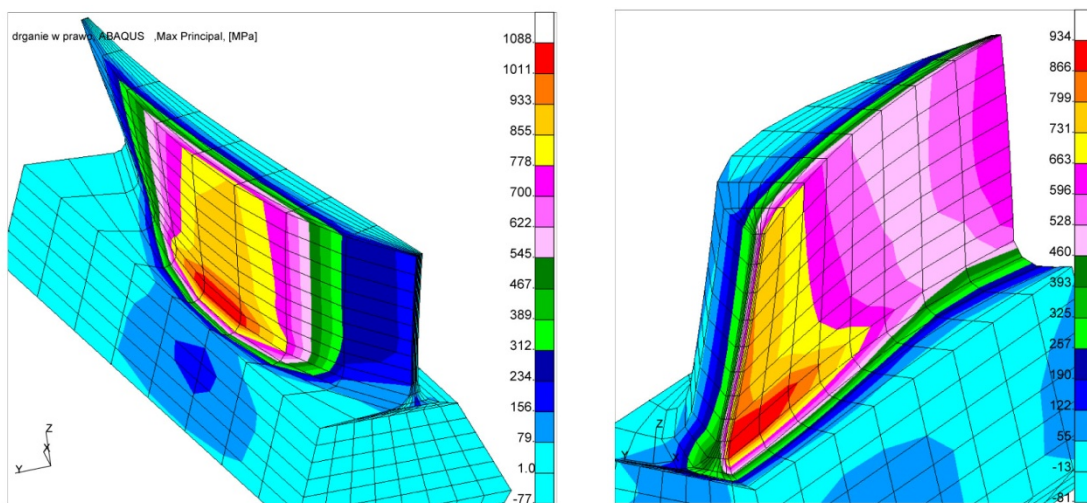
Fig. 12. Maximum principal stress distribution during resonance (mode I, transverse vibrations, amplitude of blade tip: 2,5 mm.). Cross-section in the crack zone before crack initiation. Right (a) and left (b) deflection of blade.

Analysis of numerical results showed, that a main reason for fatigue cracks appearing was high stress occurred during blade resonance. Moreover in the cross-section of blade high stress gradient was observed.
