EXPERIENCE IN RENEWAL BWEs BUCKET AT MÁTRAJ ERŐMŰ SA OPEN PIT

RENOWACJA CZERPAKÓW WIELONACZYNIOWYCH KOPAREK KOŁOWYCH W KOPALNI MÁTRAJ ERŐMŰ SA

Ladányi Gábor, Zoltán Virág - University of Miskolc, Department of Geotechnical Equipment, Hungary

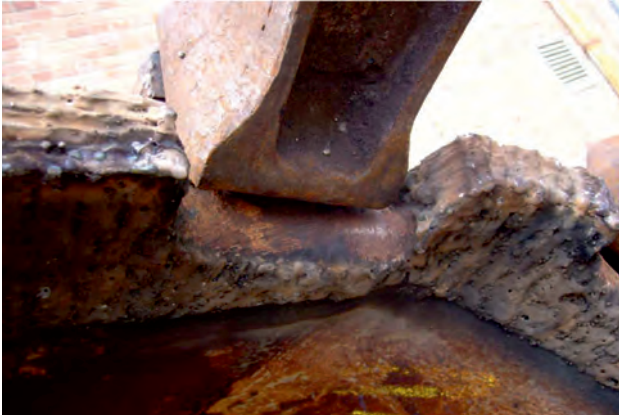
Fig. 3. The deficiency of the relative position of the tooth on cutting blade at the renewed buckets

Rys. 3. Błędna pozycja zęba na ostrzu tnącym po renowacji czerpaka

A general deficiency, – present at ~95% of teeth – the tooth is located in the teeth support (adapter) in such a manner that it is not fitted on the cutting blade of the bucket (Fig. 3).

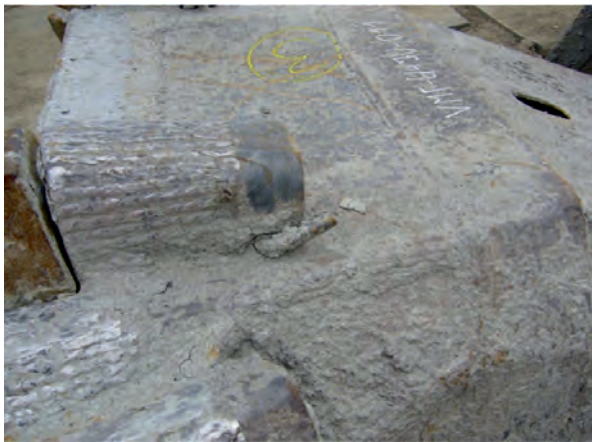
Fig. 4. Wrong positioning of the tooth adapters on the renewed buckets

Rys. 4. Złe ustawienie opraw zębów na czerpakach po renowacji

The tooth adapters are not well positioned (located) in many cases. The incorrect setting of tooth adapters in the positions near to the connecting edges of the cutting blade can be observed even visually without any measuring device. In the figures 4-5 we can easily observe the wrong distance between two adapters located in the vicinity of the connecting edge between front plate and lateral plate of cutting blade.

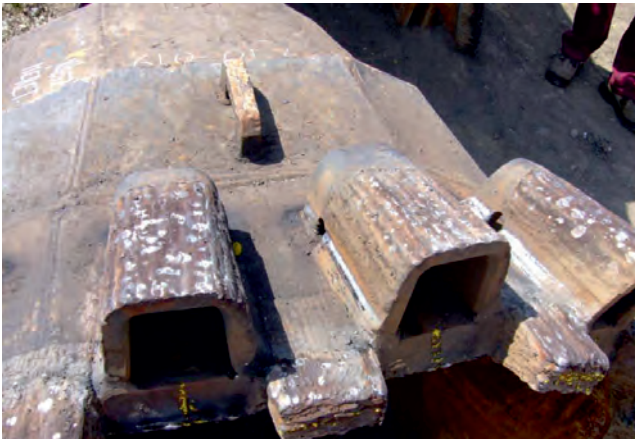
Fig. 6. Renewed cutting blade with adapters

Rys. 6. Odnowione ostrze tnące z oprawami

The intervals between adapters of the cutting blade, during renewal are burdened with weld, so they lose the “cutting edge” character, as it can be seen in figure 6. It is recommended that, during renewal to maintain the initially – prescribed in the design- chamfered edge.

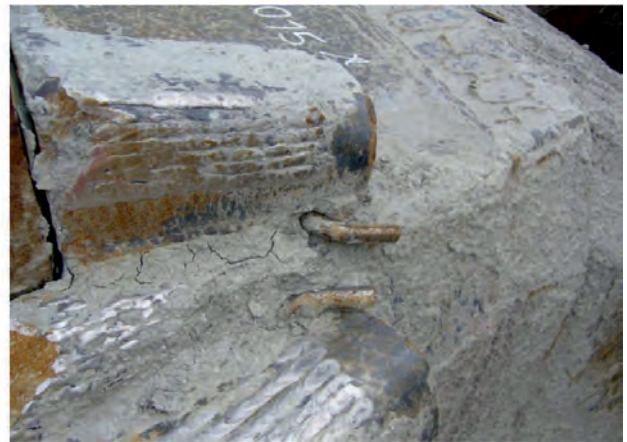
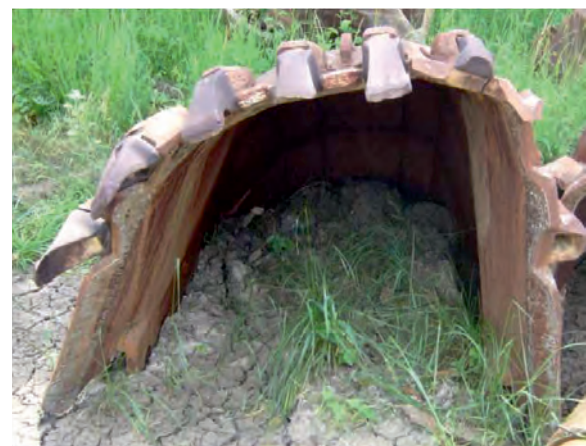
Fig. 7. Failure of teeth

Rys. 7. Uszkodzenie zębów

Also we have had suspicions about the constant character of the teeth’s material. The experience revealed that after different

renewal cycles, teeth made from different quality of material were mounted on buckets. The figure 7 illustrates the evidence of such a situation. We can see on the same bucket bent teeth together with broken ones. That indicates that the quality of teeth’s material varies in a very large range.

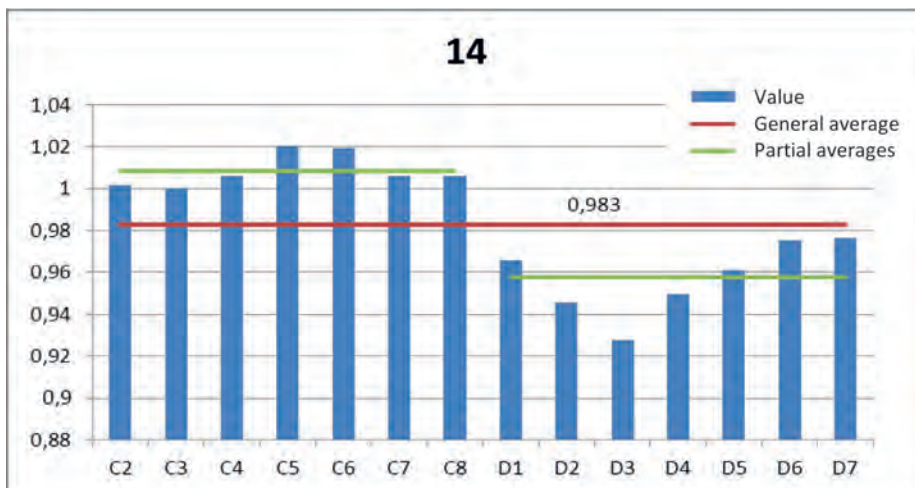
As it can be seen, the average value of the relative deformations (red line with value above) is not very high, being under 2%. But if we analyse individual values, we find greater deviations, as the D3 value on figure 9 is 92.8% of the average value, so the deviation is 7.2%, the highest among 14 records of 17 buckets.

Fig. 9. Relative deviations diagram for the bucket no. 14
Rys. 9. Wykres względnych odchyień dla czerpaka nr 14

The extent of the present paper does not allow to present the diagrams of each of 17 bucket, but analysing them together it is evident that distances from C are above the average, and those from D are located below the average, which is better illustrated by the location of corresponding partial averages marked on diagrams with green lines above each group of measured distances. 71% of buckets were deformed in such of manner that C values increased while D values decreased. By our opinion, this is due to the general overload during excavation and the intrinsic characteristic of asymmetrical shape of the bucket.

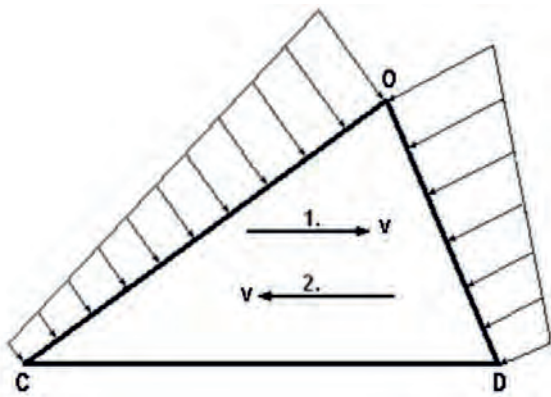
Fig. 10. Simplified triangular shape model of the bucket
Rys. 10. Uproszczony, trójkątny model czerpaka

In the figure 10, we modelled the bucket with a triangular shape frame, taking into account the load carrying aspect. The

asymmetric character has been represented by the non-equilateral shape of the triangle. The figure illustrates that in case of slewing direction marked with 2 the structure exposes a lower rigidity than in case of opposed slewing direction, marked with 1. In this last case, it can be seen that the CO element is able to support the resultant forces acting on DO element. In the opposite case the DO capability to balance the forces acting on CO segment is lower than previous. So, in case of overload, the structure is more exposed to be deformed in case of 2 slewing direction.

This assumption is confirmed by the fact that in reality the DO segment is more frequently damaged (bending, failure, rupture). When slewing in direction 2, the bucket avoid the increased load, by deformation, the rigid support in case of slewing in direction 1 the DO side is more exposed to failure.
