MONITORING VERTICAL DISPLACEMENTS OF AN ENGINEERING OBJECT WITH MASONRY WALLS

Keywords: vertical displacements, geodesic monitoring, engineering object

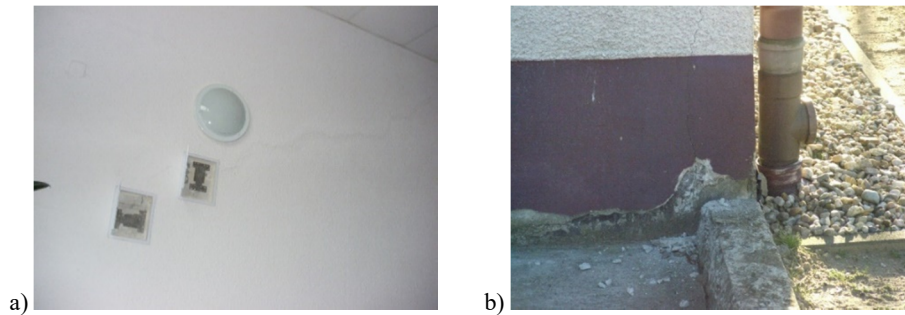
Fig. 2. a) The hall- landing (I-II), the width indicators installed; Fig. b) The corner of the north-west wall, the crack on the wall

Numerous scratches and cracks on the walls were found especially on the second floor of the building. They were the same cracks that had been described in the inspection report from 2006. No other, significant cracks were found inside the building (on lower storeys).

The scratches and cracks were plastered over or covered with nonwoven fabric wallpaper. They did not get wider and the wallpaper was intact, which indicates that the settlement of the building was stable.

Fig. 2 shows the inner corner of the north-west wall. At that place the wall is cracked. Point 4 of the external measurement network is located not far from that place. At that point the displacement is greatest (-2.93 mm).

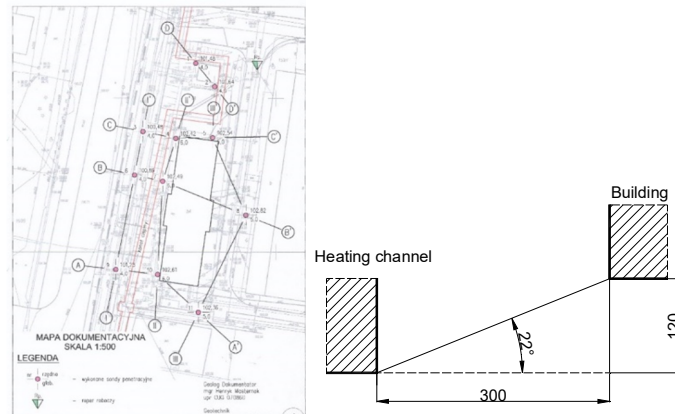
The heating duct running in the vicinity of the building was built earlier than the building. Fig. 3 shows a sketch of the location of the structure in the ground vertically in the place closest to the heating duct.

The building was built on sandy made ground covering the area for many decades. After many years' deposition, sandy made ground can have the characteristics of medium compacted sand.

The heating duct, built earlier than the building, is located deeper. Fig. 3 shows that during the construction of the duct there was no need to prepare the ground for the future building.

Fig. 3. A sketch of the location of the structure in relation to the heating duct

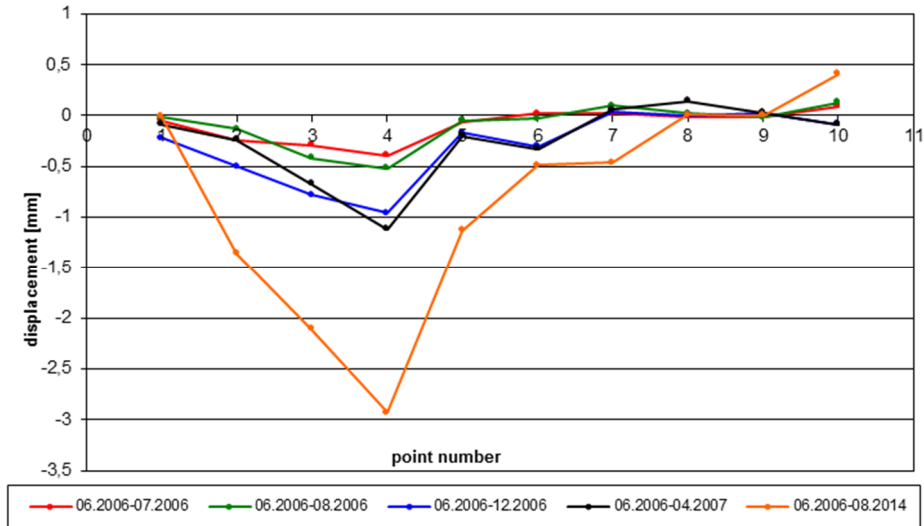
Fig. 6. A diagram of the displacements of points in the external measurement and control network between June 2006 and August 2014

Knowing the displacement values for points in the external measurement and control network located at the foundations, it is possible to notice that these values range from 0.01 mm to -2.93 mm. The largest displacement (-2.93 mm) occurred for point 4 located in one of the corners of the building in the north-west. It should be emphasized that during the measurement campaign (June

2006–April 2007), the largest displacement values were also recorded for point 4. Significant displacements were also observed at points 2 and 3 located on the north wall of the building and at point 5 located on the west wall. The displacements at these points were -1.36 mm, -2.11 mm and -1.13 mm respectively. During the whole research period (June 2006–August 2014), the greatest displacements were observed for point 4. Counting from the beginning of the research, the total displacement of this point is 2.54 mm, which was recorded during the measurement carried out in August 2014.

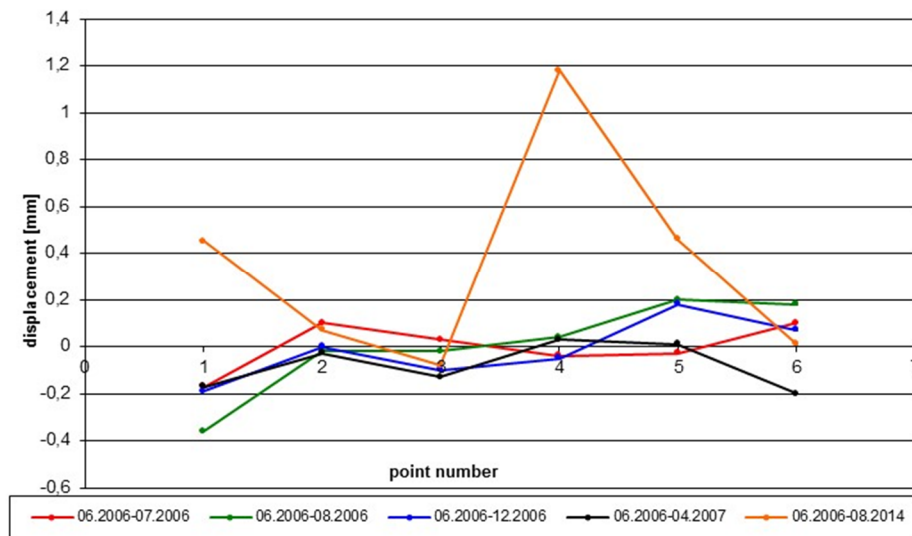
Fig. 7. A diagram of the displacements of points in the internal measurement and control network between June 2006 and August 2014

The displacements of points in the geodesic network located inside the building have values from 0.01 mm to -1.18 mm. The greatest displacement was observed for point 4 located in the staircase on the east wall of the building and in comparison to the initial measurement (June 2006) there was an increase in displacements by 1.22 mm. At the other points of the internal network, displacement values are within the limits of the accuracy of the measurements carried out and do not change significantly in comparison to the initial measurement.

The results of geodetic measurements show that the building's settlement is not even, however, the displacements are very small. The highest value of internal displacement was recorded for point No. 4 and amounted to 1.2 mm. Compared with the previous measurements, this value refers to the rise of the building and not to its settlement.
