RENOVATION OF SHAFT MINING BUILDING NO. 2 IN KŁODAWA SALT MINE

Tomasz BŁASZCZYŃSKI¹, Przemysław WIELENTEJCZYK²

Poznan University of Technology,
Institute of Structural Engineering, Poznan, Poland

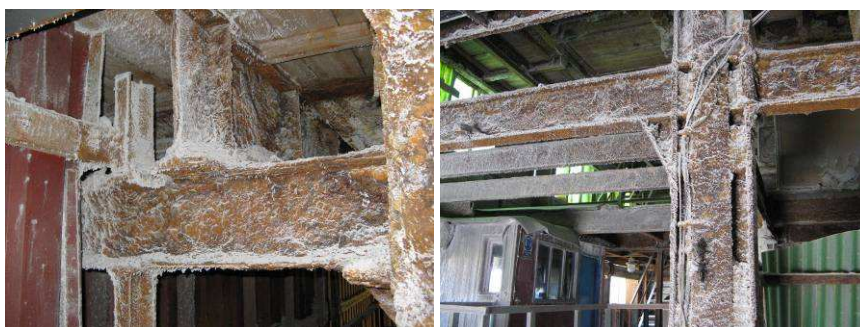
An assessment of the technical state of the building was made along with necessary photographic documentation. The level of damage caused by the corrosion of the steel construction was measured, with particular attention paid to the main load-bearing construction of the floors and columns in areas of increased loads. The state of the construction has been shown in Fig. 3.

Fig. 3. View of the technical state of load-carrying beams and main beams of the frame

A percentage scale indicating the degree in which the thickness of the walls of profiles are reduced in relation to their initial thickness was used to assess the degree of corrosion. This facilitated the introduction of the actual characteristics of the cross-section into a computer program at a later stage of the analysis. Measurements of the depth of corrosion in the cross-sections of columns, secondary beams, primary beams, girders and joists were taken. It was established that the depth of corrosion varies in the different steel profiles. Some of the steel construction is in good shape (elements repaired in 2002), whereas some at immediate risk of failure and requiring replacement. On the basis of the above inspection as well as statistical calculations indicating the

Ceiling and load-carrying beams in the area of the sieves at the level of +8.00 m, between axes 1 and 3 were severely damaged by corrosion and practically impossible to repair. Moreover, they were covered by a thick layer of salt. Immediate replacement of these beams was recommended, as they posed an actual threat to damaging the operating machinery.

The main beams at the various floor levels as well as their connections with columns were strengthened by enclosure in a box using 15 mm (upper and lower strips) and 10 mm (both sides of the web) sheet metal. For this purpose, the wood construction of the ceiling was successively taken apart and upon reinforcing the construction areas, renovation work carried out. In areas where it was not possible to apply the designed methods of reinforcement, additional profiles were welded beneath the existing ones. The connections of columns with beams were strengthened using 15 mm sheet metal and, what is very important, the continuity of strength being carried over from the beams to columns ensured.

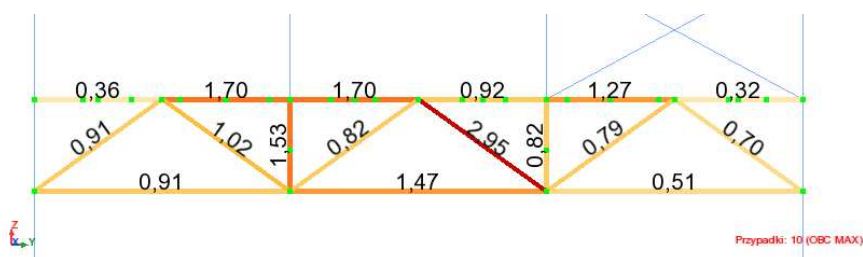
In order to demonstrate the durability analysis procedure and accepting necessary reinforcement on its basis, sample calculations of the load-bearing lattice in axis 3 below the level of +5.30 m have been presented in this chapter. This is a very important element of the construction, as it carries the loads of many higher floors. The calculations were carried out in the Autodesk Robot Structural Analysis program. The spatial model has been presented in Fig. 2. Figure 4 presents the level at which the lattice bars are used, accounting for 30% weakening due to corrosion (state determined on the basis of studies). A coefficient of 1 indicates 100% use. As indicated, the stress-strain state of most profiles in the central zone of the girder significantly exceeds the permissible limits. It should be recognized that a beam with a use of 2.95 was improperly selected at the initial design stage of the construction or that the technological load increased over the time the building was in service. Fig. 5 shows the stress-strain state of the elements of the lattice accounting for strengthening. Examples of how the profiles can be strengthened have been presented in pt. 5.

Fig. 4. Stress-strain state of lattice in axis 3 with profiles weakened by corrosion

The lattice under the level of +5.30 m in axis 3, due to the high stress-strain state of the bars and progression of corrosion, was strengthened by fitting cross braces and additional angle sections adding a minimum of 50% to the cross-section of strengthened bars. The connection of the lattice beam to the existing studs was additionally strengthened by constructing a table under the lower strip. Attention was given to maintaining the continuity of the added angle brackets in the upper and lower strips of the lattice girder. The angle brackets were connected outside the joints on full butt welds.

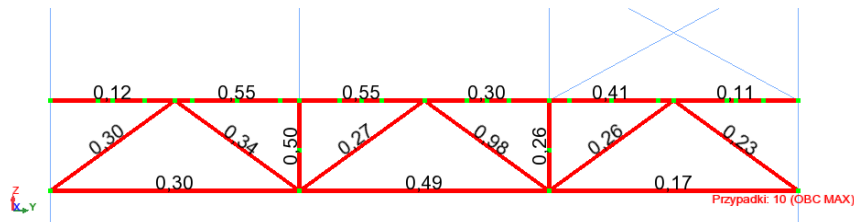
Fig. 5. Stress-strain state of lattice in axis "3" following strengthening

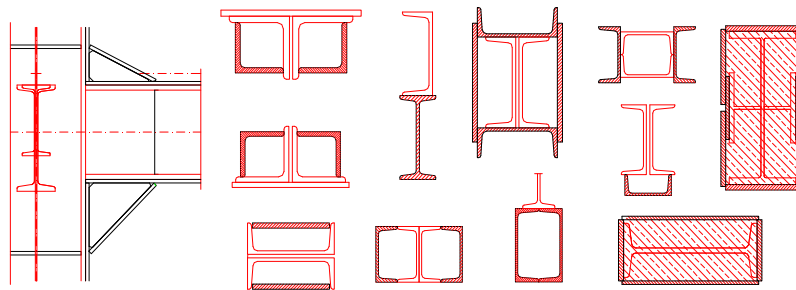
Fig. 6. Examples of ways in which the various load-bearing elements can be repaired

The lattice in axis 4 was strengthened by welding additional rolled profiles and sheet metal, adding a min. of 50% to the cross-section of the reinforced bars.

Schematic means of reinforcing the profiles have been presented in Fig. 6.
